**EVALUATION OF SELF CONSOLIDATING CONCRETE AND CLASS IV CONCRETE FLOW
IN DRILLED SHAFTS – PART 1**

BDV25 TWO977-25

Task 2b Deliverable – Field Exploratory Evaluation of Existing Bridges with Drilled Shaft Foundations

***Chapter Four: Field Exploratory Evaluation of Existing Bridges with Drilled Shaft Foundations
(Task 2b Deliverable)***

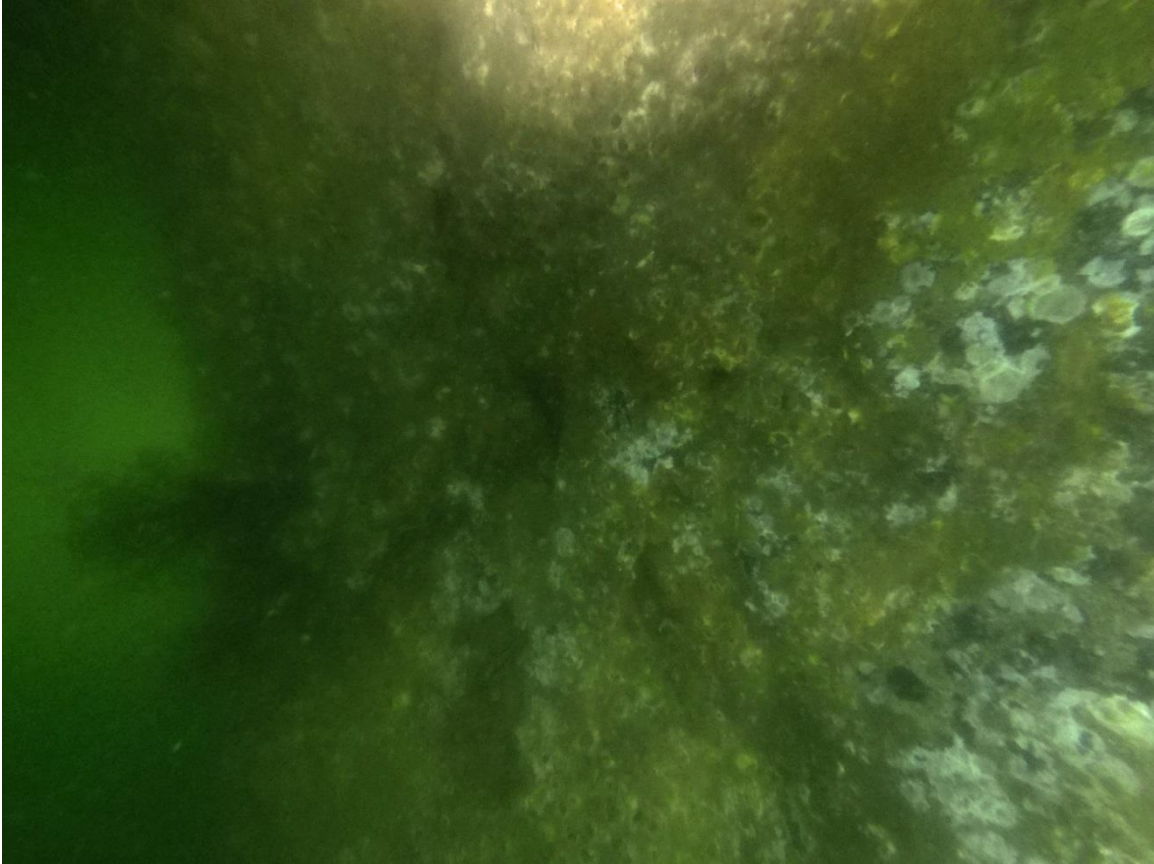
Two shafts were chosen for inspection on Pier 95, 95-1 and 95-3 on the north side. Noted in the diver report, 95-1 had a void 12 in. below the footing/seal that is 32 in. H x 12 in. W x 2 in. D. 95-3 had no known deficiencies. All shafts at Pier 95 are 4 ft in diameter and have a Type 1 reinforcement cage (Figure 4.19b).

95-1 did have a void as noted, and it was noticeable even prior to cleaning (Figure 4.20). This void was substantial; Figure 4.21 shows the void before cleaning, which involved scraping barnacles, grinding and/or wire-brushing. A screwdriver was used for reference of void depth, which was about 2-3 in. (Figure 4.22). However, on the south (interior) side of the same shaft, the concrete was smooth (Figure 4.24). Figure 4.24 does demonstrate a crease, however this was noted to be from casing removal as it was a singular occurrence. The north and south sides of the shaft can be seen in Figure 4.23 and 4.24 respectively. It should be noted that the sides of shafts appear to be concave; however, this is only from lens distortion.

Figure 4.20 95-1 prior to cleaning.

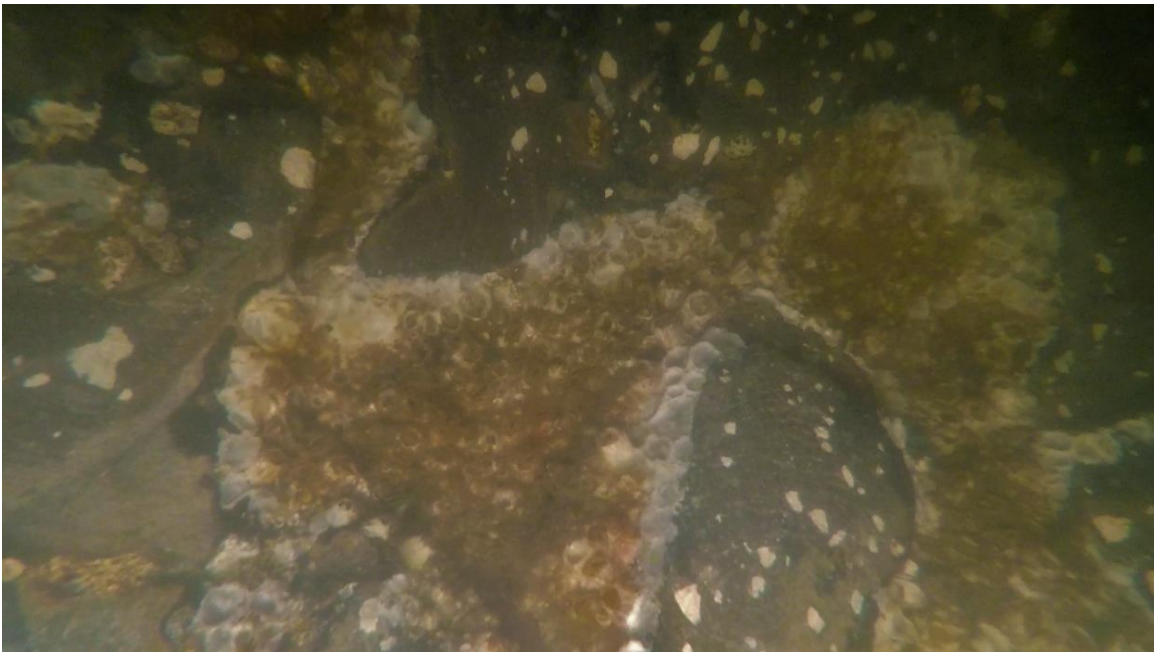
Figure 4.21 Void on 95-1, this was taken after grinding the shaft and before scraping out the barnacles residing in the voids.

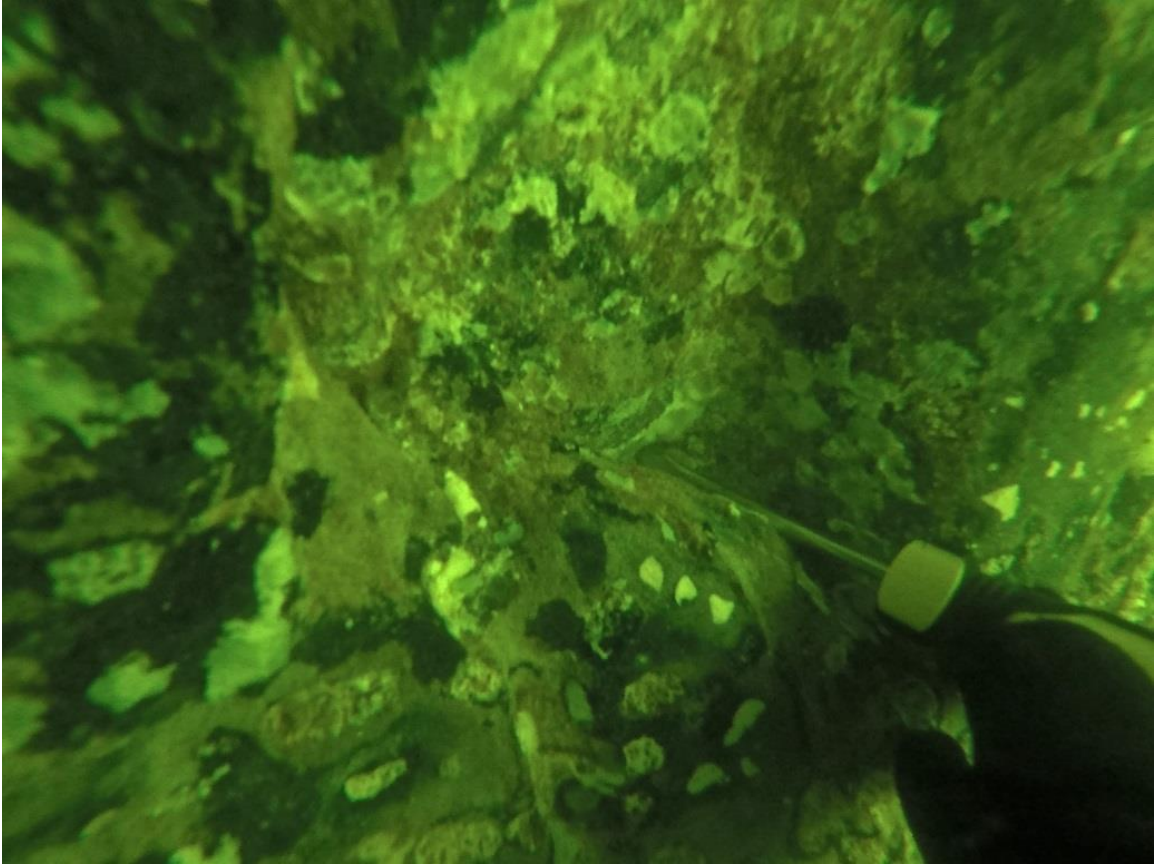
Figure 4.22 2-3in. void in Shaft 95-1 post-barnacle scraping

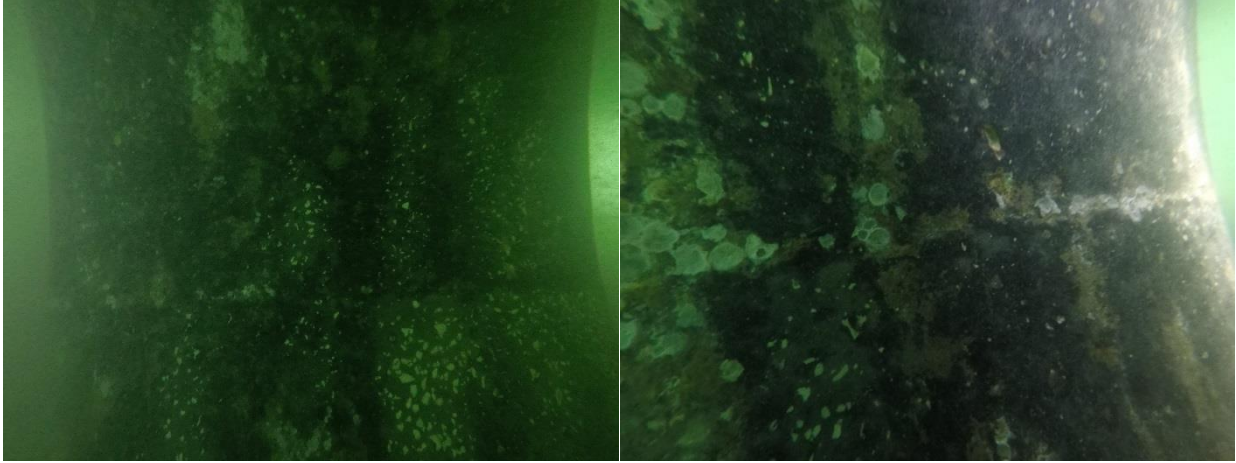
Figure 4.24 (a) South (interior) side of 95-1 post-cleaning, (b) zoomed in view of (a)

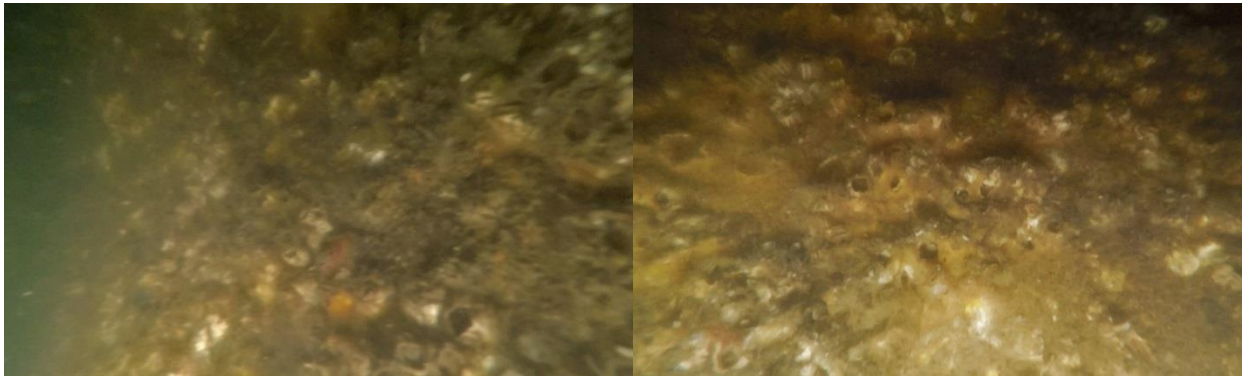
95-3 was cleaned for comparison as a shaft with no observed problems. Figure 4.25 shows 95-3 prior to cleaning. Due to the lack of water clarity on the day of inspection it was difficult to take a picture of the entire shaft, so sections are presented instead of an overall image. Figure 4.26 demonstrates a cleaned portion of the shaft. This shaft did not have any noticeable voids like 95-1. As seen from the cleaned portions the concrete surface was smooth.

Figure 4.25 Shaft 95-3 pre-cleaning

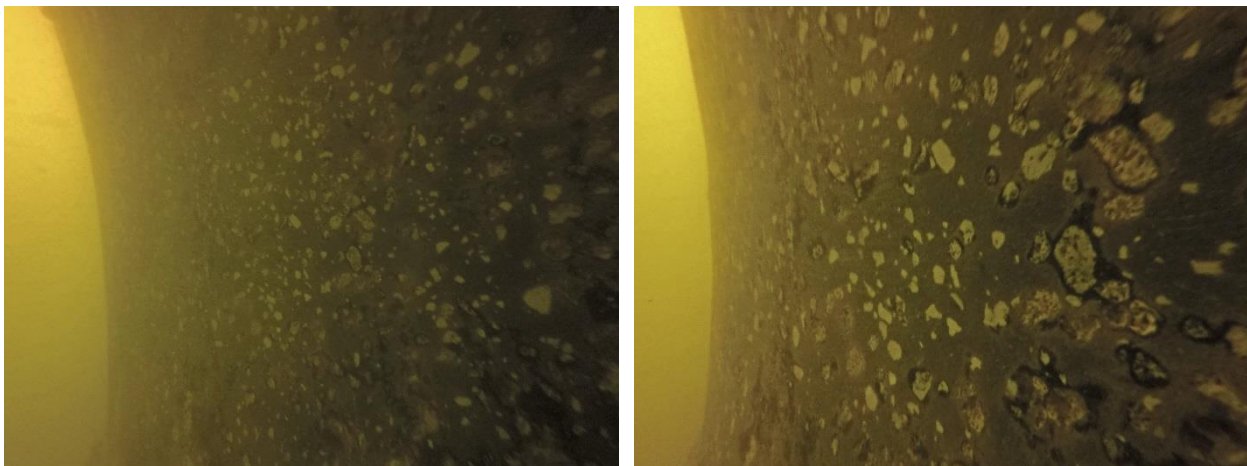
Unfortunately there is no image of 85-2 before cleaning; however, it looked similar to others covered in barnacles. While the cleaned section of the shaft overall shows a smooth surface (Figure 4.30), there are small crevices. As seen in Figures 4.31 and 4.32, barnacles and sea-life fill in these voids. The small voids/crevices are believed to have been caused by the double reinforcement cage, as this was not seen on the 4 ft diameter, single reinforcement cage shafts inspected at Pier 95.

Figure 4.30 Shaft 85-2 after cleaning

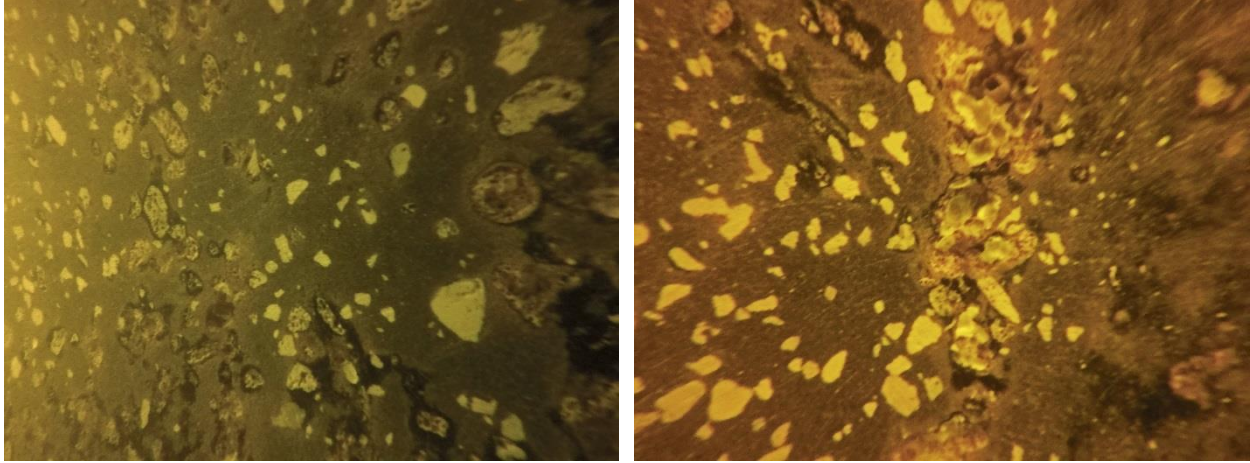
Figure 4.31 Crevices in 85-2 filled with barnacles

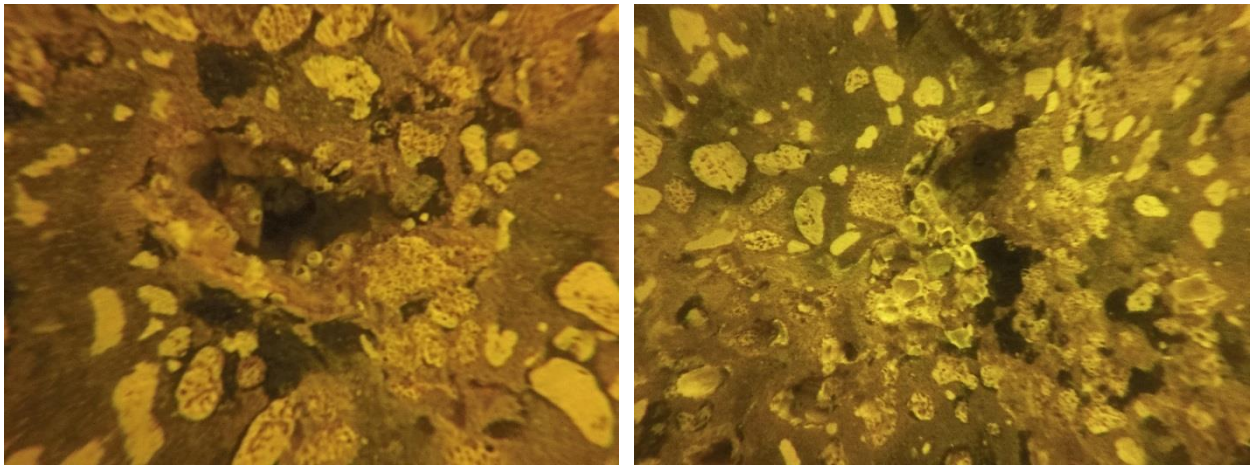
Figure 4.32 Small voids in 85-2 filled with sea-life and barnacles

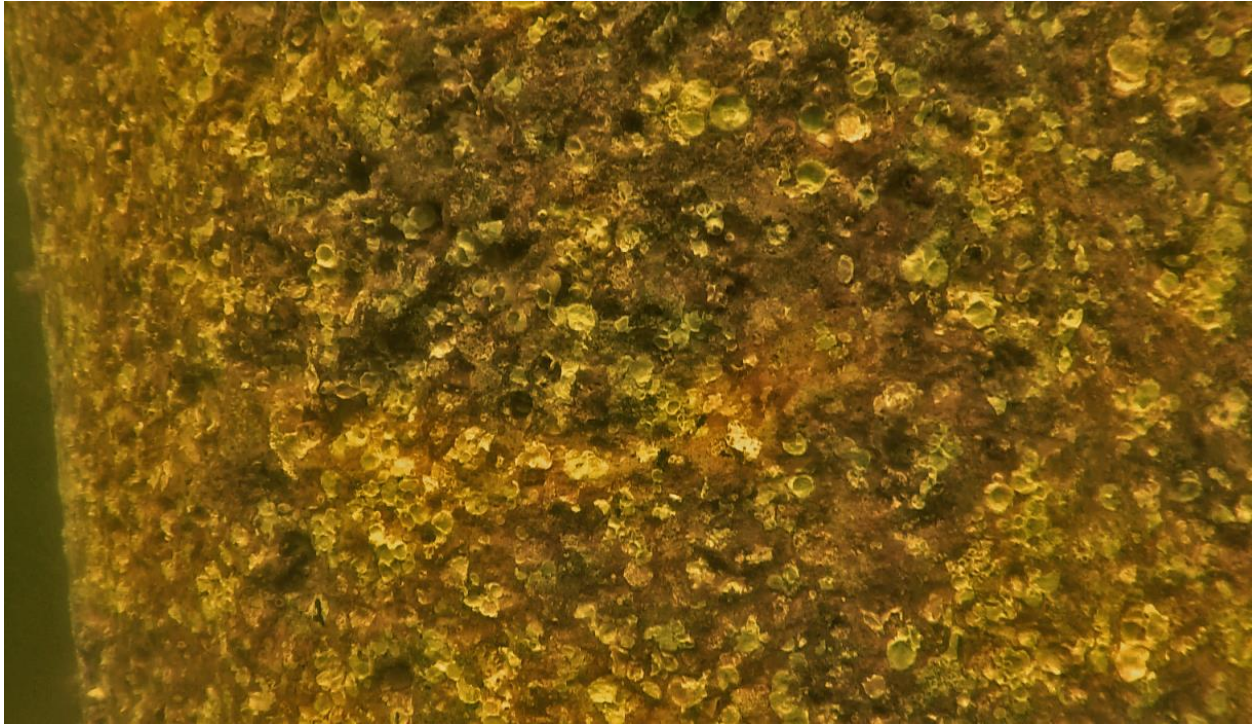
In contrast to Pier 85, Pier 84 had voids on all four shafts. Pier 84 contains 6-ft diameter Type 1 reinforced shafts (Figure 4.19(c)). Shaft 84-4 was chosen for inspection as it is listed as having two voids. Figure 4.33 shows 84-4 with a thick layer of barnacles prior to cleaning. This layer is better viewed in Figure 4.34 where the cleaned concrete transitions into the barnacle layer. Figures 4.35 and 4.36 show the cleaned portions of the shaft from east and southeast sides. It can be seen in these figures that the concrete is not completely smooth like the 4-ft shaft. The circled red areas on Figure 4.35 represent areas of the cleaned concrete that are filled with barnacles. Therefore the 6-ft Type 1 shafts seem to experience at least small voids in the concrete. As mentioned for Pier 85, this is suspected to have been caused by the double reinforcement cage. Figure 4.37 shows the layers found when cleaning the concrete. Consistently throughout the examination of the Gandy shafts, encrustations were found consisting of barnacles and miscellaneous plant life/organisms. Upon initial cleaning, barnacles were knocked/scraped off and the remnants of the barnacle attachment were then removed. Below this layer, a thin black layer was encountered which was difficult to remove. In cases of smooth surfaces with no significant voiding, pristine concrete could clearly be seen. Rougher surfaces with voids retained the plant life, barnacles and black layer. Except for isolated instances, there was no attempt to dig into voids and determine the full depth.

Figure 4.33 Shaft 84-4 prior to cleaning

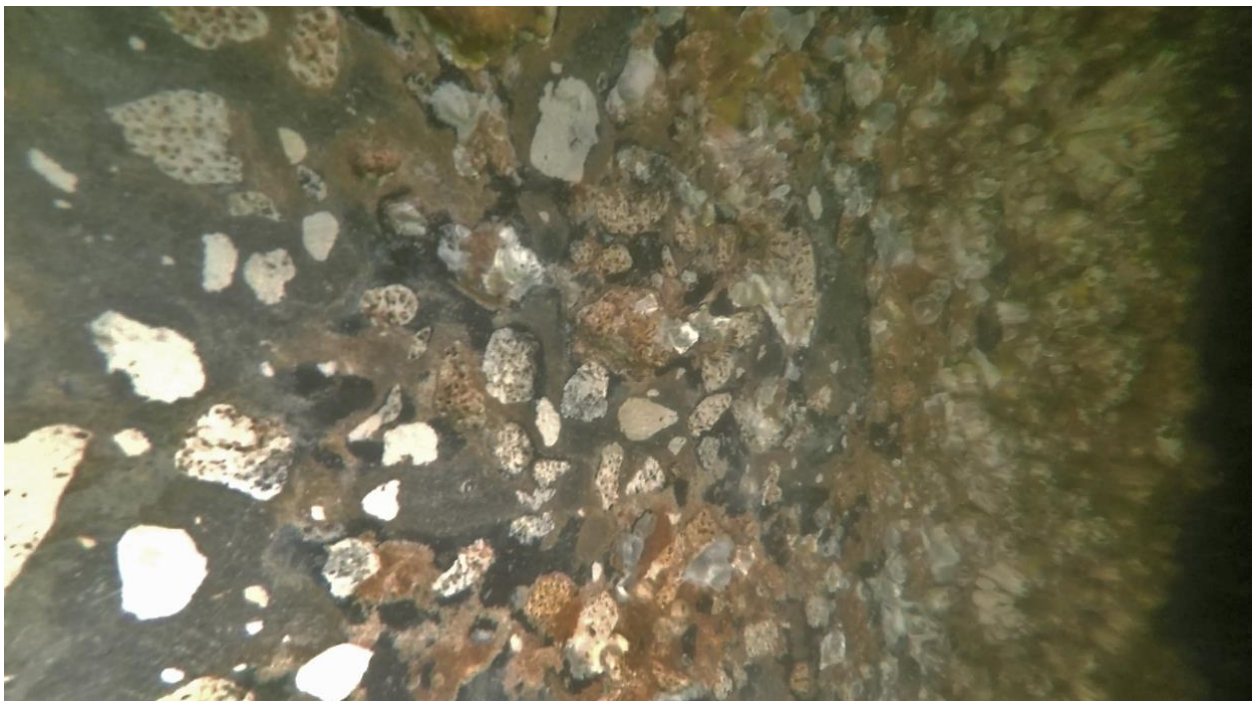
Figure 4.34 Shaft 84-4 partially cleaned, note clean concrete going into layer of barnacles

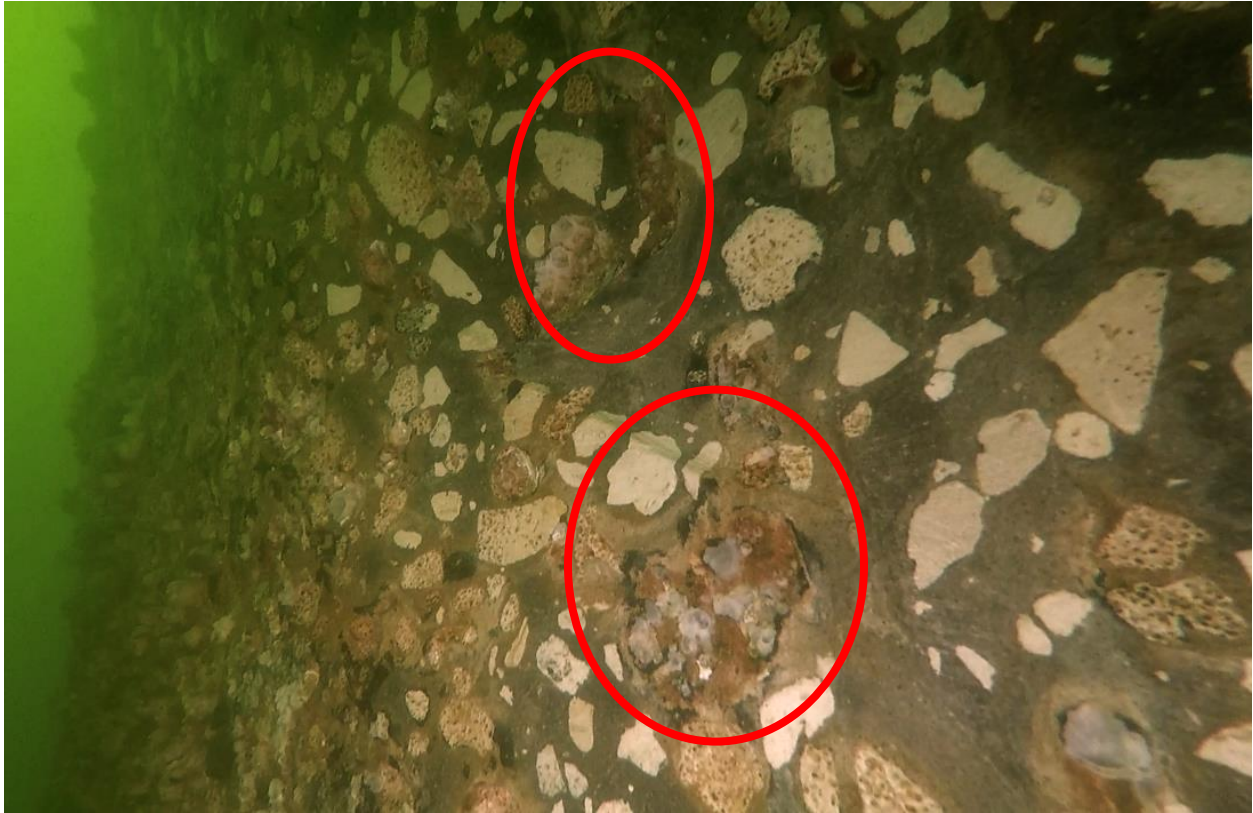
Figure 4.35 Cleaned portion of 84-4 on the southeast side of the shaft, circled sections indicate small voids in concrete filled by barnacles

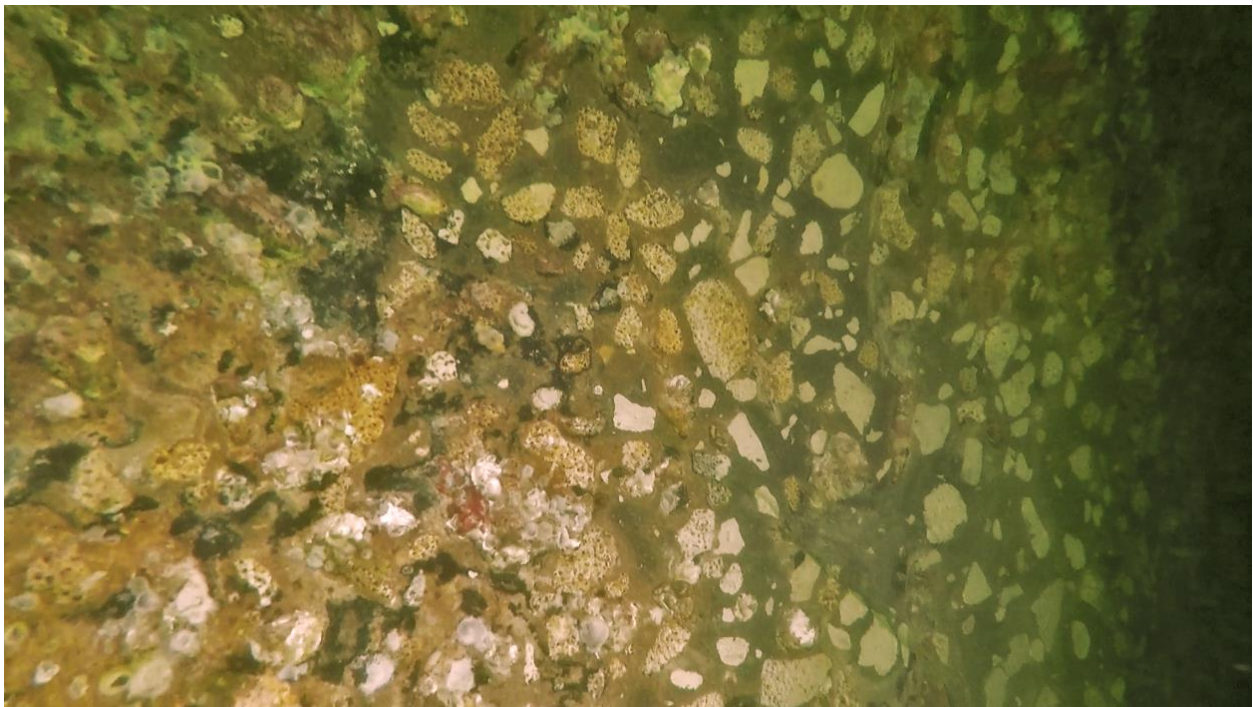
Figure 4.36. Cleaned portion of 84-4, east side of shaft

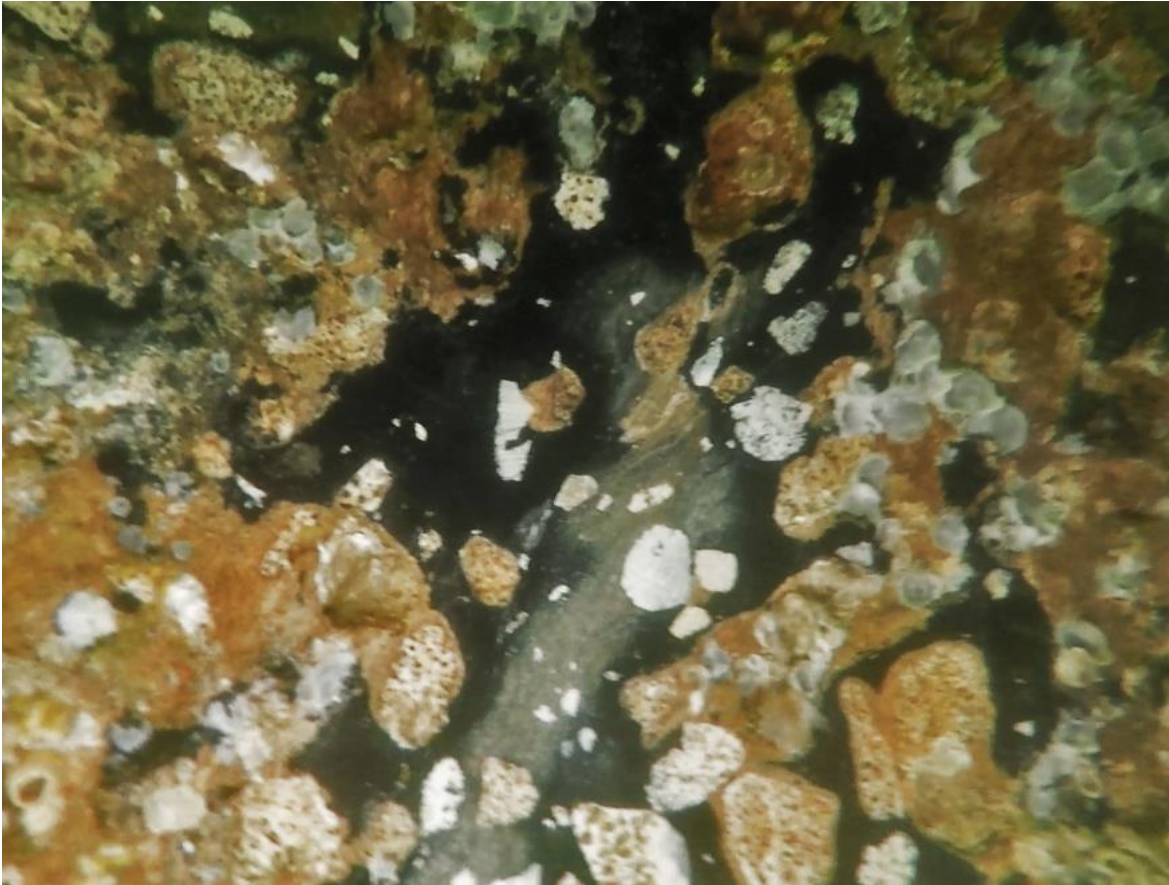
Figure 4.37 Layers from barnacles to black unknown layer to concrete

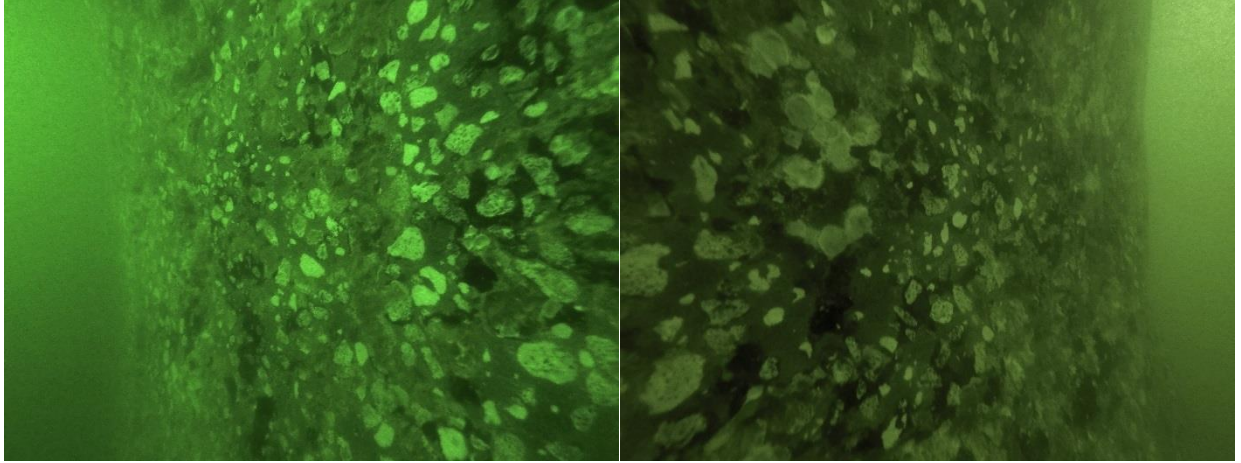
Pier 71 contains 7-ft diameter Type 1 shafts (Figure 4.19(d)). Two shafts 71-1 and 71-4 were listed as having voids in the dive report, and shaft 71-4 was chosen for inspection. Unfortunately, no images of the shaft were taken before cleaning; however, it looked similar to the shafts shown above, covered in a layer of barnacles. Figure 4.38 shows each side of the cleaned portion of the shaft. As noted for Piers 84 and 85, the 7-ft shafts also had small voids in the cleaned concrete surface (Figure 4.39). Sections of cleaned concrete can be seen up-close in Figure 4.40; note that this concrete was the roughest seen on this bridge. Figure 4.41 shows a long crevice in 71-4.

Figure 4.38 Shaft 71-4 post-cleaning

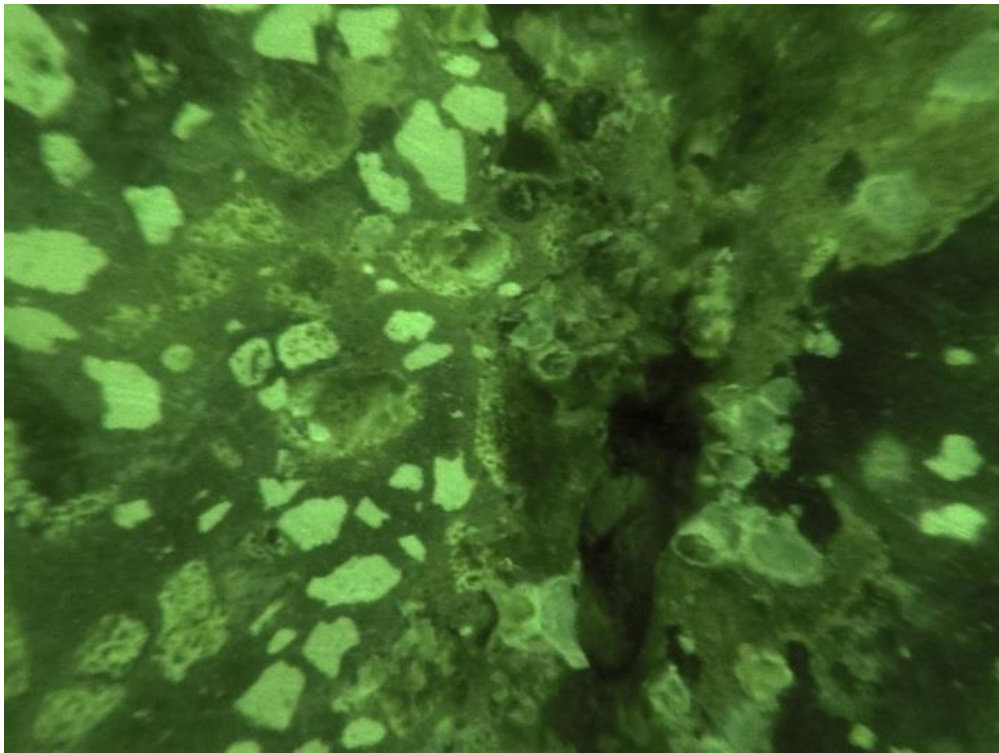
Figure 4.39 Close up of a small void on 71-4

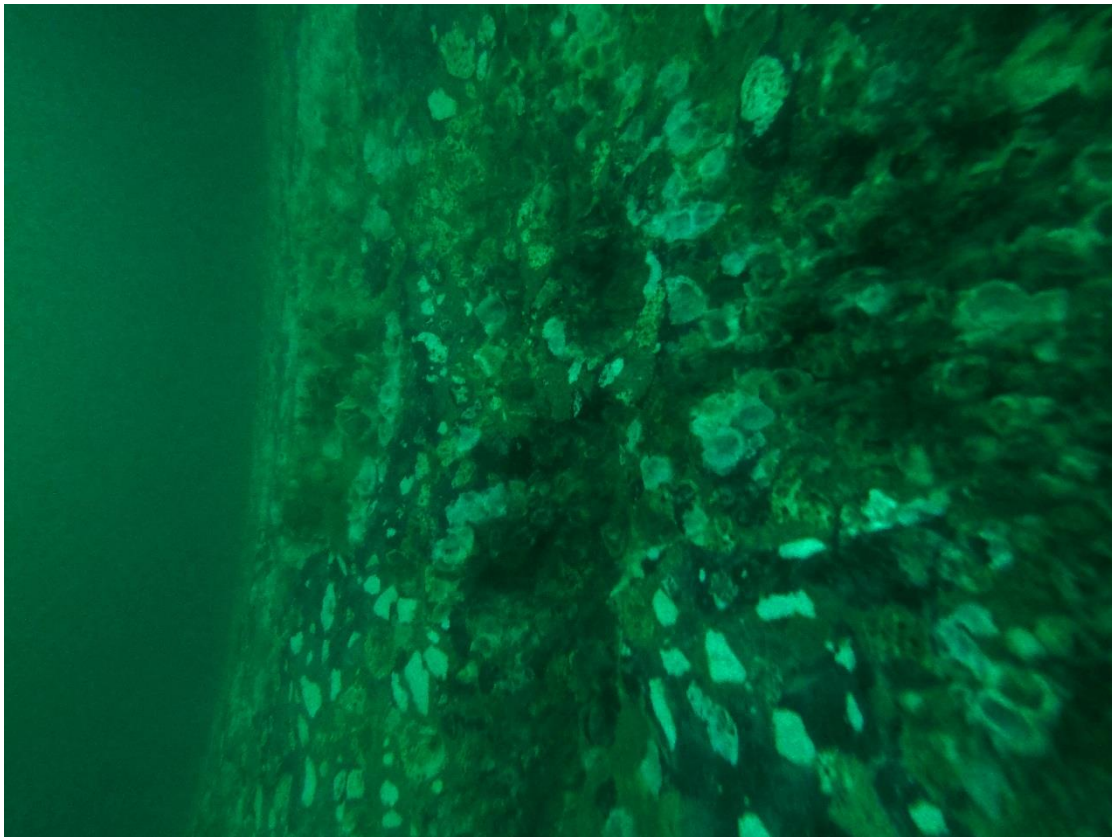
Figure 4.41 Large void found on the south side of 71-4

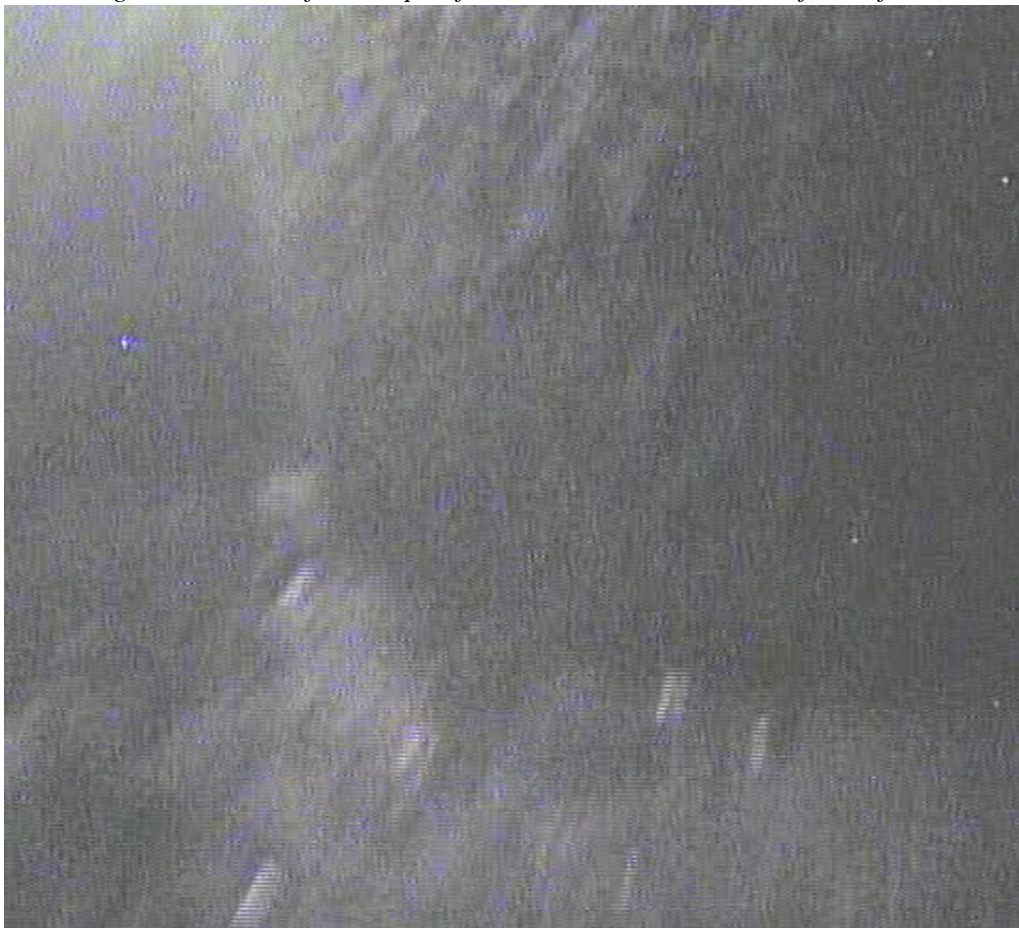
Figure 4.47 One of the columns at the mudline, no exposed shaft available for inspection

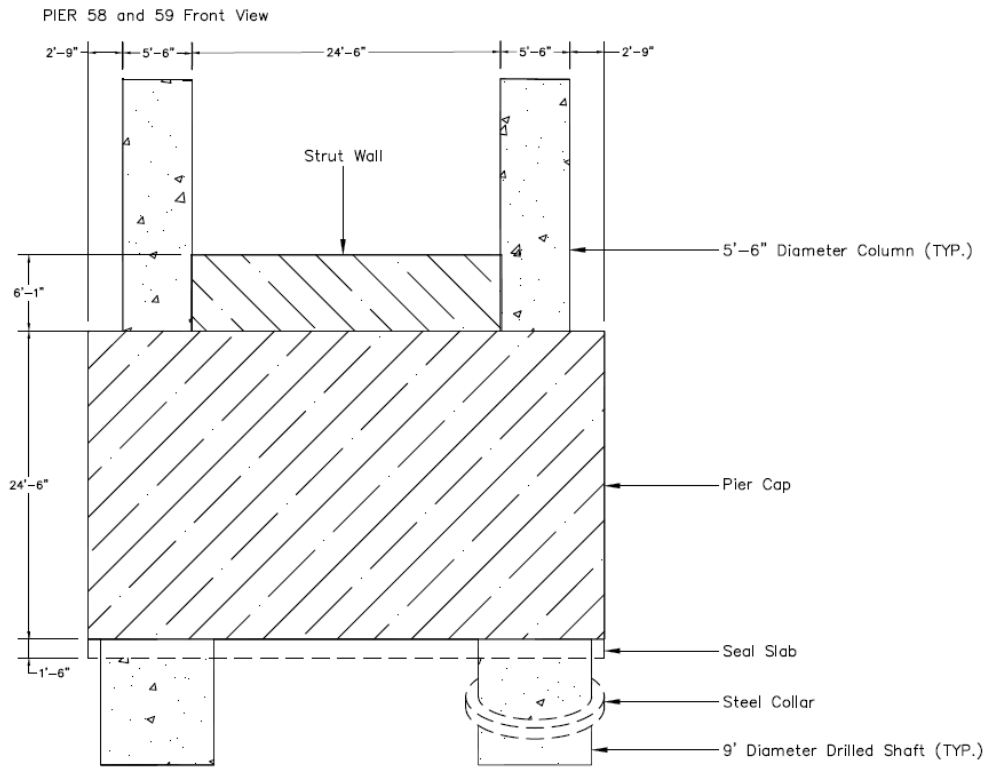
While it was expected that there would be exposed shaft, after inspection it was realized that the only portion exposed was from what looked like a missing seal slab (Figure 4.53). Rubble on the bottom or river was likely to be remnants of the seal slab, and a steel collar was seen around shaft 2. Nevertheless, approximately 16-18 inches of uncased shaft was visible. Figure 4.54 is a picture of what the exposed portion of shaft looked like prior to cleaning shaft 58-1 (note shafts were labeled 1 and 2 based on river flow seen in Figure 4.50). Figure 4.55 shows the 58-1 shaft after cleaning. Figure 4.55 also shows four positions labeled 1-4 corresponding to close-up images taken at those locations. The water clarity was poor and made overview images unhelpful. In all four images of Figure 4.55, vertical or horizontal creases were found; image (2) shows both vertical and horizontal creases (camera slightly tilted) along with a white patching compound in the center of the squares that was not concrete.

Figure 4.53 Front view of Pier 58 with expected seal slab and observed steel collar around shaft 2.

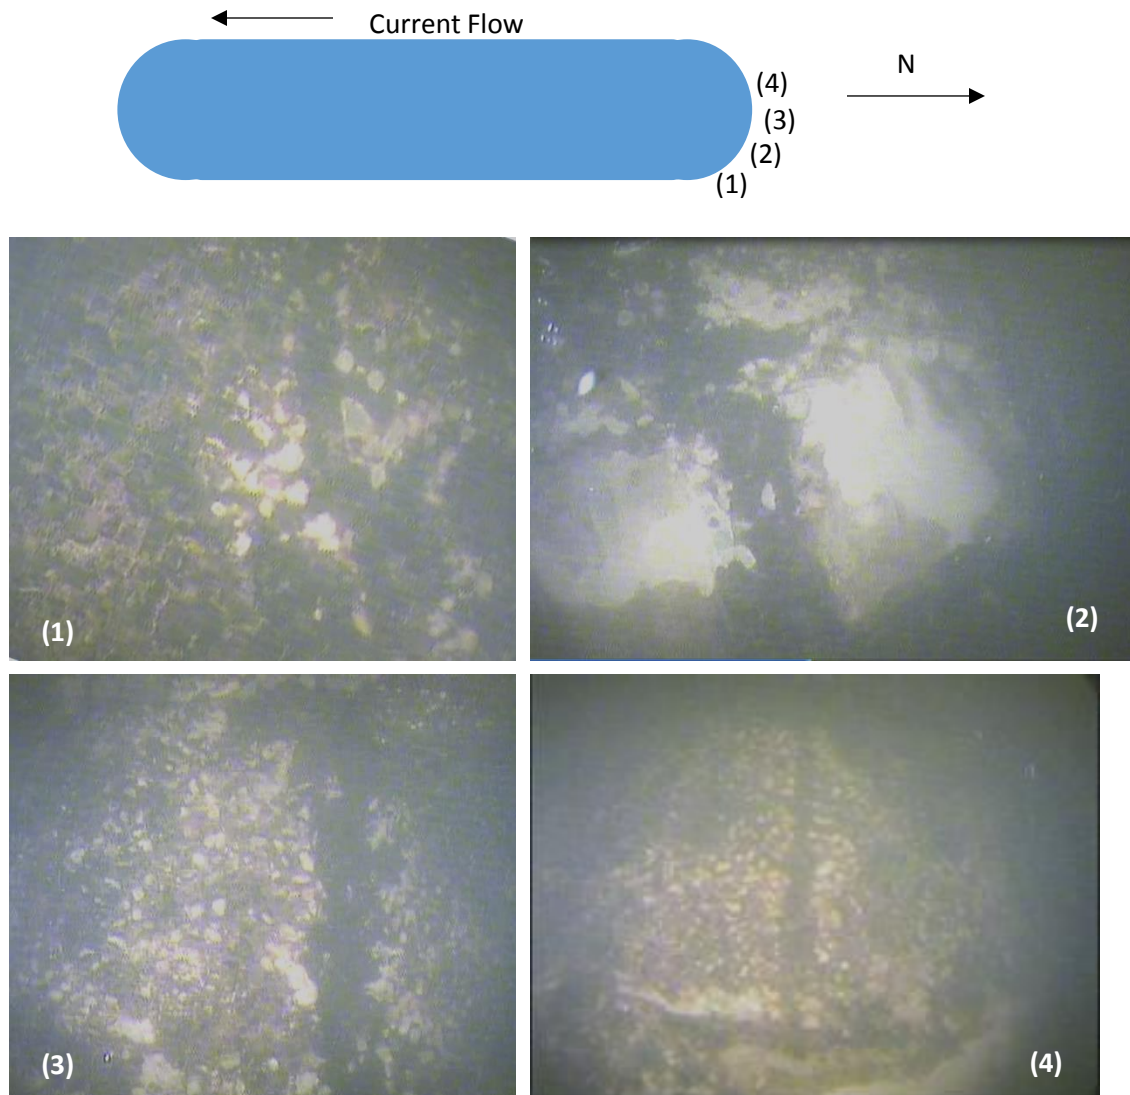
Figure 4.55 Images demonstrating quilting on Shaft 58-1. Images 1-4 correlate to positions 1-4 noted at the top of the figure.

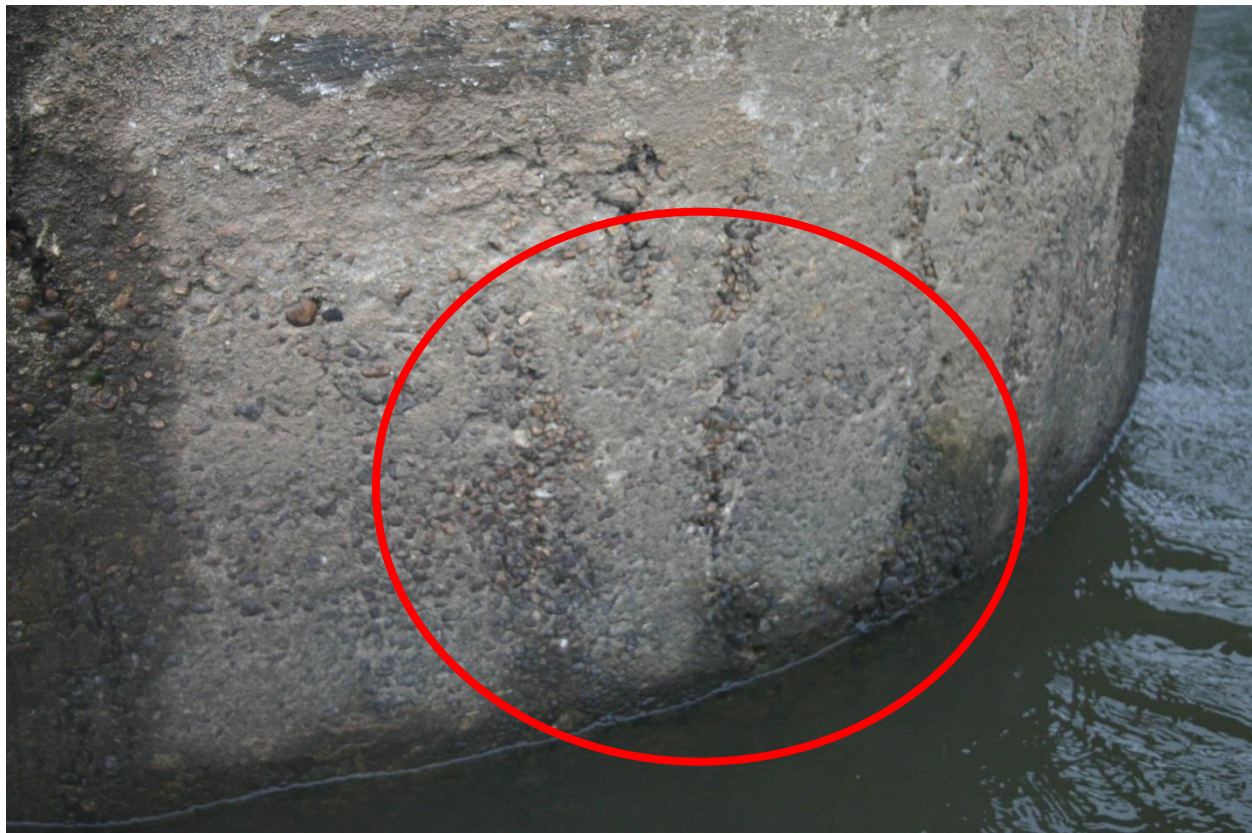
Adjacent Pier 59, test shaft 8 (Figure 4.56) was also inspected. This is a 9-ft diameter out-of-position shaft south of pier 59 near the main channel. By visual inspection there was some light creasing along the vertical reinforcement (Figure 4.57). Figure 4.58 shows test shaft 8 before cleaning; Figure 4.59 shows after cleaning. Again, the creasing is light but it can be seen. Being a test shaft, construction sequencing is often not exactly the same as production shafts. This shaft had additional longitudinal instrumentation, which compounds concrete flow problems.

Figure 4.57 West side of test shaft 8, light creases from vertical reinforcement

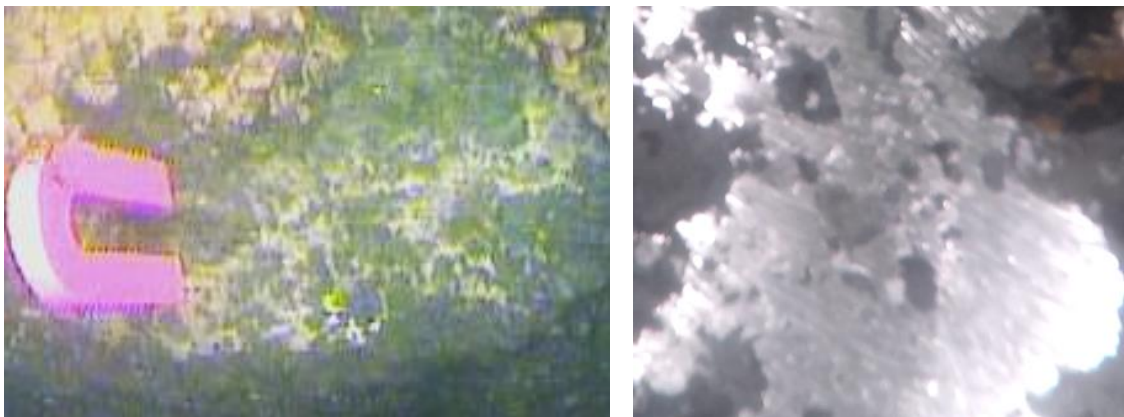
A surprising discovery from diving both fresh and salt water bridges was that pitting in the steel casing was much worse in fresh water (Figure 4.65) when compared to salt water. The bridges compared, Gandy and Blountstown, were almost the same age, built in 1996 and 1998, respectively. Figure 4.65 shows pronounced pitting corrosion at Blountstown and very little visible pitting in the Gandy casings. When preparing the surface of the Gandy shafts, a thin black presumably organic layer was found that was difficult to remove (Figure 4.65 and 4.66). This layer was hypothesized to be a layer of anaerobic decay from the barnacles and sea-growth, which would be an oxygen barrier and may slow or prevent corrosion. Samples were taken and are currently under investigation. Discussions with the USF Department of Integrative Biology confirmed similar observations of a black layer under oyster and barnacle growth. Some consideration will be given to promoting encrusted surfaces that would be beneficial to both concrete and steel surfaces under these conditions. While the Bridge of Lions casing was heavily encrusted, no data or observations were collected which could have provided insight into the effect of east coast marine conditions on corrosion.

Figure 4.65. Pitting corrosion in freshwater (left); very little pitting in marine environment (right).

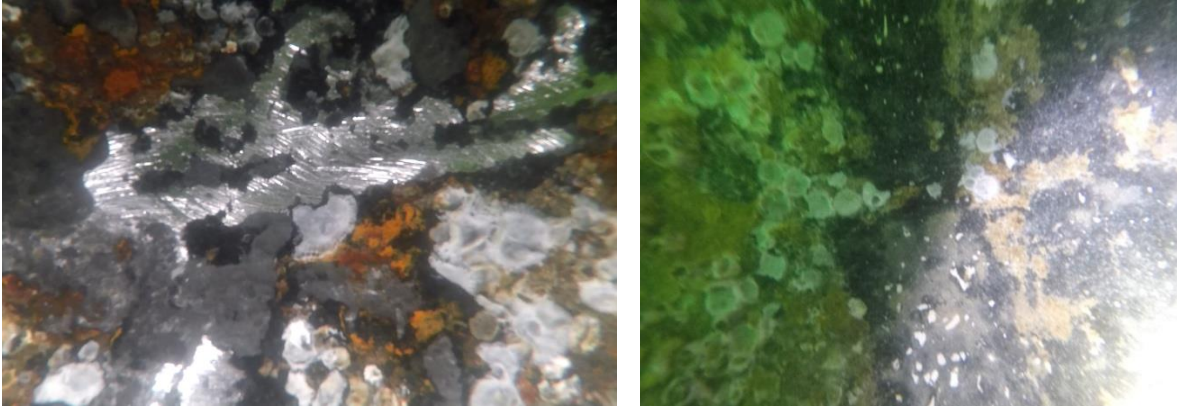
Figure 4.66 Black organic layer beneath barnacle growth: on steel casing (left), on concrete (right)
