**ATTENUATING MASS CONCRETE EFFECTS IN DRILLED SHAFTS  
BD-544-39**

**DRAFT FINAL REPORT**

June 2009

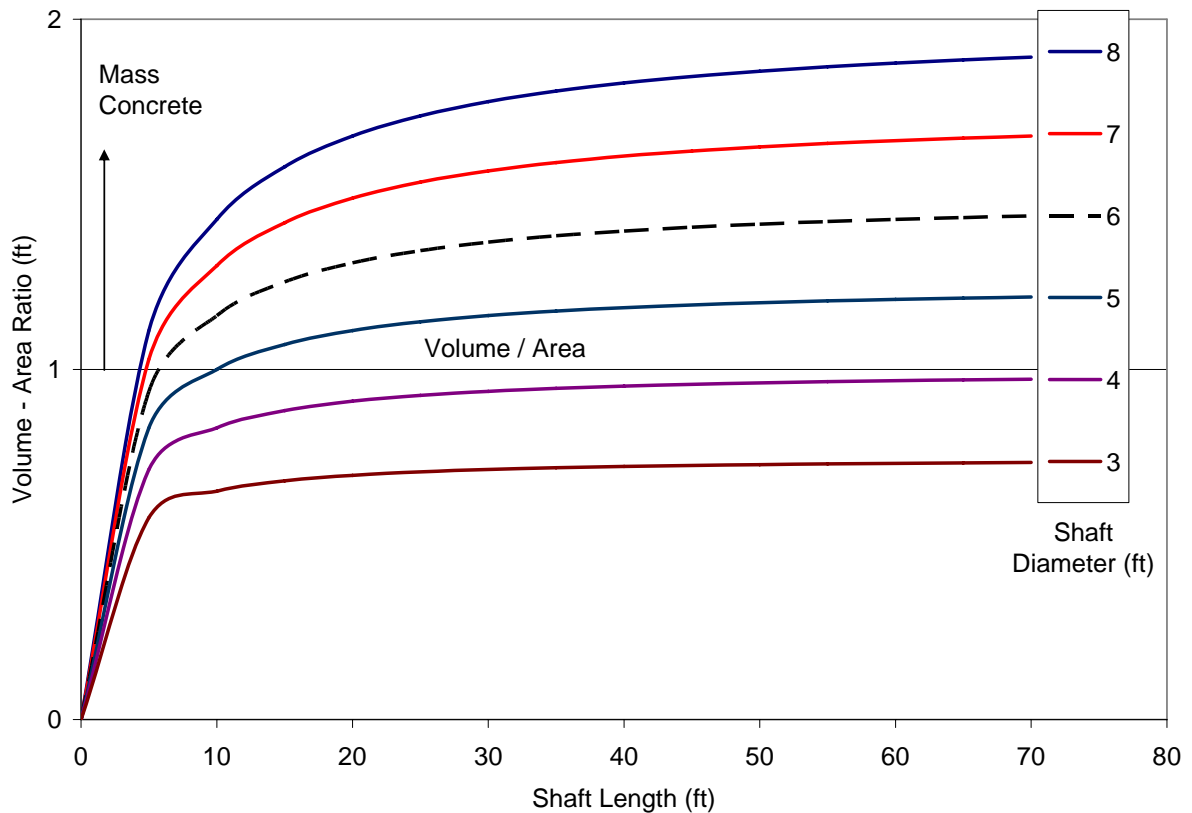
Figure 1-1. Mass concrete geometry criteria applied to various shaft diameters.

The traditional approach to ascertaining mass concrete was to evaluate the volume to area ratio limit from the SDG 3.9 which stated that any concrete element with volume in  $\text{ft}^3$  greater than the dissipative surface area in  $\text{ft}^2$  would likely be unable to stay within reasonable temperature limits. Further, if the minimum dimension of a concrete element was 3 ft or greater the same lack of temperature control could be anticipated. When applying more performance specific restrictions to such elements the differential temperature was limited to 35 deg F regardless of dimensions. Using this simple formula, the shaft cut off diameter should have been a bit more restrictive limiting it to 4 ft diameter shafts as shown in Figure 1-1.

Some state DOTs have defined geometric guidelines that identify potential mass concrete conditions as well as limits on the differential temperature experienced. For instance, the Florida DOT designated any concrete element with minimum dimension exceeding 3 ft or a volume to surface area ratio greater than  $1 \text{ ft}^3/\text{ft}^2$  will require precautionary measures to control temperature-induced cracking (FDOT, 2006). The same specifications set the maximum differential temperature to be 35F (20C) to control the potential for cracking. For drilled shafts, however, any element with diameter greater than 6 ft is considered a mass concrete element despite the relatively high volume to area ratio mentioned in Chapter 1 (Figure 1-1).

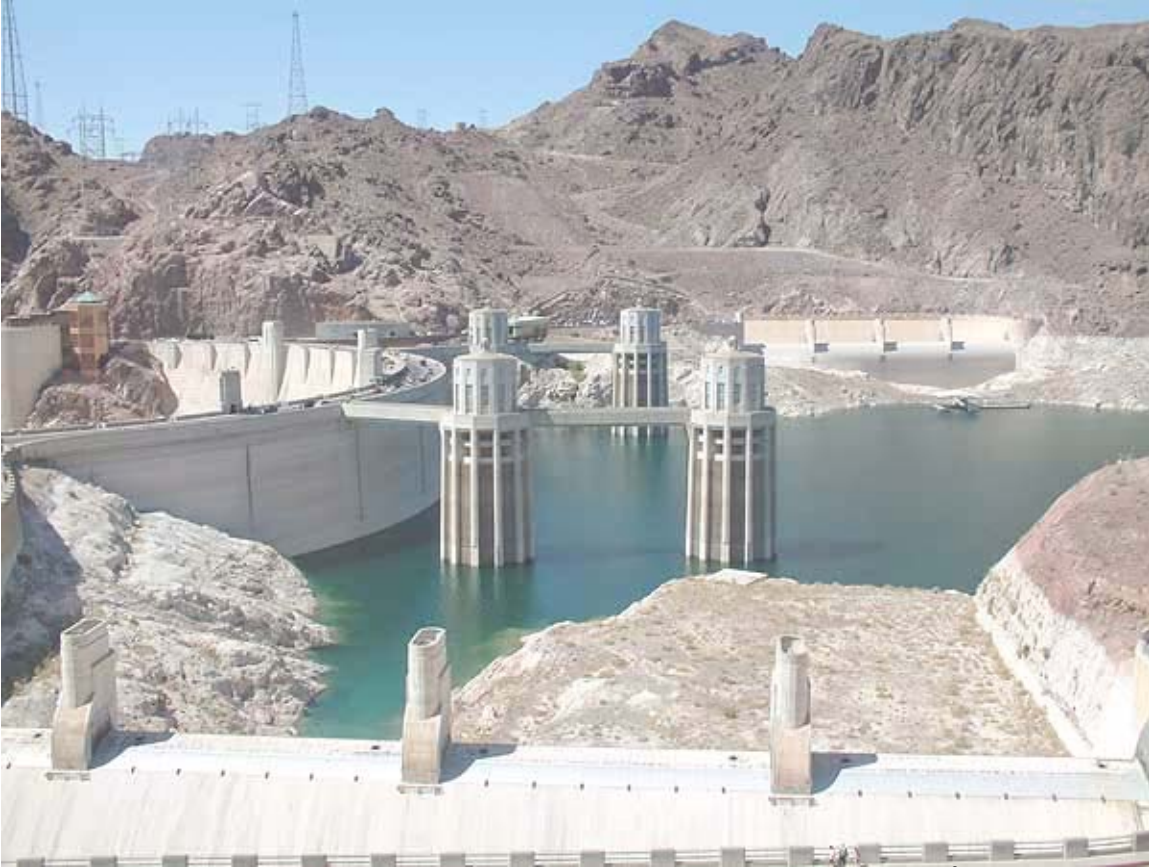
Figure 2-1. Hoover damn project (built circa 1935) used over 5 million  $\text{yd}^3$  of concrete.

**2.3.1 Hoover Dam.** The most famous of the many cited mass concrete projects is perhaps the Hoover Dam project (Figure 2-1) constructed during the depression from 1932 to 1935 where over 5 million cubic yards of concrete were used. At that time it was understood that staged construction and a cooling system would be required to help control elevated temperatures. The primary concern was concrete cracking from differential temperature and the associated leakage. Without these considerations, temperature dissipation is estimated to have taken over 100 years and temperature-

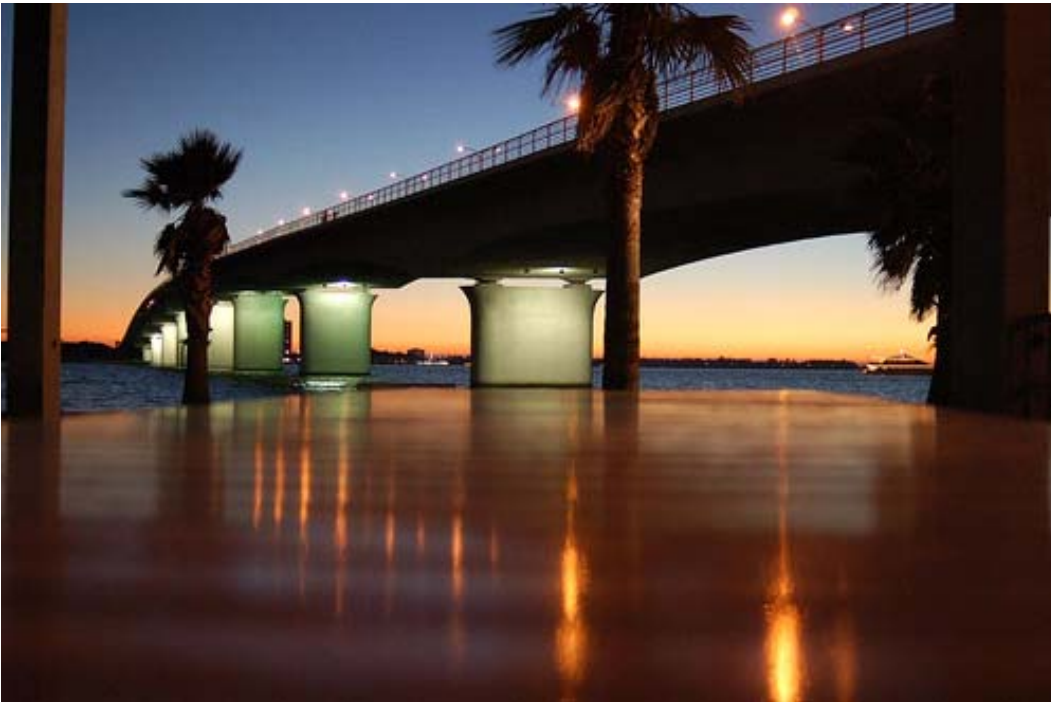
Figure 2-2. Ringling Causeway Bridge founded on 2- 9 ft diameter shafts at each pier.

**2.3.2 Ringling Causeway Bridge.** A relatively recent structure (built 2001-2003) which shed light on drilled shafts as mass concrete was the Ringling Causeway Bridge spanning across Sarasota Bay, Florida (Figure 2-2). This segmental, post-tensioned concrete box girder bridge is supported by single column piers founded on two 2.75m (9 ft) diameter drilled shafts. The concrete mix was a type I/II with 20% cement replacement with fly ash (probably class F). In spite of relatively cool weather (for Florida) and that it was bathed in cool bay water, the core temperature of the shafts reached 69C (157F). Figure 2-3 shows temperature traces over a 9 day period for the shaft center and edge as well as in the surrounding water and air. The bay water temperature averaged 17C (63F) while the air temperature dipped as low as 3C (37F). The cooler environment exacerbated differential temperature conditions wherein a maximum differential temperature of 37C (67F) was recorded shortly after the coldest spell.

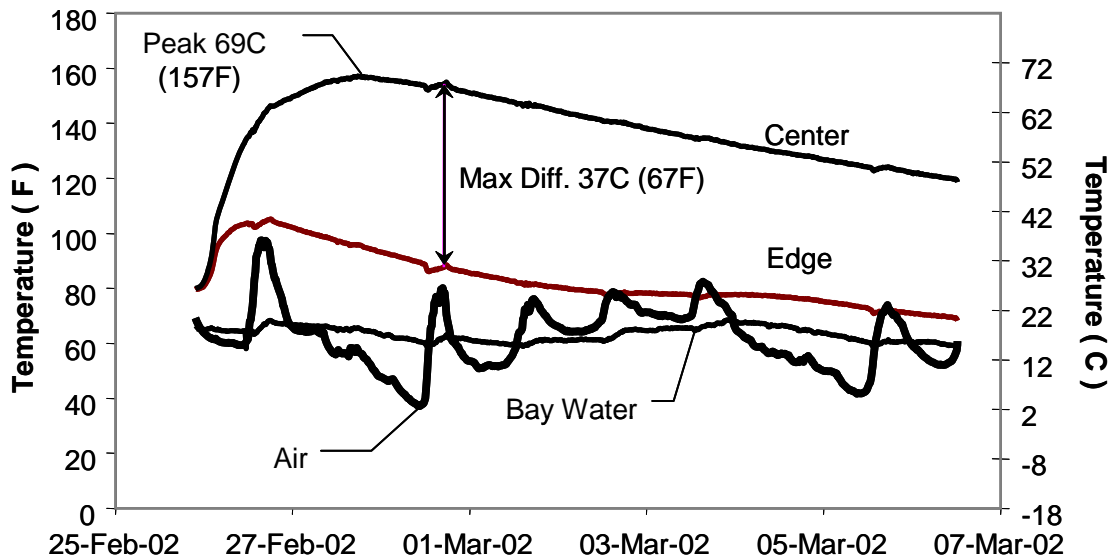
Figure 2-3. Temperature traces from the Ringling Causeway Bridge.

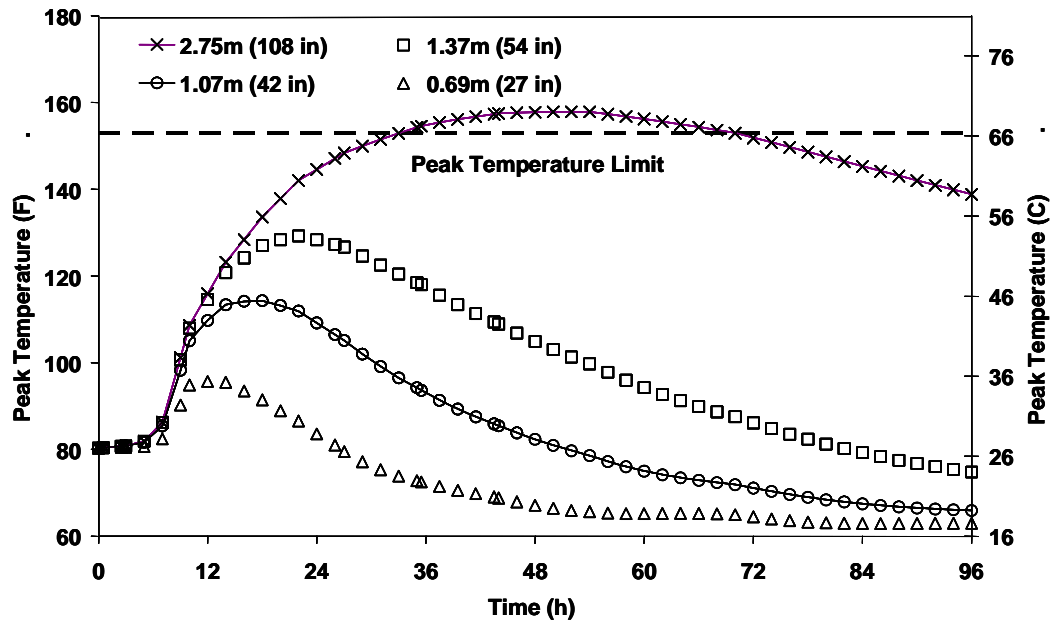
Figure 2-4. Modeled peak temperature traces for various shaft sizes, based on “Ringling” shaft mix design and conditions.

Information gathered from this site was used to calibrate a 3-D numerical model from which predictions of how other sized shafts would have fared under these conditions. Figure 2-4 shows predictions wherein only the peak core temperatures are considered and that smaller sized shaft would not have exceeded safe peak temperature limits.

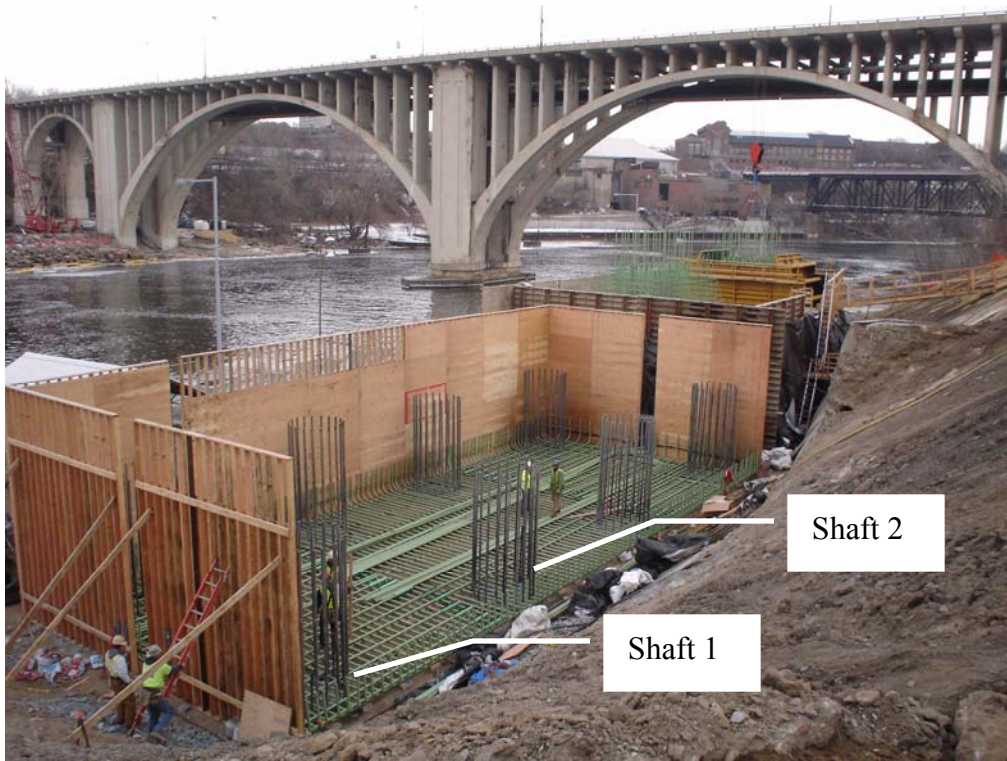
Figure 2-5. I-35W Bridge replacement southbound Pier 2 (40'x 90'x 12'  $\approx$  1600yd<sup>3</sup>).

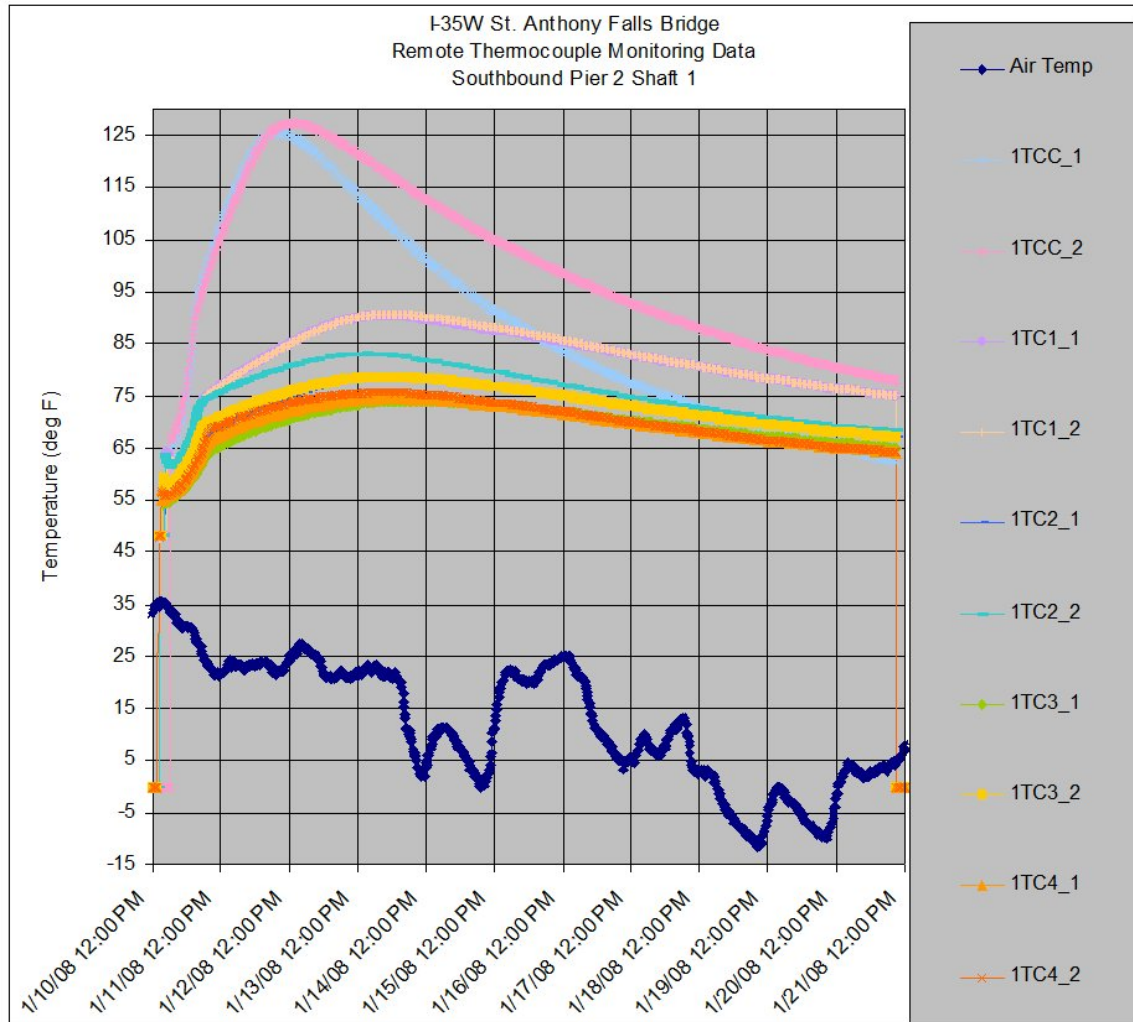
Figure 2-6. I-35W Bridge Southbound Pier 2 Shaft 1 Thermocouple Data.

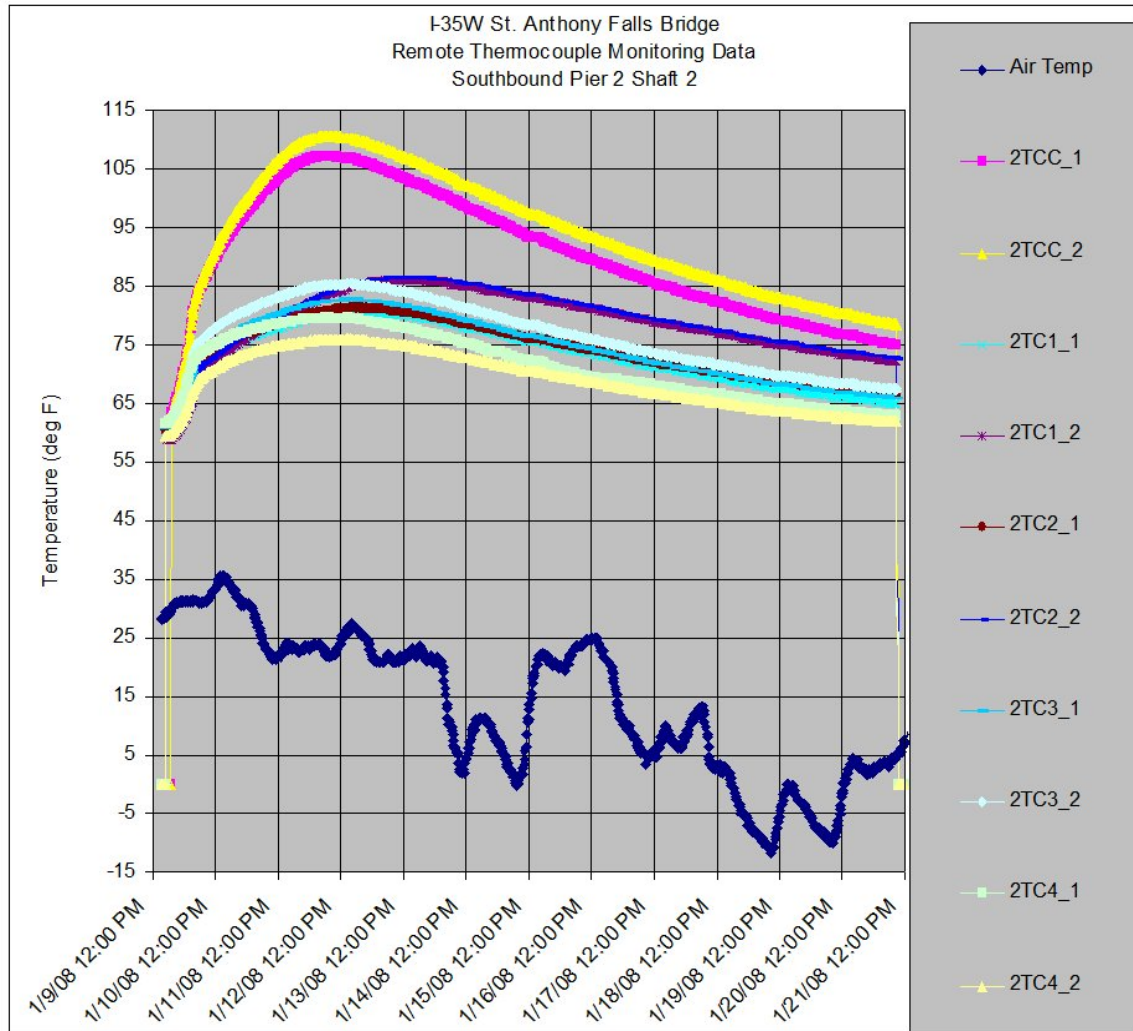
Figure 2-7. I-35W Bridge Southbound Pier 2 Shaft 2 Thermocouple Data.

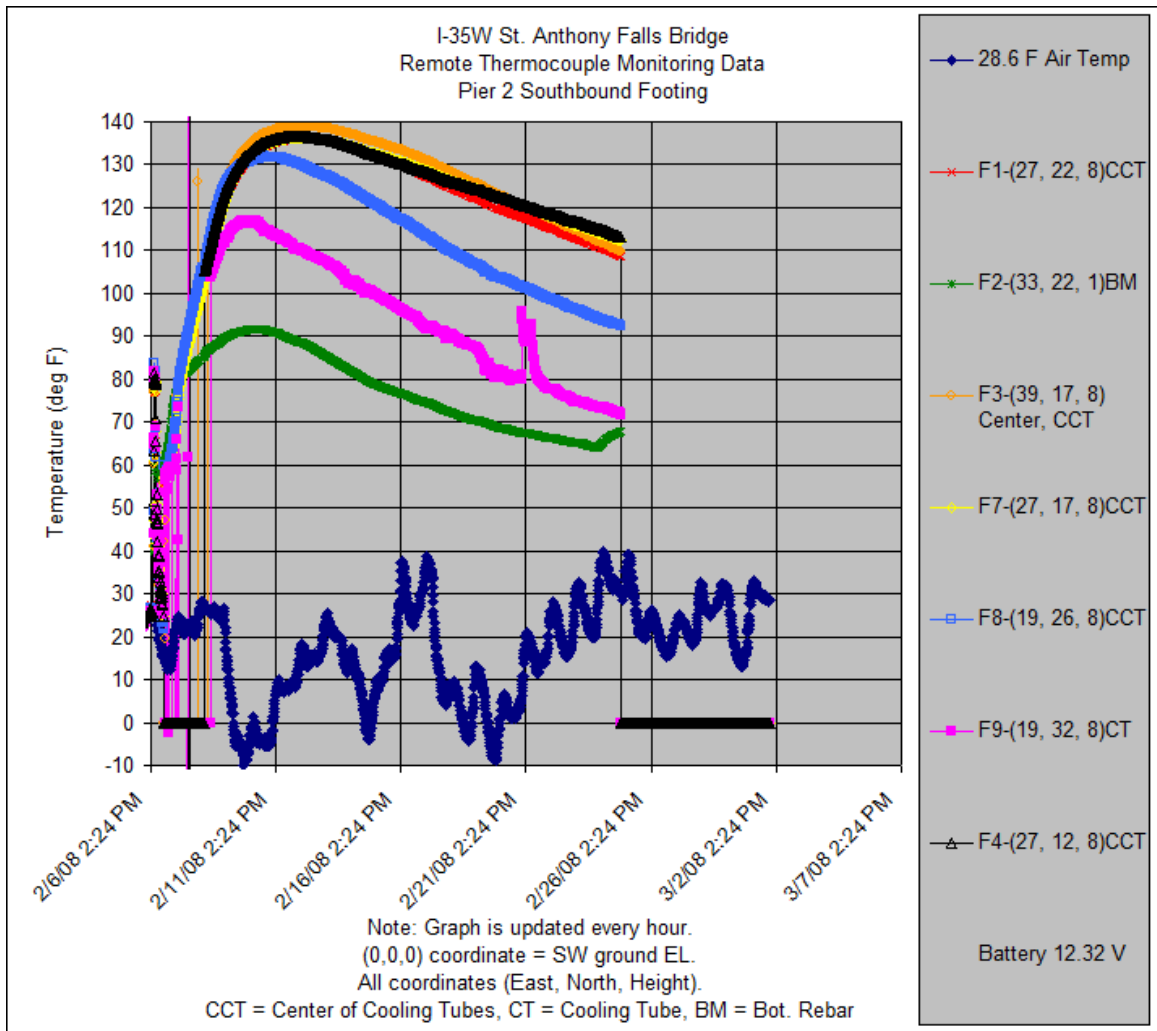
Figure 2-8. I35W Pier 2 Southbound Footing Thermocouple Data.

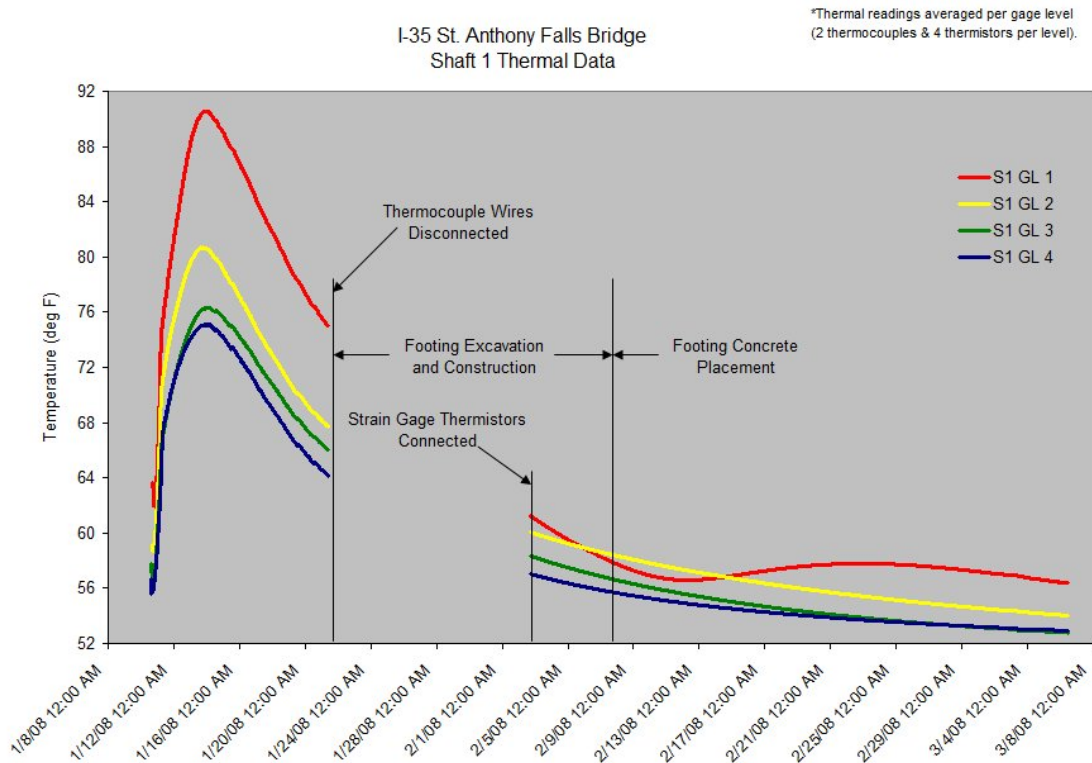
Figure 2-9. I-35W Bridge Shaft 1 Thermal Data from Thermocouples and Thermistors.

Long term measurement were also made possible by way of the thermistors incorporated into the vibrating wire instrumentation throughout the shaft. Figures 2-9 and 2-10 show the thermocouple data prior to footing concrete placement and the thermistor data after footing concrete placement. The gap shown in the data accounts for the time when no data could be collected due to interference with construction activities. Interestingly, the upper levels of the shafts show heating caused by the presence of the massive footing above.

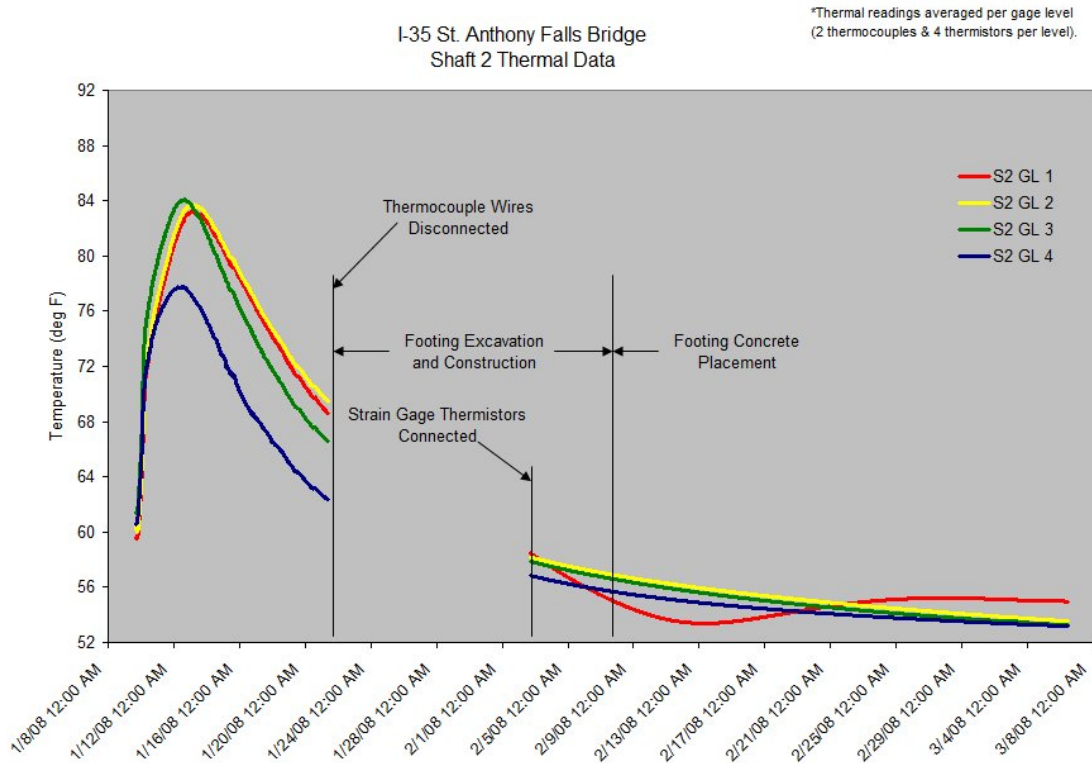
Figure 2-10. I-35W Bridge Shaft 2 Thermal Data from Thermocouples and Thermistors.

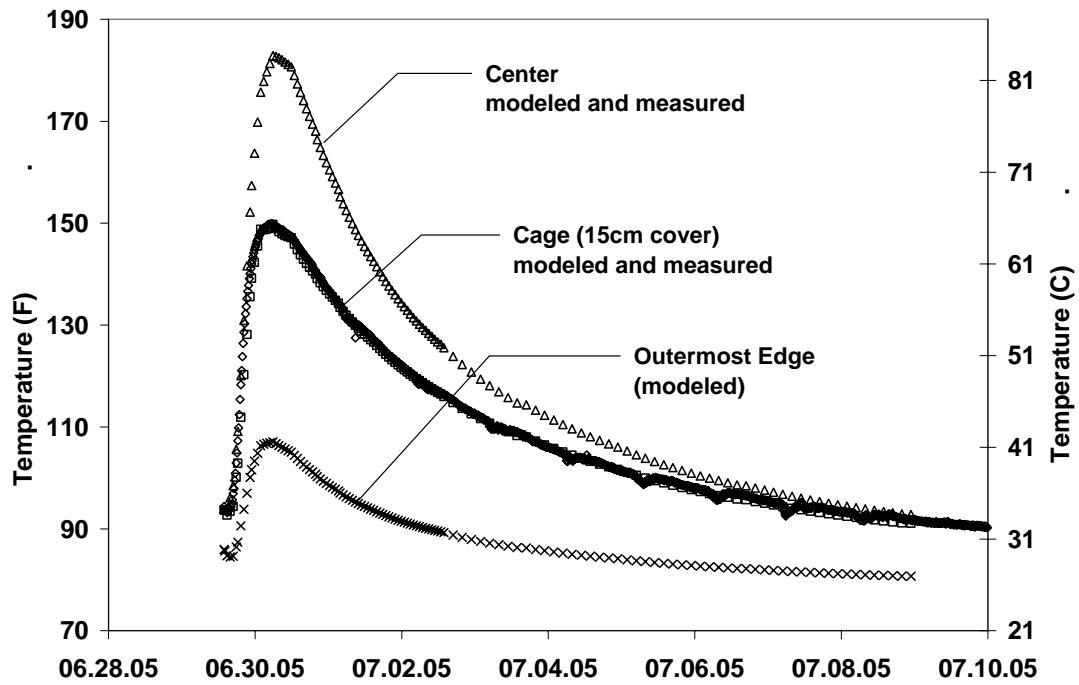
Figure 2-11. Temperature traces for the 1.22m Clearwater shaft (modeled and observed).

Using the measured temperature response, the same numerical model was applied to this site's conditions which were significantly different from the Ringling site. Specifically, the ambient temperature was much higher, the surrounding heat diffusing materials were non-convective (no flowing water), and the mix design contained little to no pozzolans. Figure 2-11 shows the measured and modeled results superimposed with no recognizable differences aside from the diurnal temperature fluctuations on one thermocouple channel. A peak temperature of 84C (183F) was observed with a maximum differential temperature of 32C (57F). These exceeded both recommended limits for peak and differential temperatures.

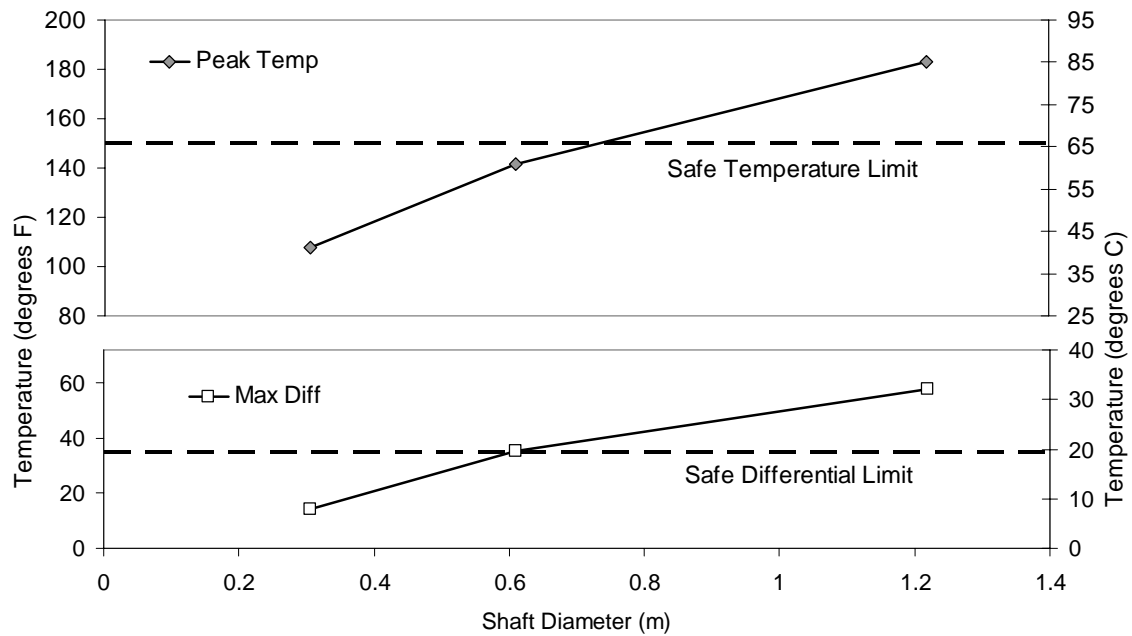
Figure 2-12 Peak and differential temperature model predictions for various-sized shafts using the “Clearwater” site conditions.

Using the same Clearwater conditions, the numerical model was extended to simulated smaller shaft sizes (Figure 2-12). The results showed that even the smallest of constructible shafts (2 ft) would exhibit mass concrete under these highly adverse conditions under at least one of the temperature criterion.

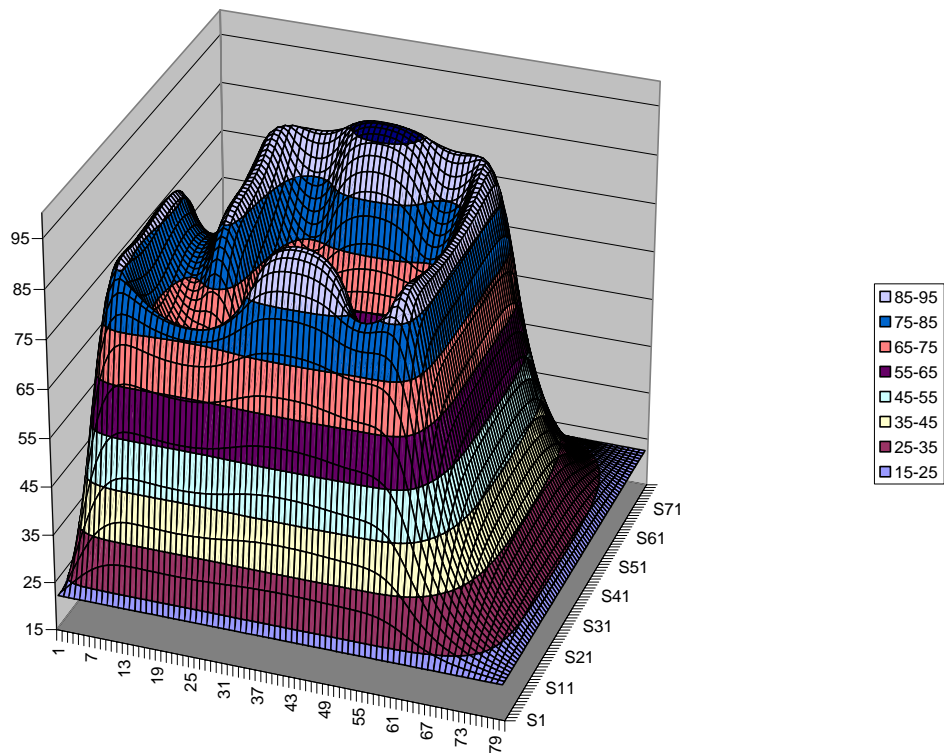
Figure 2-13. Temperature contours at mid-height of the nuclear vault walls.

Model predictions were prepared which are shown in Figure 2-13 as temperature contours from a horizontal slice through the wall at mid-height. The peak temperature of 182F (83C) and an edge to center differential of 62F (34C) were corroborated by field measurements taken at the mid-height of the wall from the inside face, outside face, and center of the wall (Figure 2-14). Upon, form removal and crack survey showed a sporadic distribution of small width cracks shown in Figure 2-15. Given the structure will not be exposed to marine conditions or possible soil sulfate attack, cosmetic sealing/waterproofing and painting was all that was required.

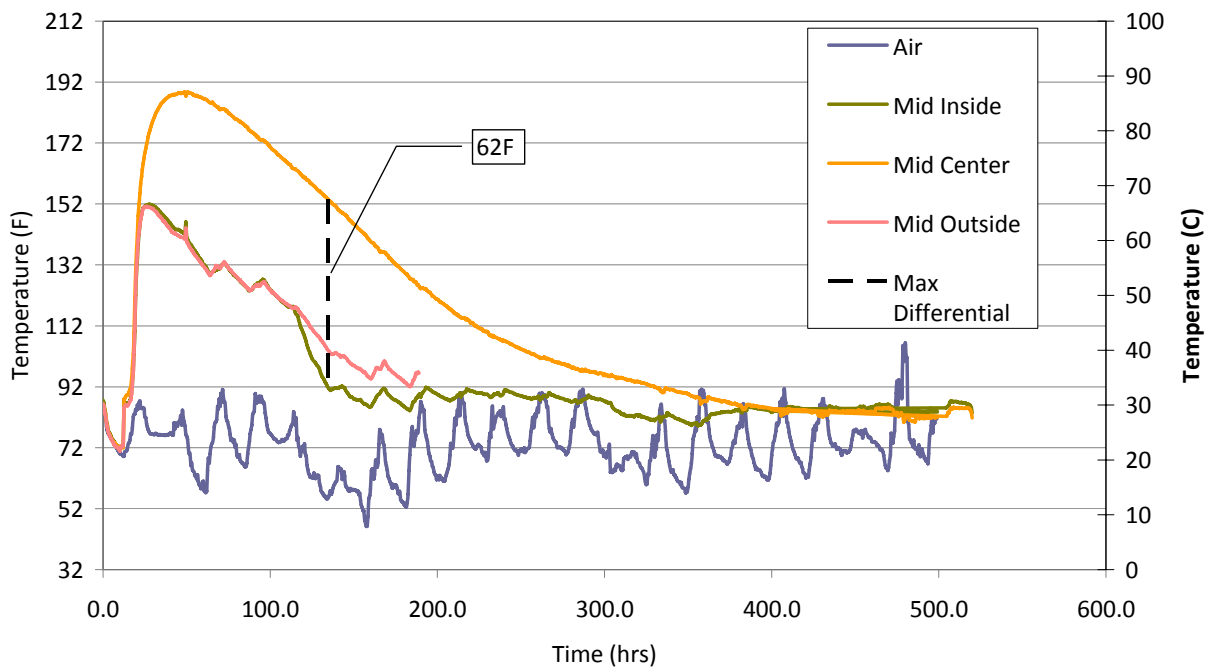
Figure 2-14. Measured wall temperatures from mid-height of nuclear vault wall.

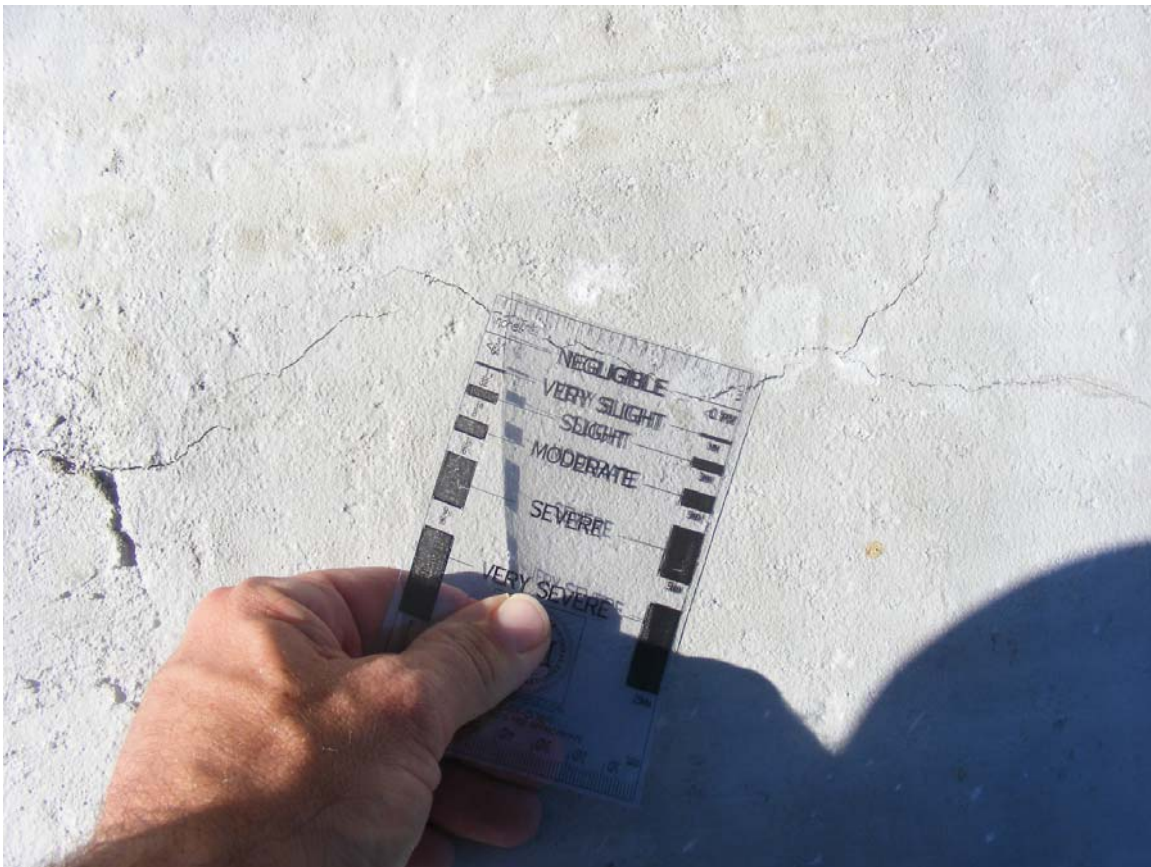
Figure 2-15. Although crack widths register as negligible, they run sporadically throughout wall.

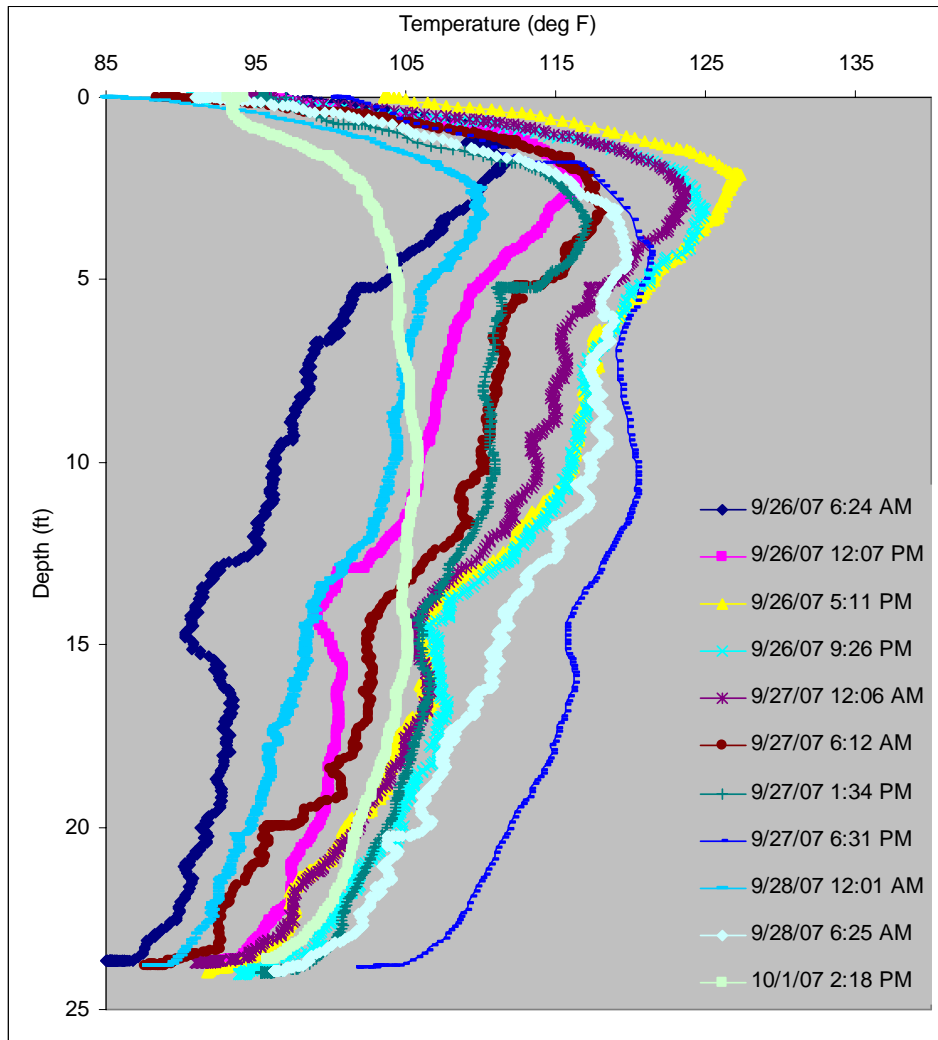
Figure 3-4. Voided shaft thermal results for tube 1.

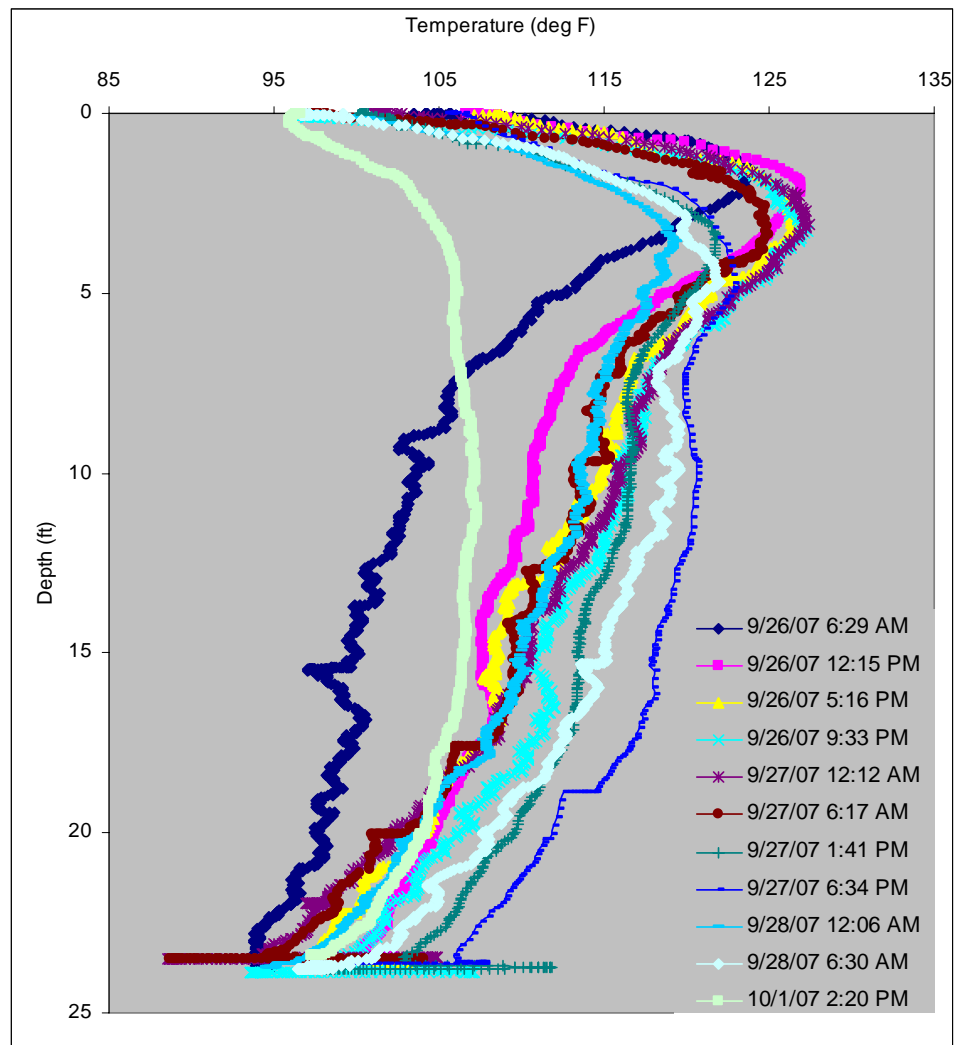
Figure 3-5. Voided shaft thermal results for tube 2.

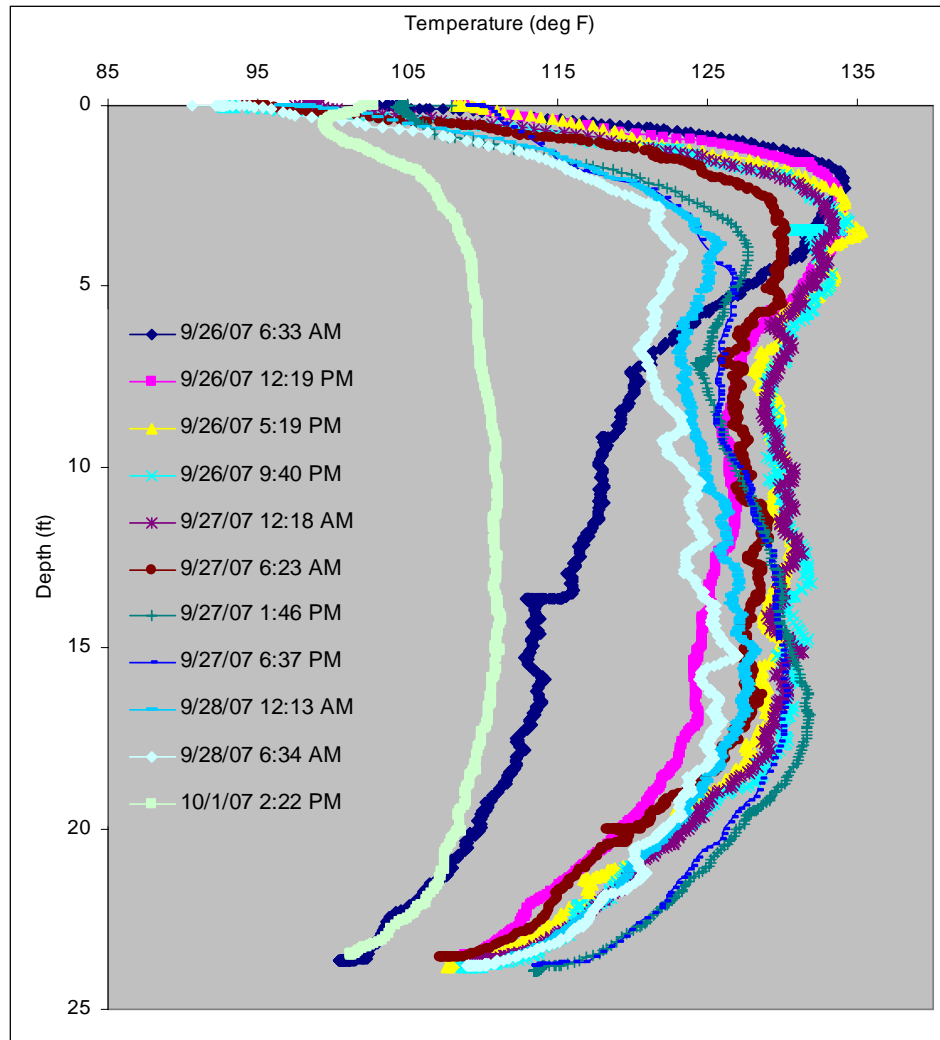
Figure 3-6. Voided shaft thermal results for tube 3.

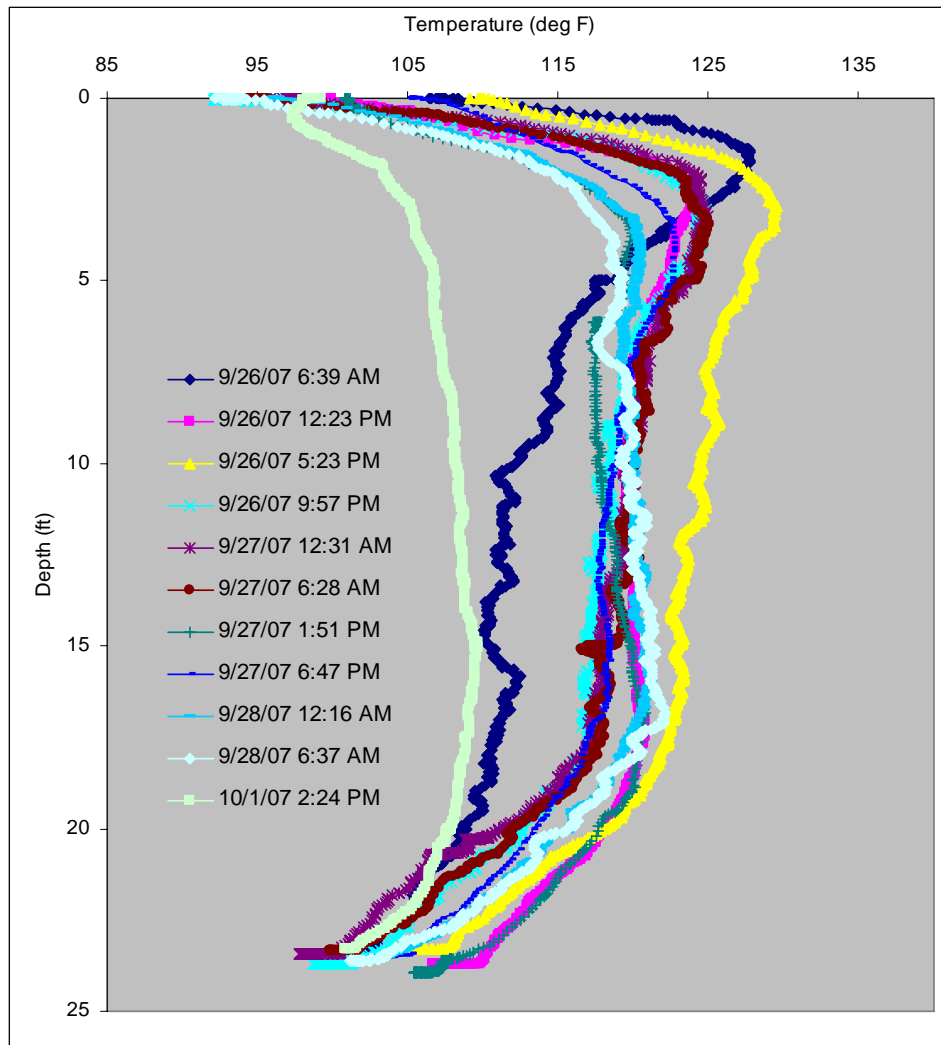
Figure 3-7. Voided shaft thermal results for tube 4.

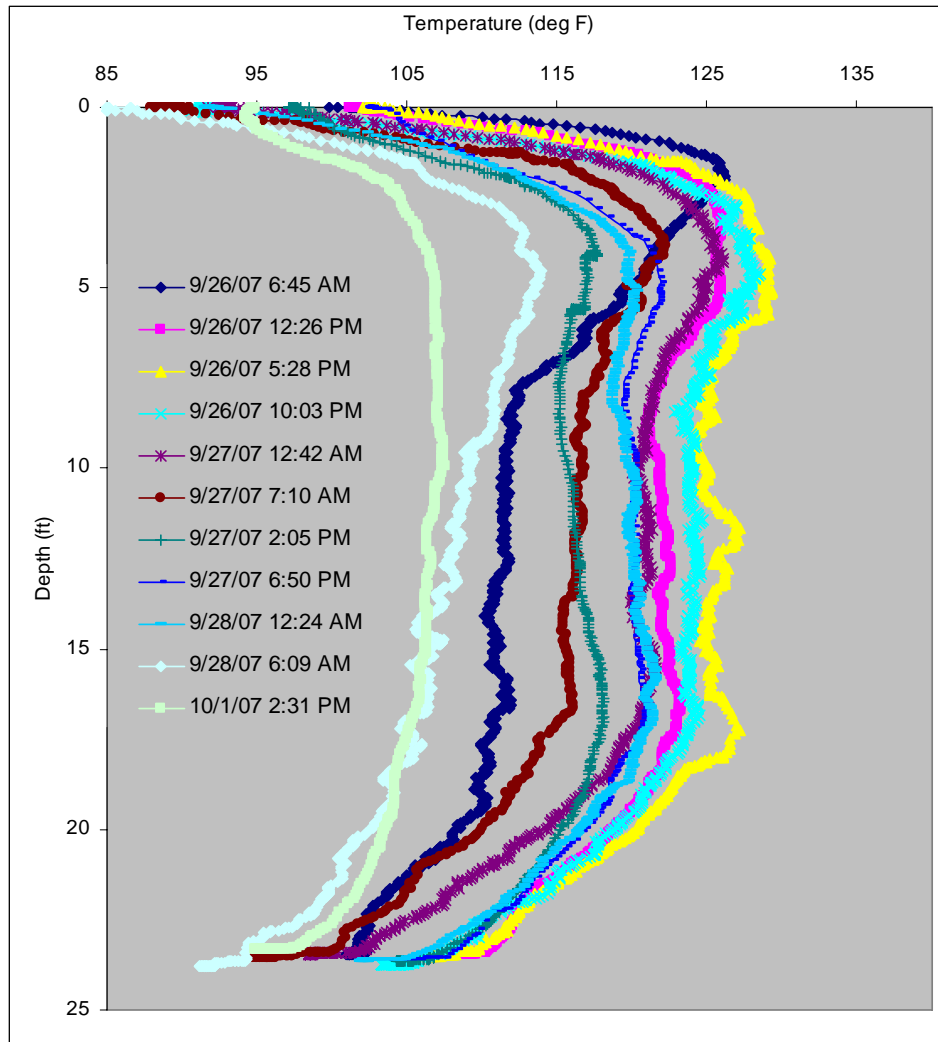
Figure 3-8. Voided shaft thermal results for tube 5.

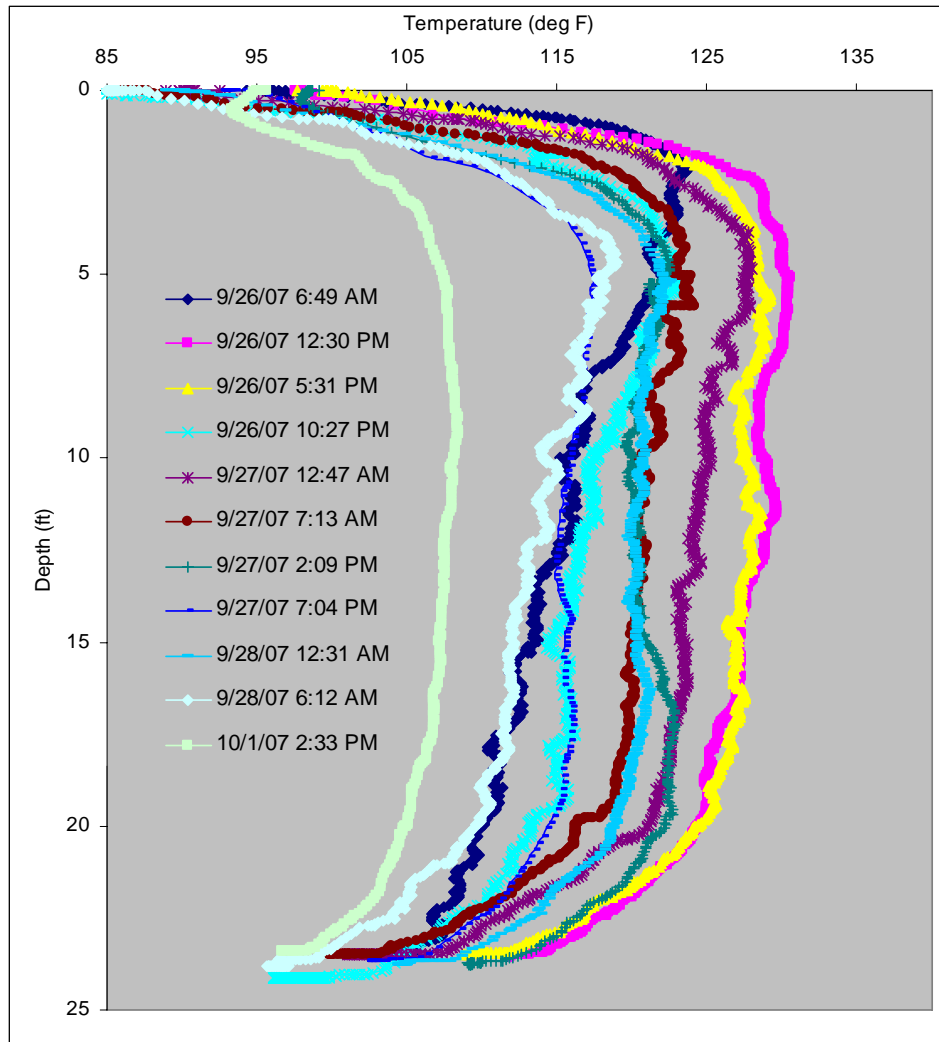
Figure 3-9. Voided shaft thermal results for tube 6.

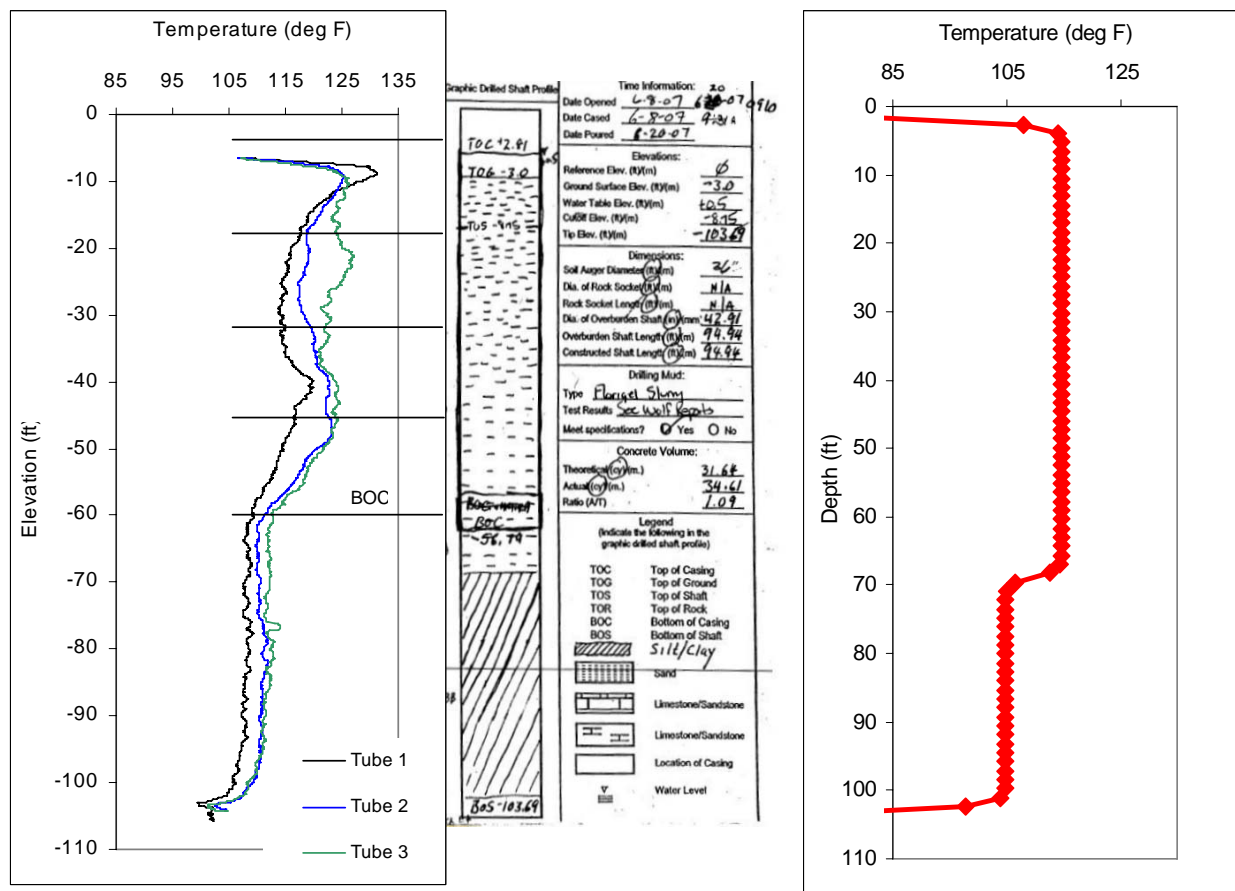
Figure 3-11. Shaft 25-3 results: measured (left), excavation log (middle), preliminary model (right).

Figure 3-11 shows the thermal data from shaft 25-3 which was tested 46 hours after concreting. The field conditions for this shaft were inputted into the T3DModel software and the results were compared against the field results. Variations in the measured results when compared to model predictions were used to add or subtract material from the model shaft to match the field measurements. In this case concrete was added around the shaft in regions that showed higher than anticipated temperature measurements. This was added by information obtained from the concreting logs (Figure 3-12).
