**ATTENUATING MASS CONCRETE EFFECTS IN DRILLED SHAFTS  
BD-544-39**

**DRAFT FINAL REPORT**

June 2009

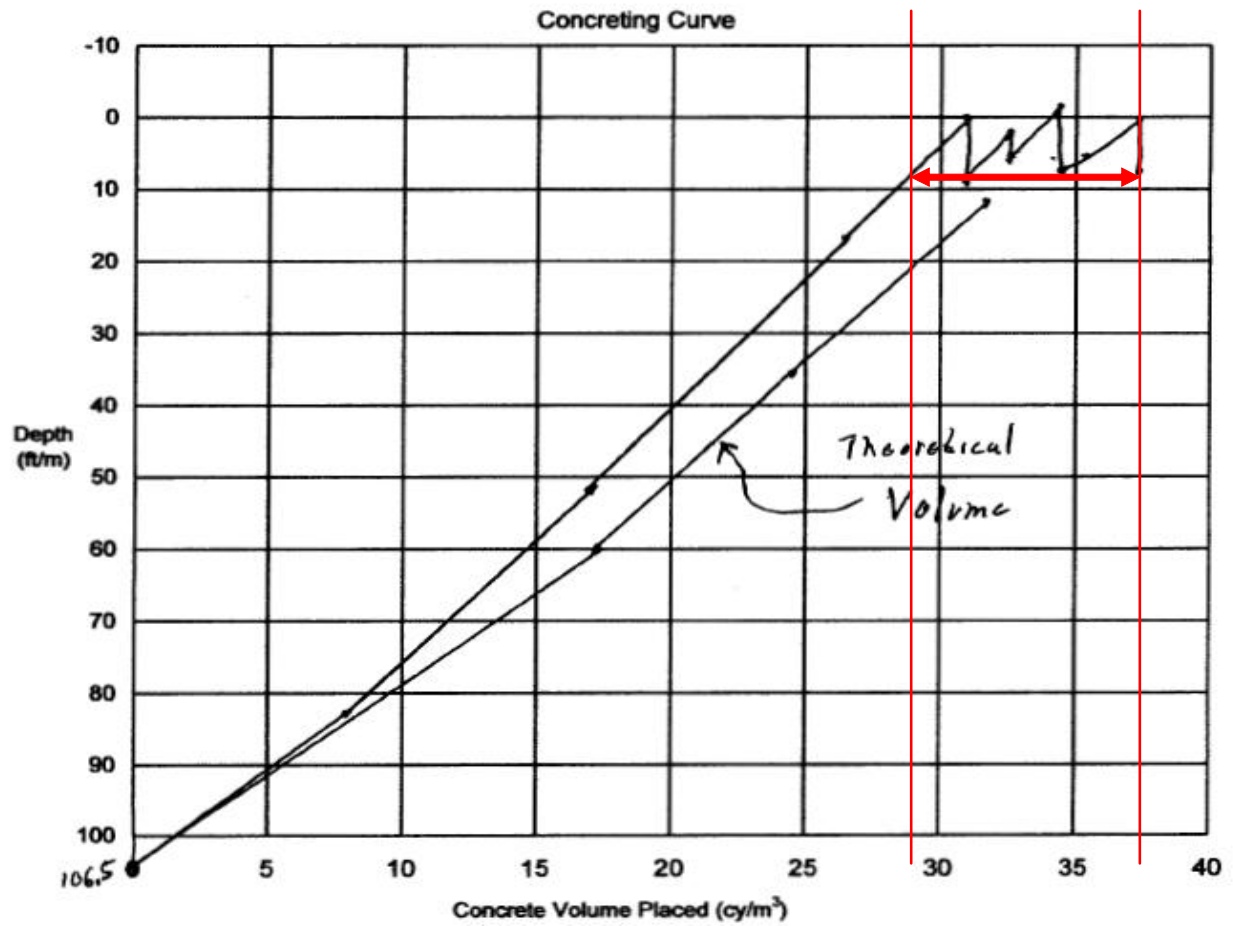
Figure 3-12. Concreting log (red arrows shows concrete used to refill while casing was extracted).

Figure 3-11 shows the thermal data from shaft 25-3 which was tested 46 hours after concreting. The field conditions for this shaft were inputted into the T3DModel software and the results were compared against the field results. Variations in the measured results when compared to model predictions were used to add or subtract material from the model shaft to match the field measurements. In this case concrete was added around the shaft in regions that showed higher than anticipated temperature measurements. This was added by information obtained from the concreting logs (Figure 3-12).

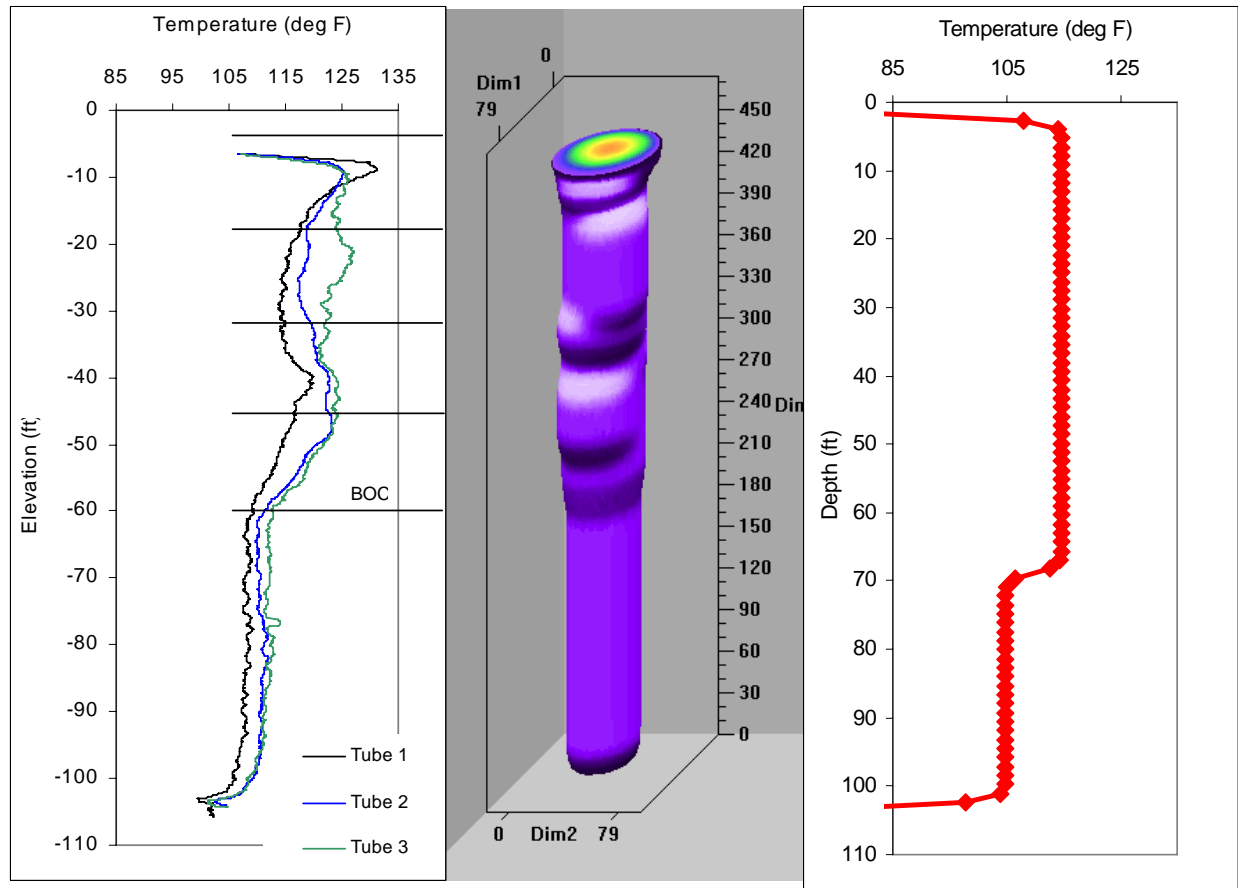
Figure 3-13. Shaft 25-3 results compared to 3-D modeled rendering showing where extra concrete finally came to reside..

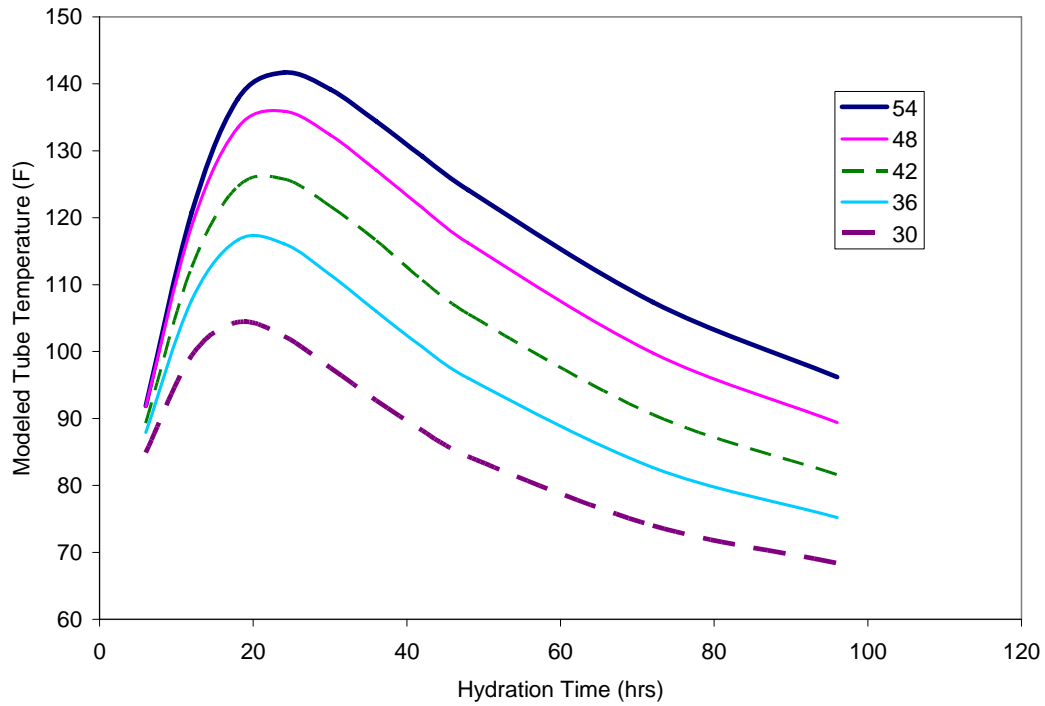
Figure 3-24 Normal access tube temperatures for shaft sizes tested.

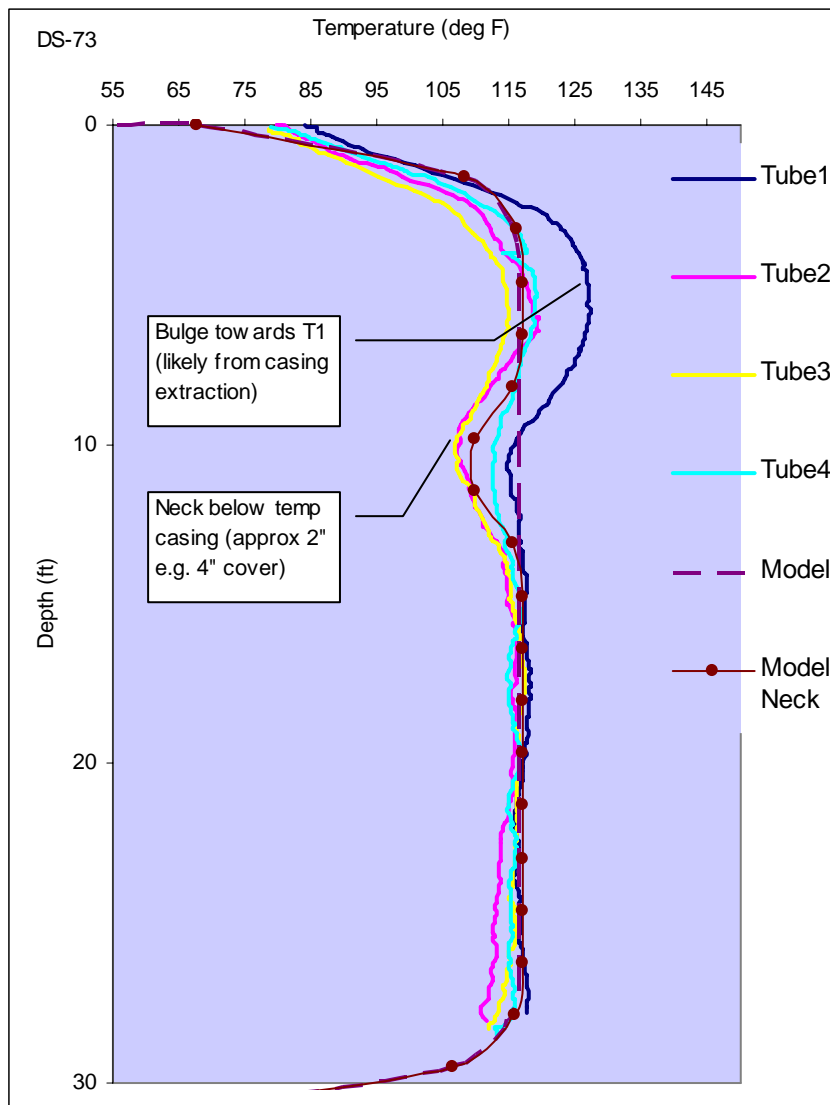
Figure 3-26 Signal match of Shaft DS-73 field results with modeled output, with and w/o neck.

DS-73	2/27/08 14:45	2/26/08 11:00	26	79	21	70	27.8	42	N/A	30	17	11	15	140		Slight neck near T1, T2, and T3 @ bottom of temp casing / depth 7-12' (approx 2 – 2.5" radius reduction)
	2/28/08 9:18	2/26/08 11:00	26	79	21	70	46.3	42	N/A	30	17	11	15	140

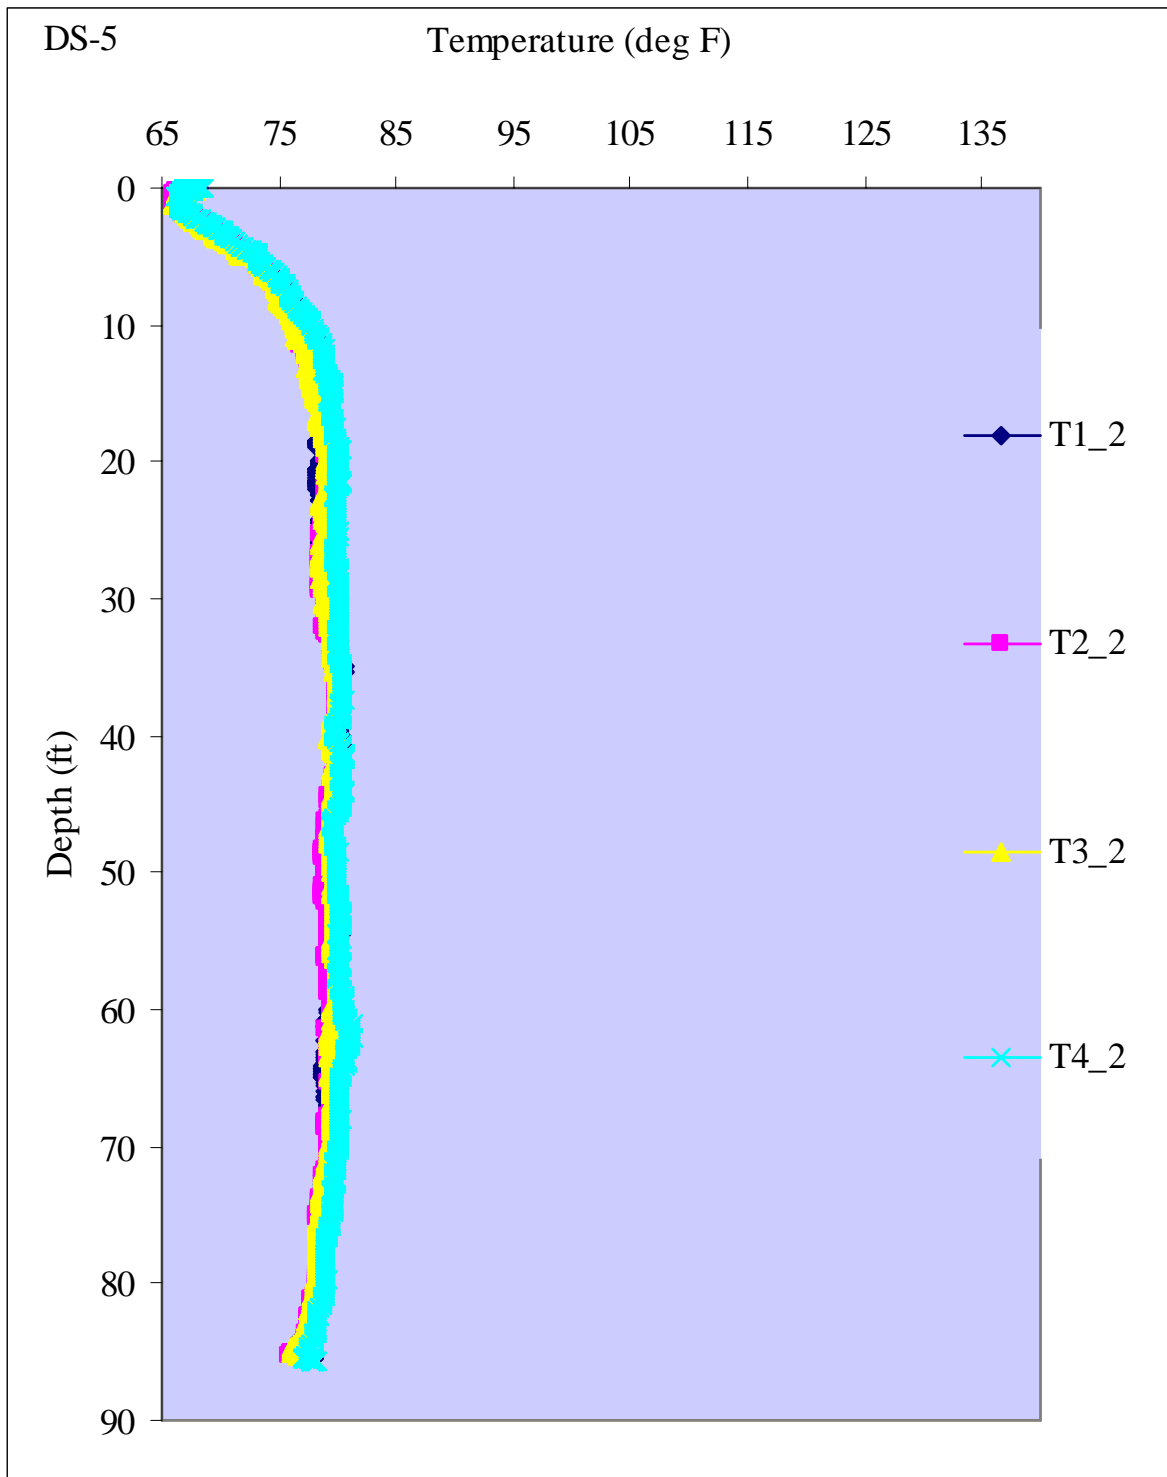
Figure 3-27. DS-5 Measured temperature traces for Tubes 1 through 4.

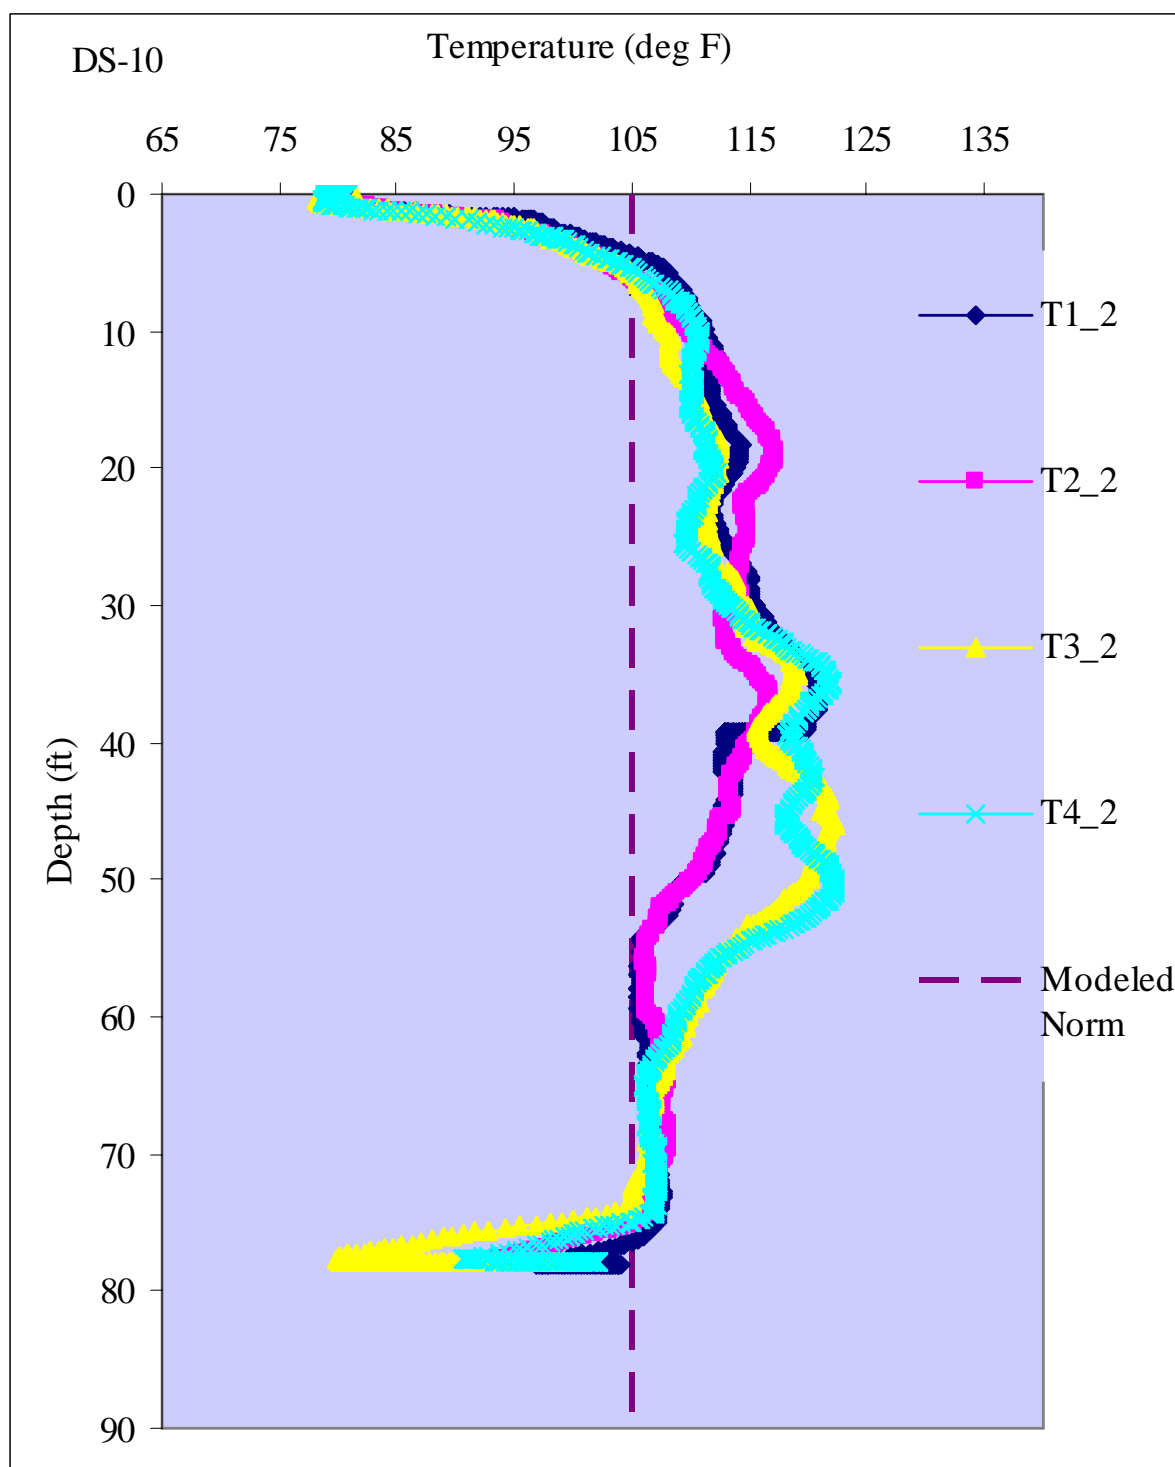
Figure 3-28. DS-10 Measured temperature traces for Tubes 1 through 4 compared to the model norm.

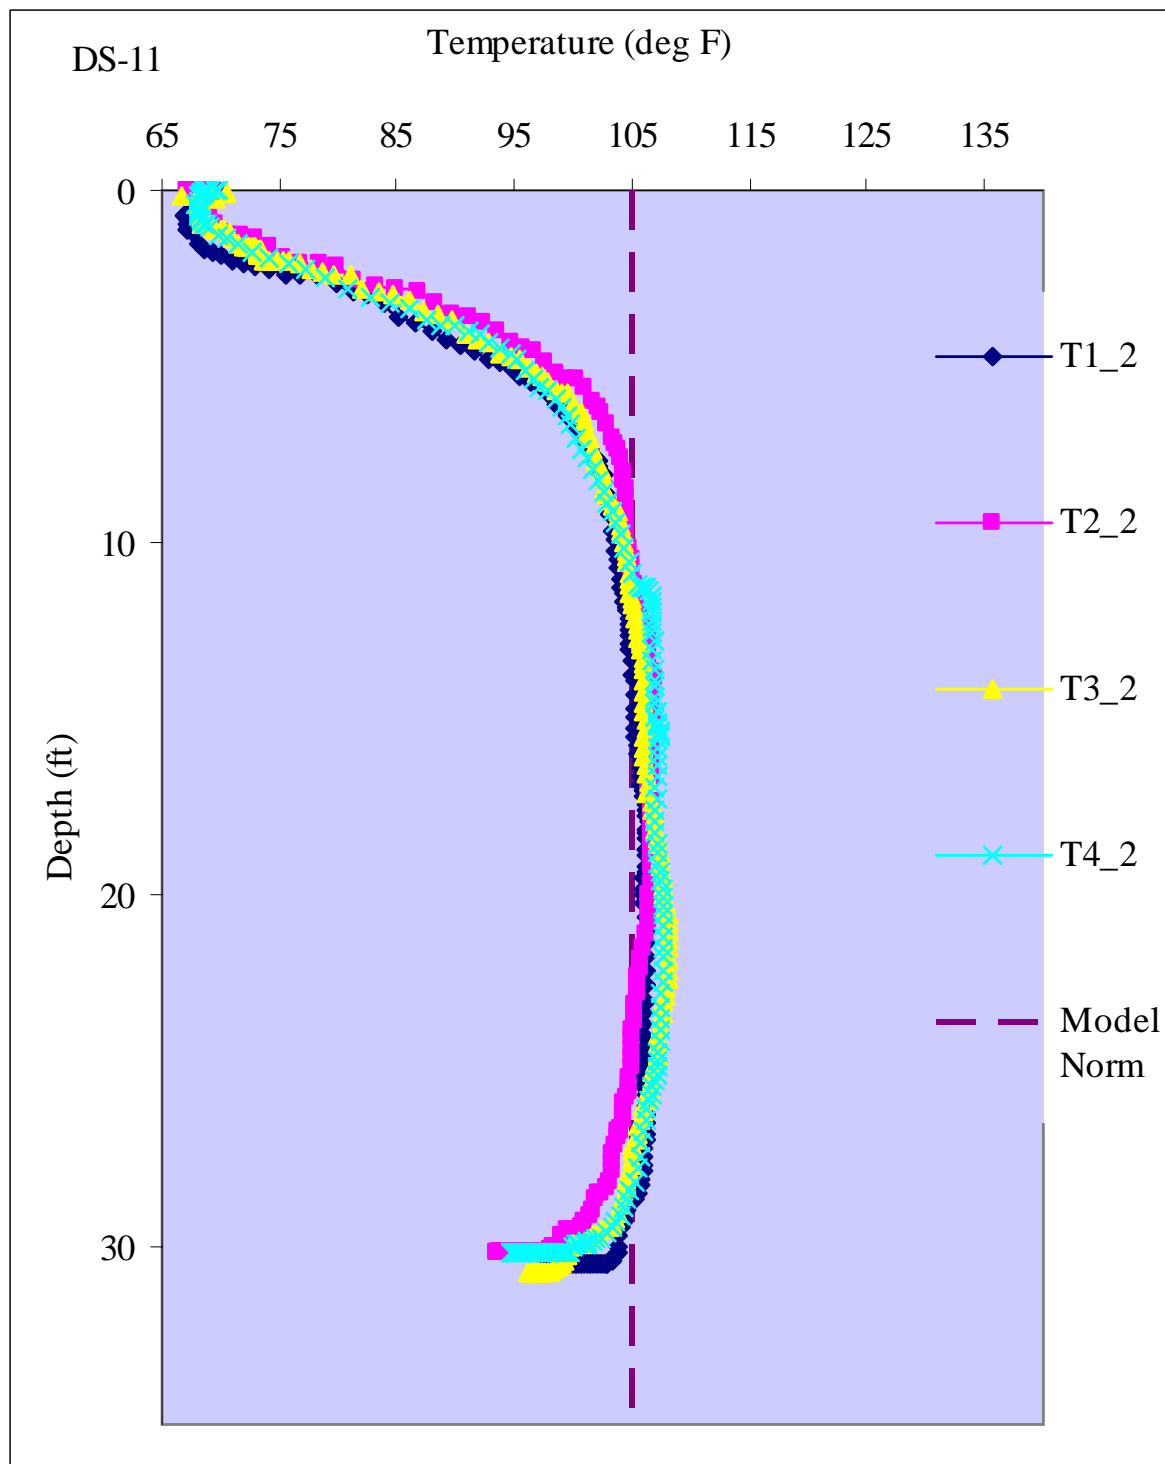
Figure 3-29. DS-11 Measured temperature traces for Tubes 1 through 4 compared to the model norm.

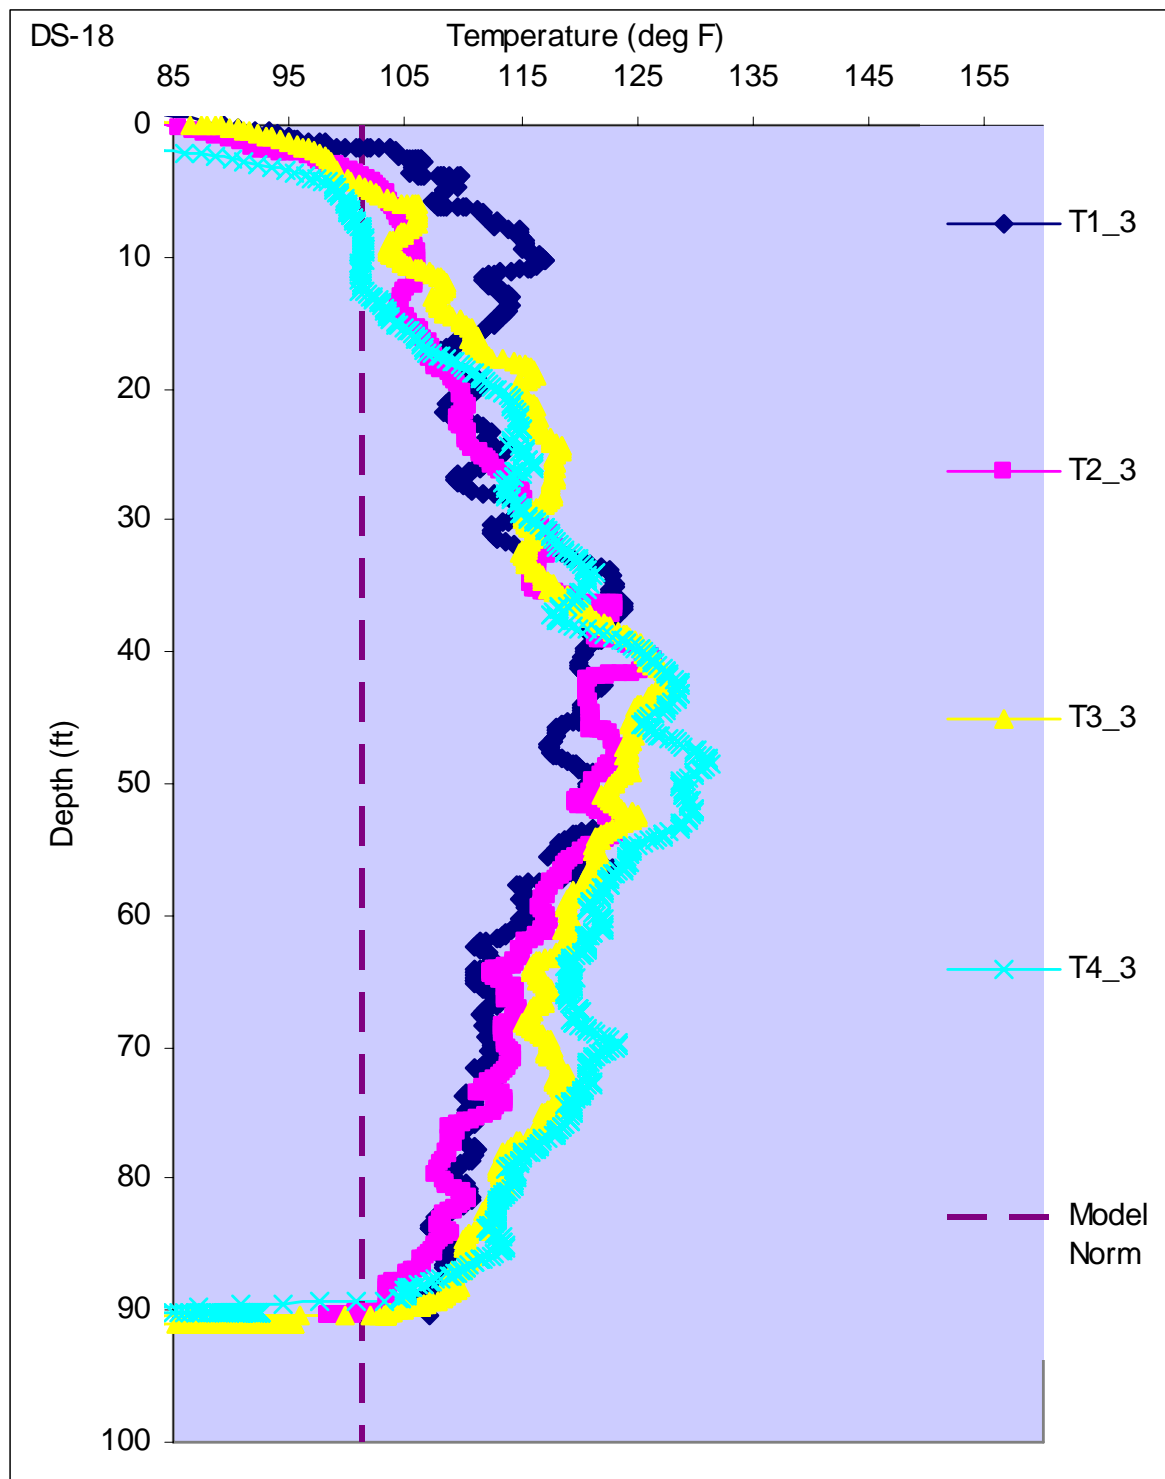
Figure 3-30. DS-18 Measured temperature traces for Tubes 1 through 4 compared to the model norm.

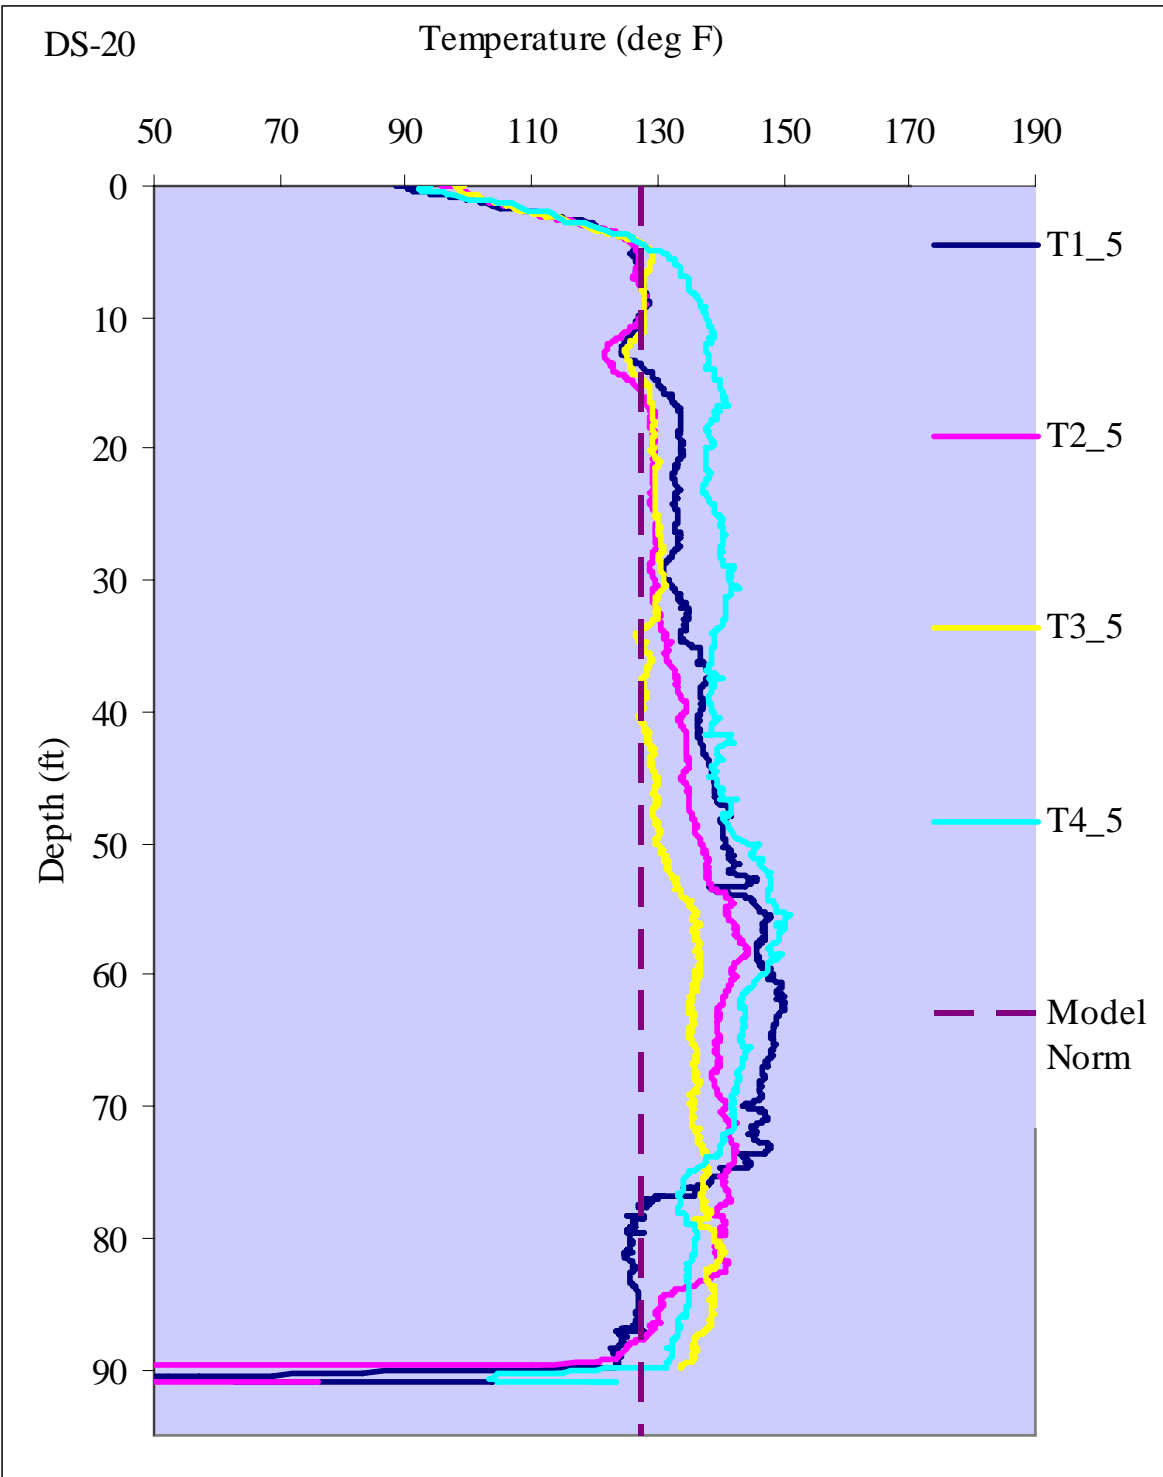
Figure 3-31. DS-20 Measured temperature traces for Tubes 1 through 4 compared to the model norm.

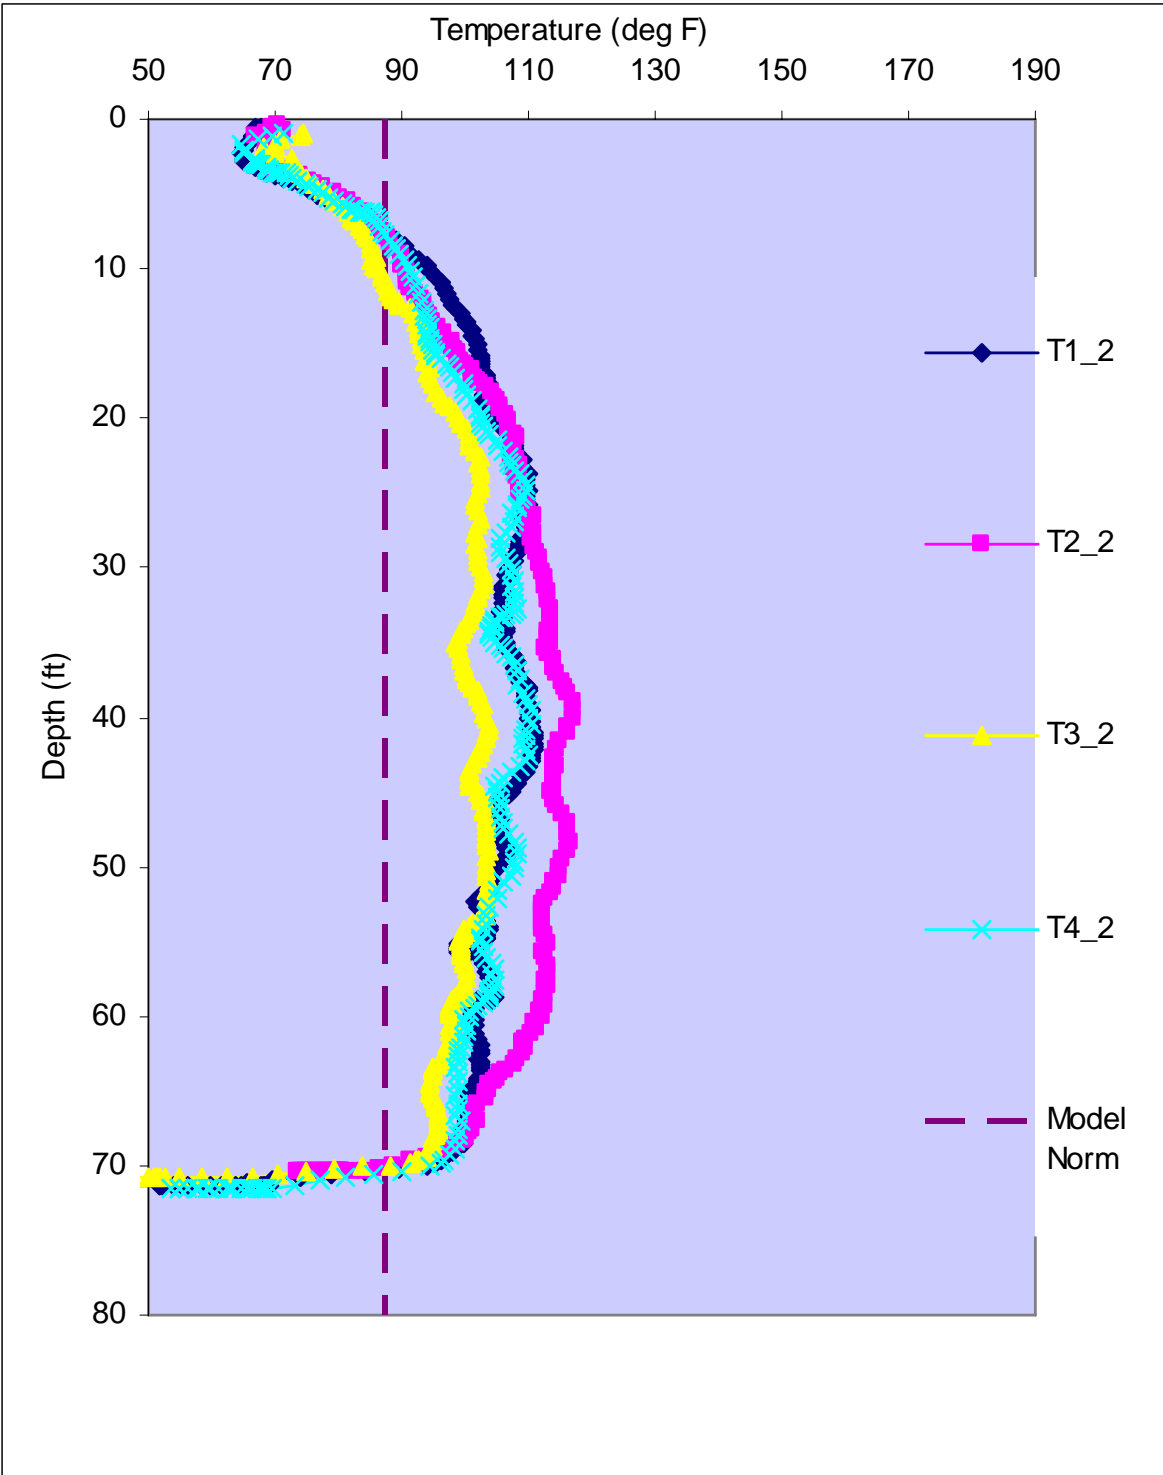
Figure 3-32. DS-23 Measured temperature traces for Tubes 1 through 4 compared to the model norm.

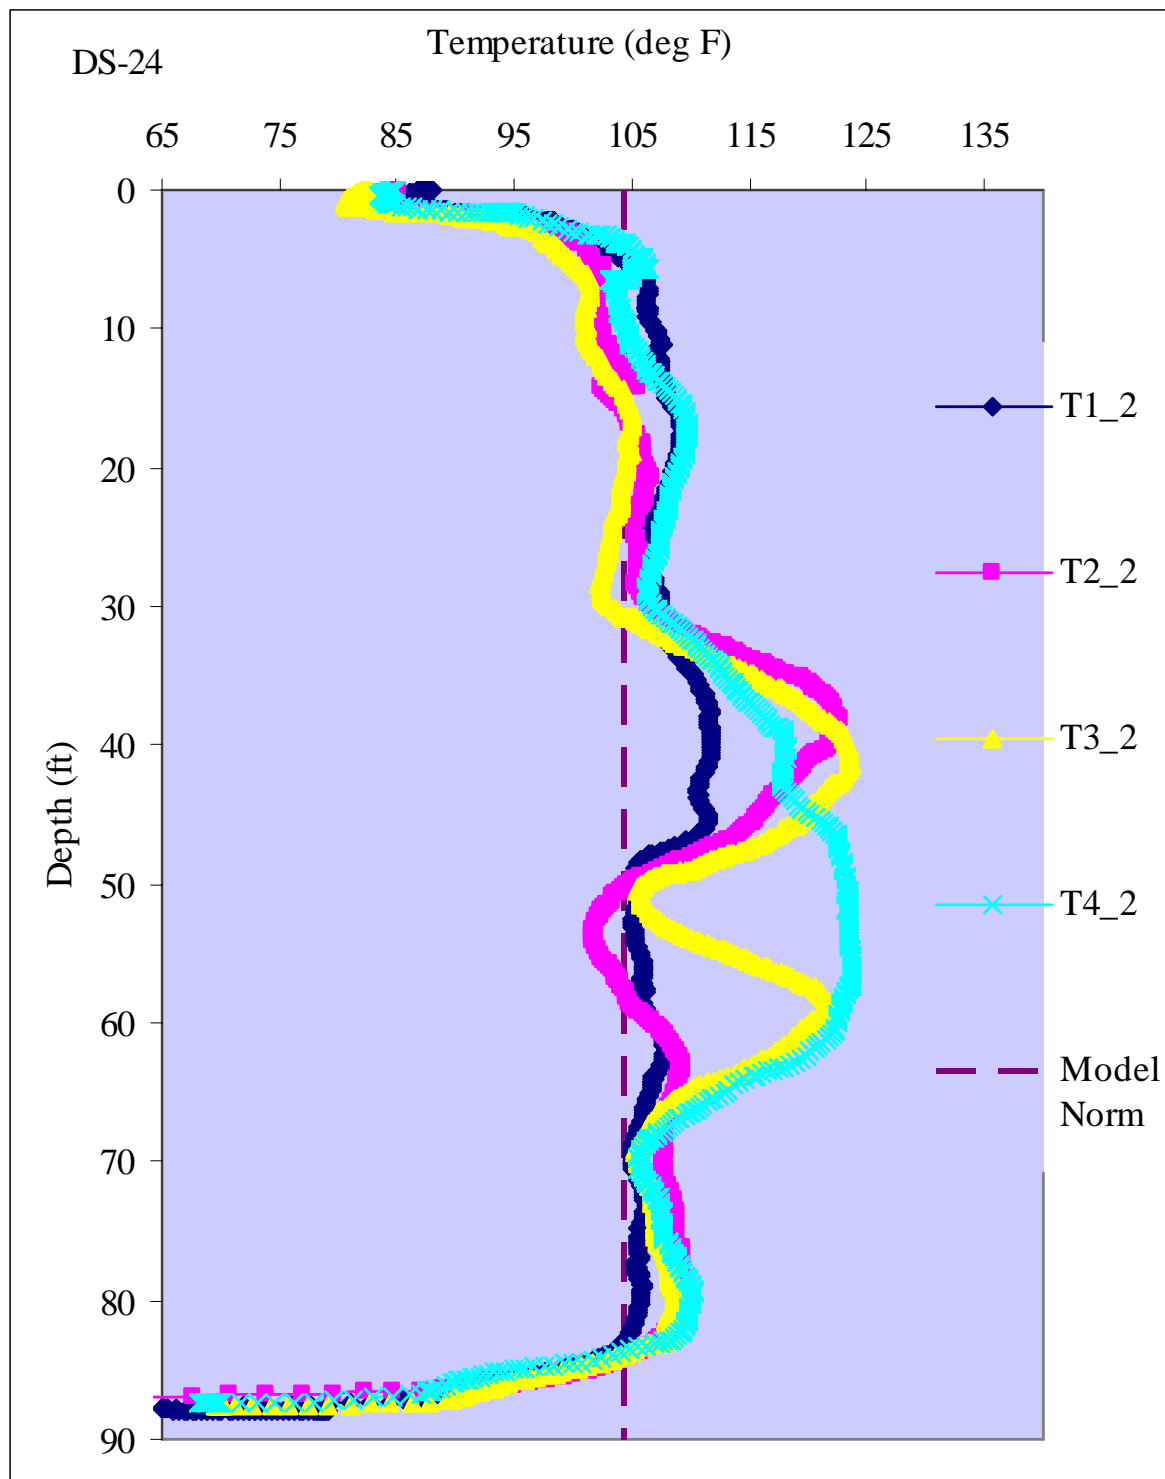
Figure 3-33. DS-24 Measured temperature traces for Tubes 1 through 4 compared to the model norm.

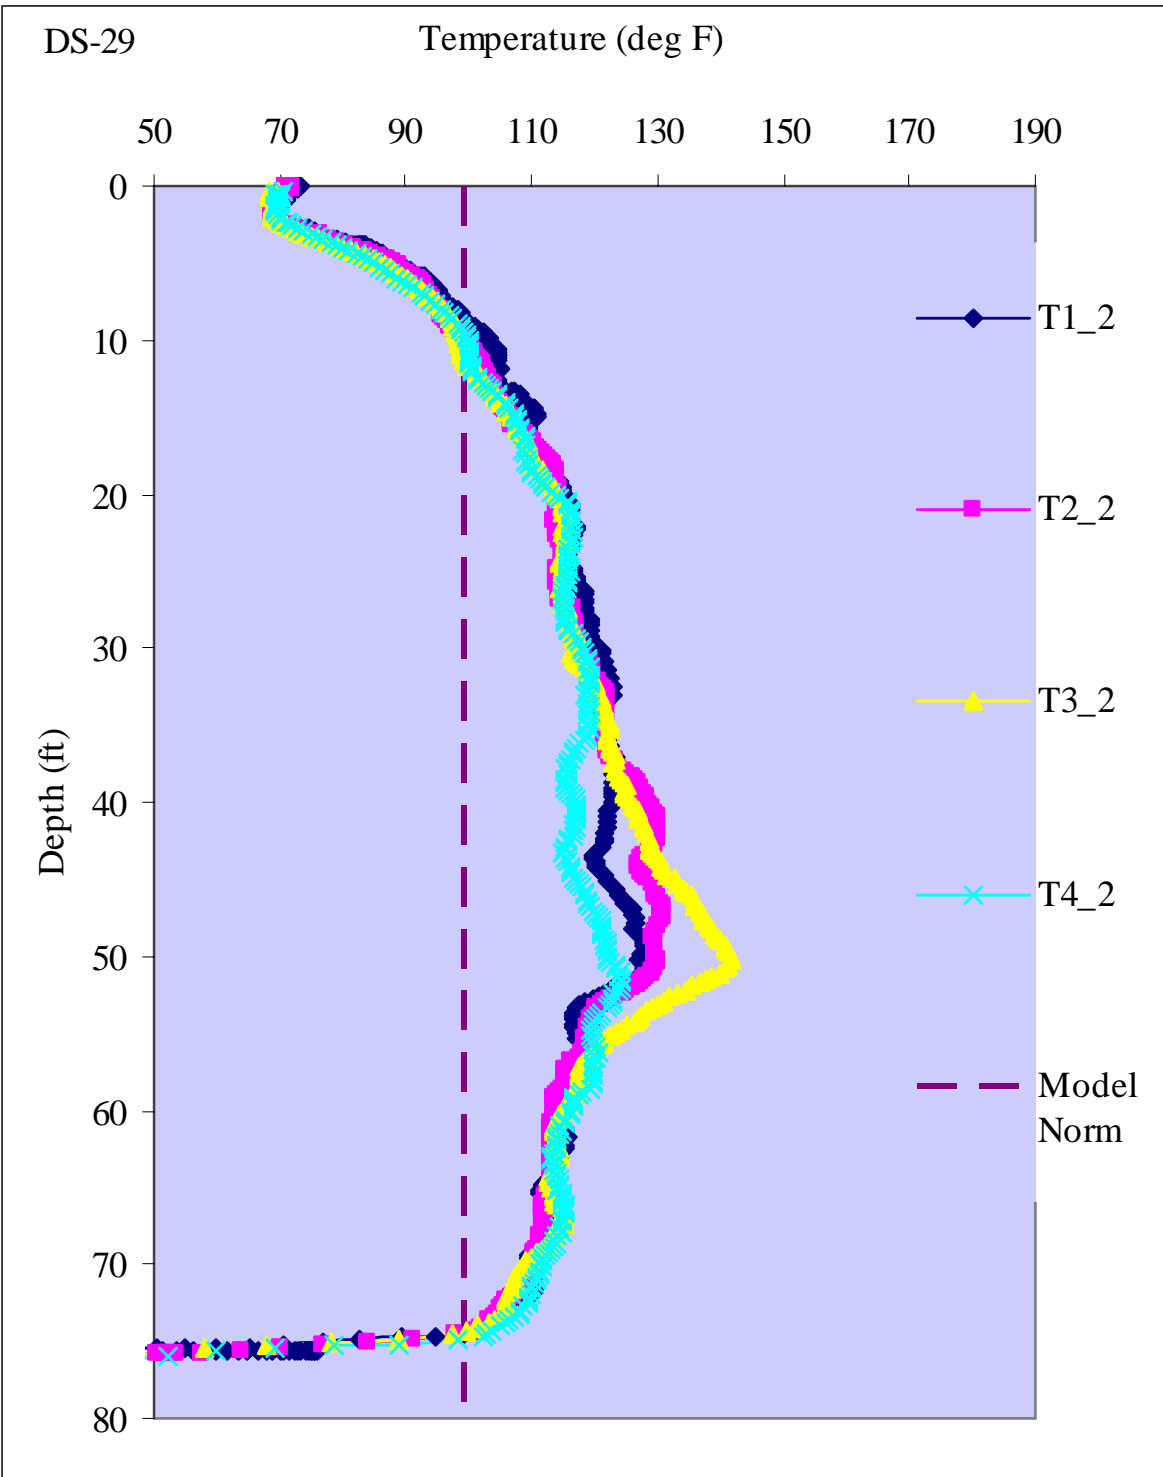
Figure 3-34. DS-29 Measured temperature traces for Tubes 1 through 4 compared to the model norm.

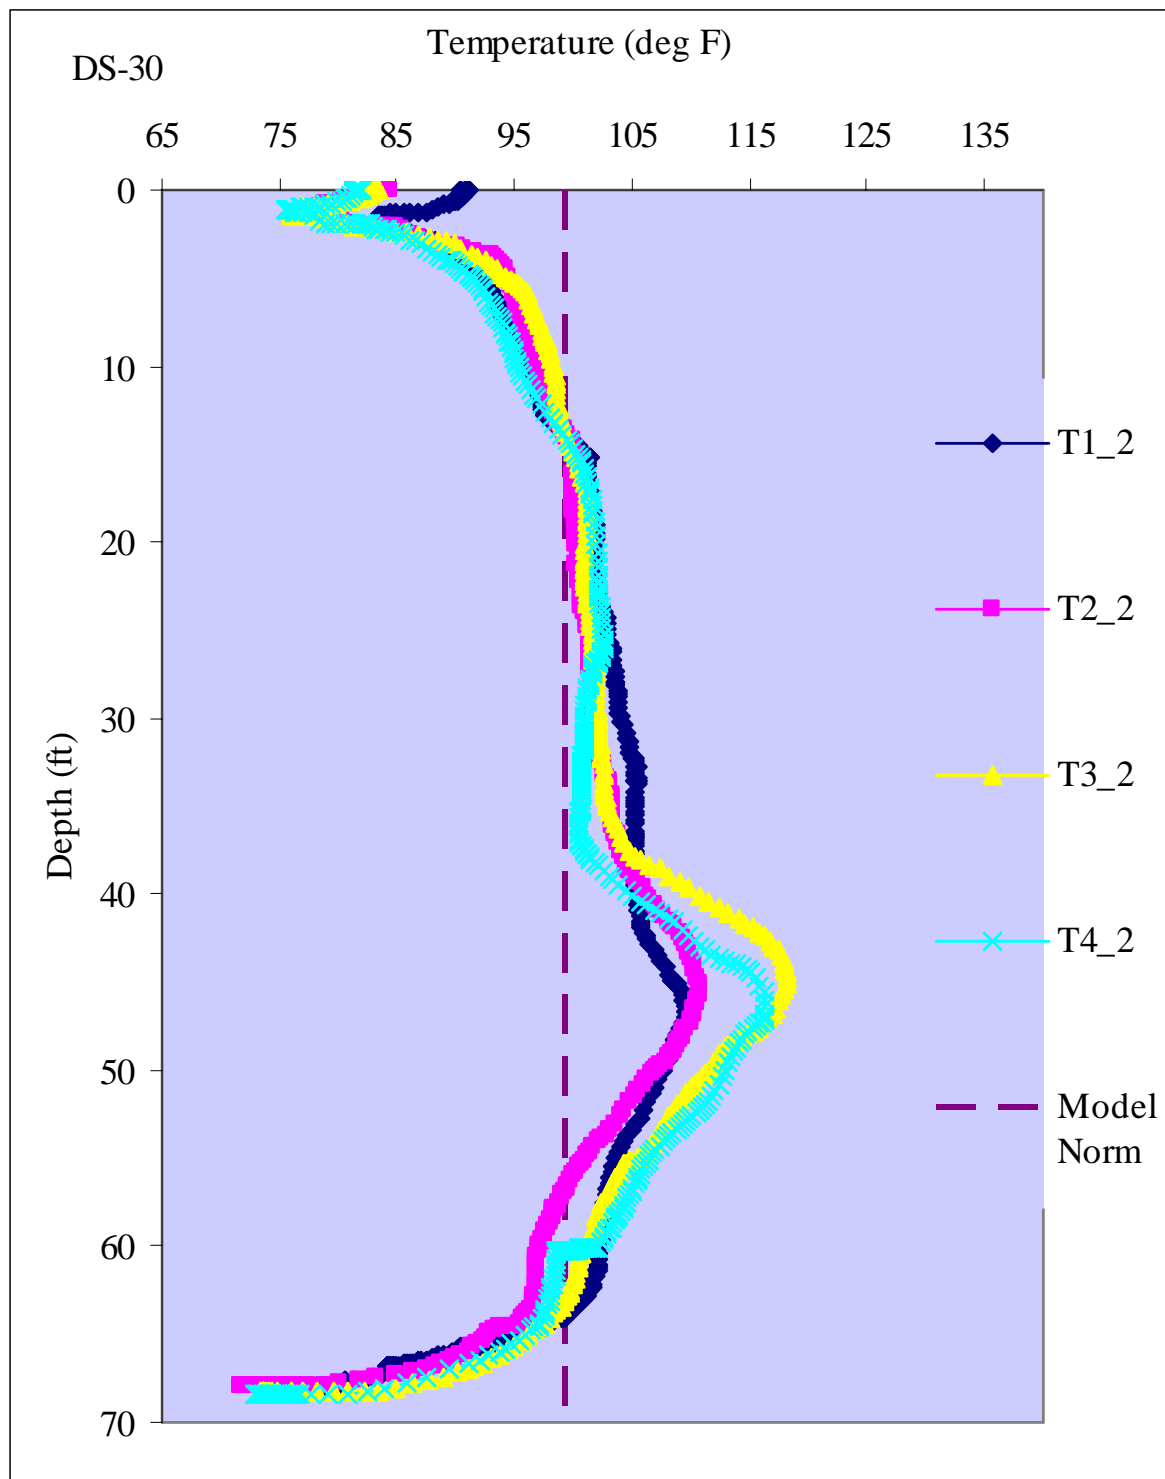
Figure 3-35. DS-30 Measured temperature traces for Tubes 1 through 4 compared to the model norm.

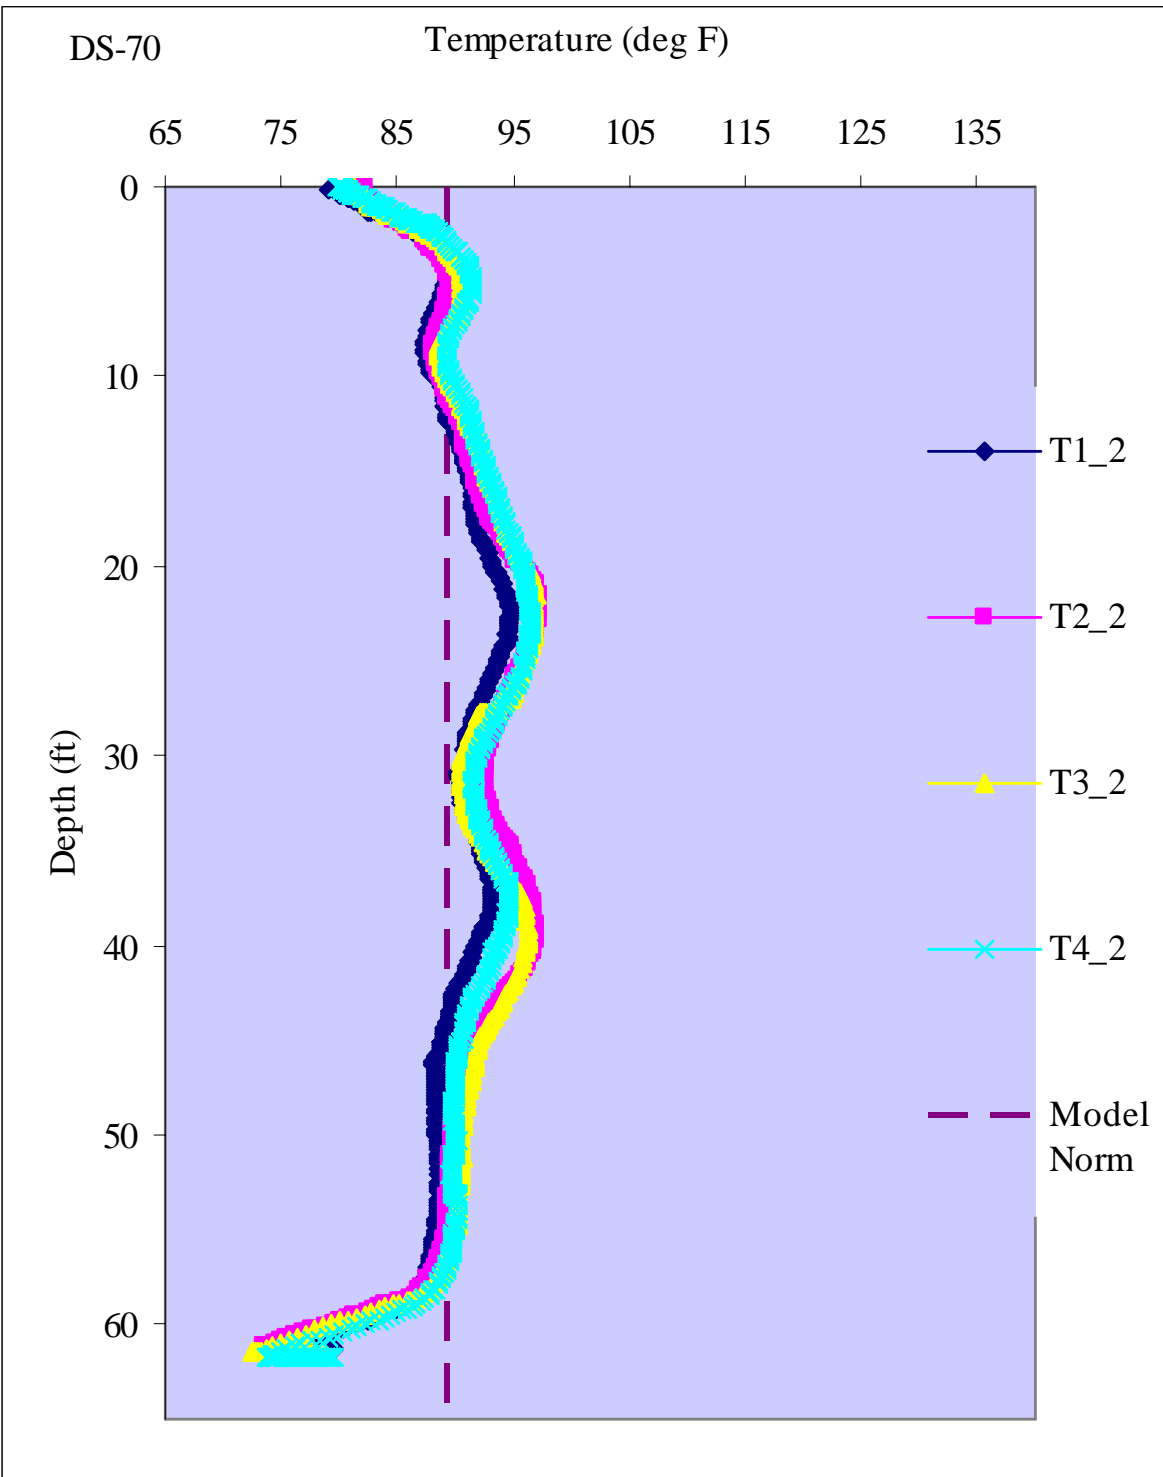
Figure 3-36. DS-70 Measured temperature traces for Tubes 1 through 4 compared to the model norm.
