**ATTENUATING MASS CONCRETE EFFECTS IN DRILLED SHAFTS  
BD-544-39**

**DRAFT FINAL REPORT**

June 2009

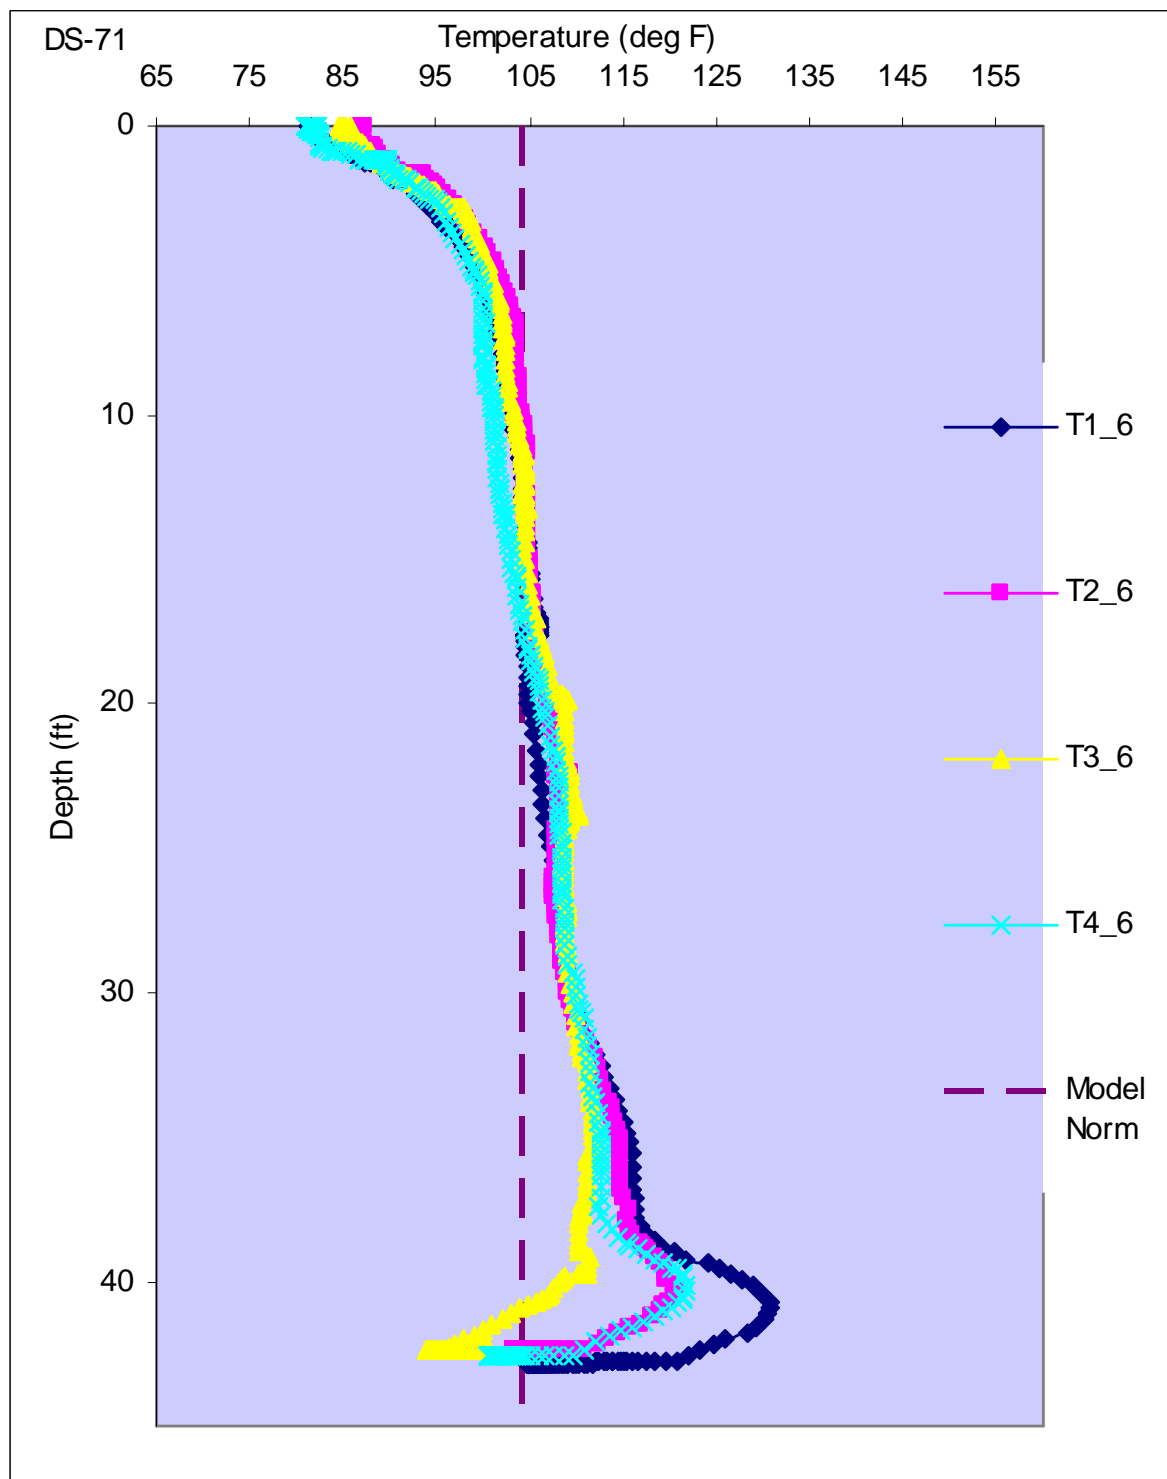
Figure 3-37. DS-71 Measured temperature traces for Tubes 1 through 4 compared to the model norm.

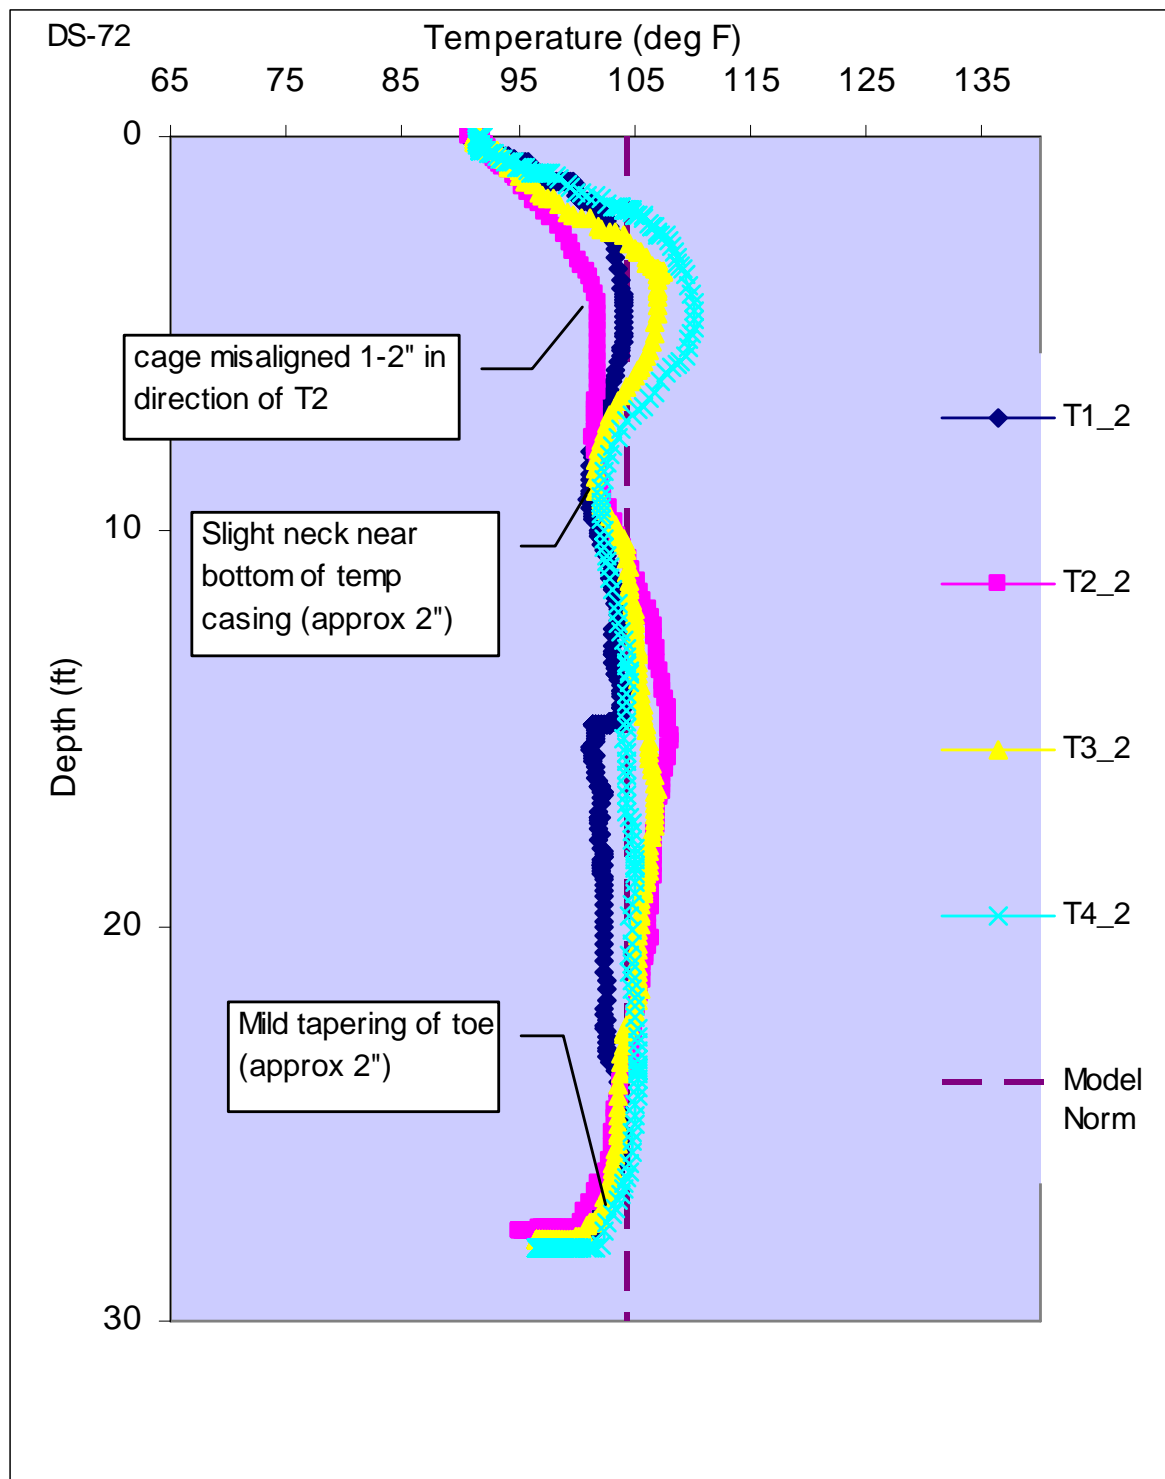
Figure 3-38. DS-72 Measured temperature traces for Tubes 1 through 4 compared to the model norm.

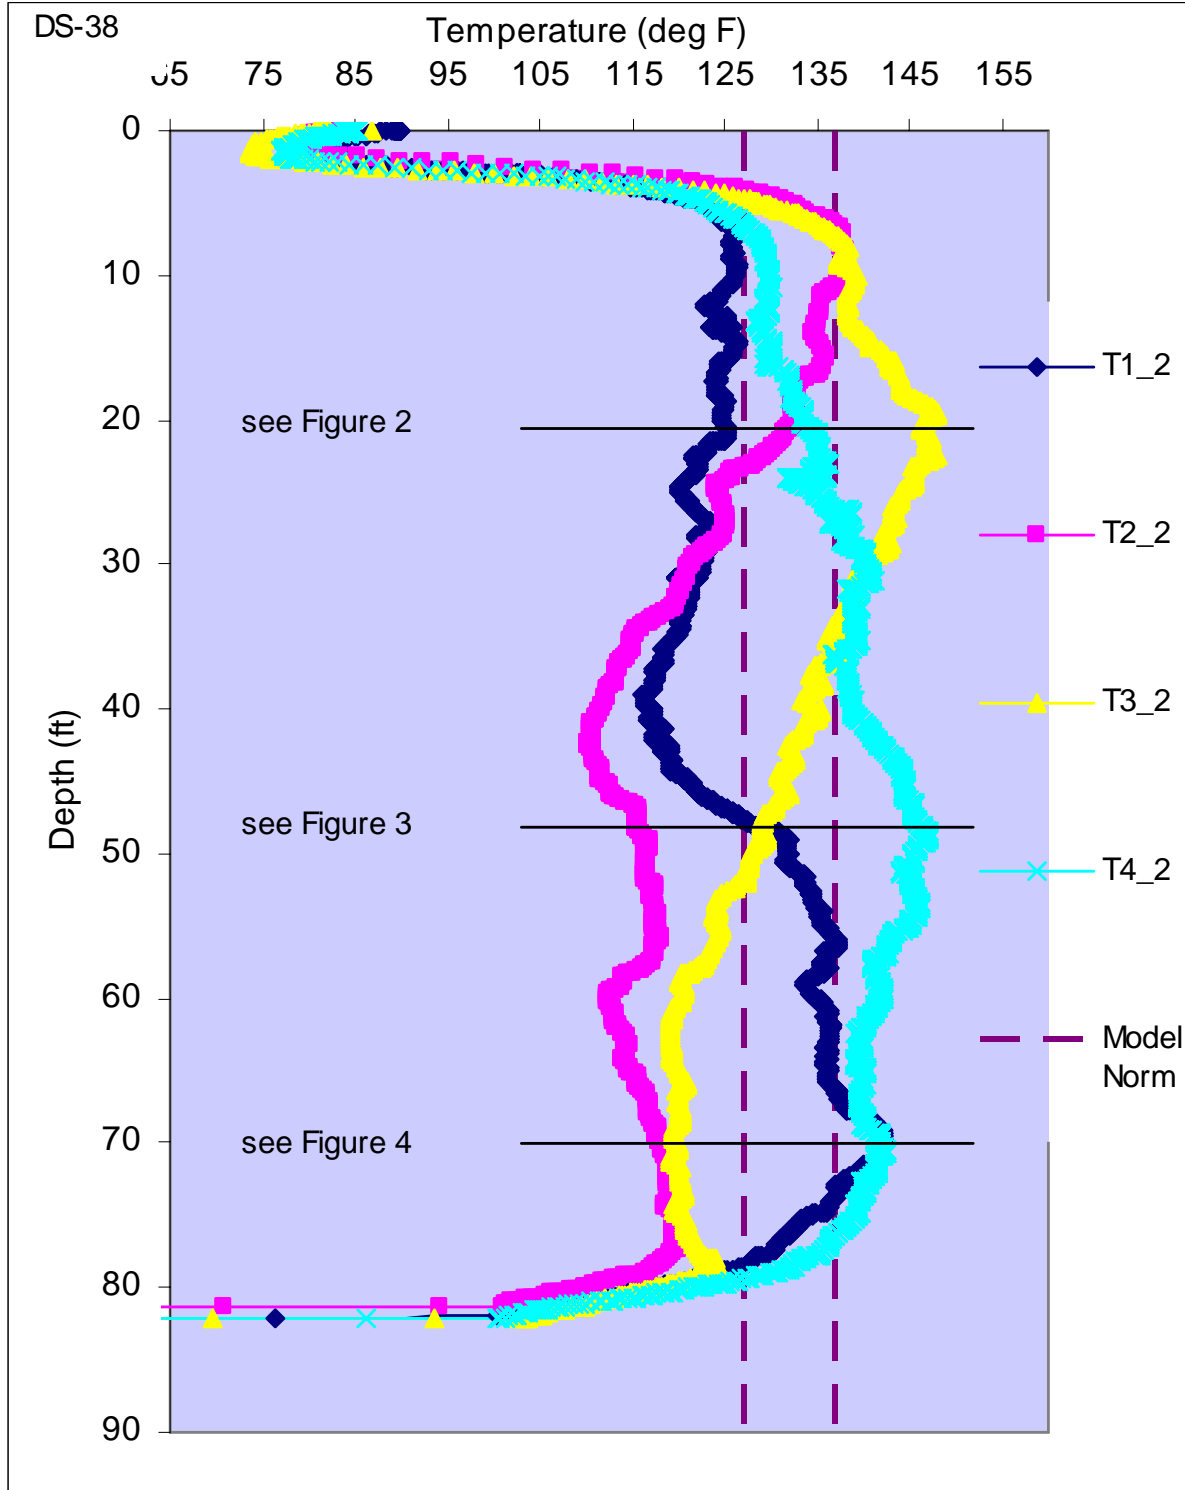
Figure 3-39. DS-38 Measured temperature traces for Tubes 1 through 4 compared to the model norm.

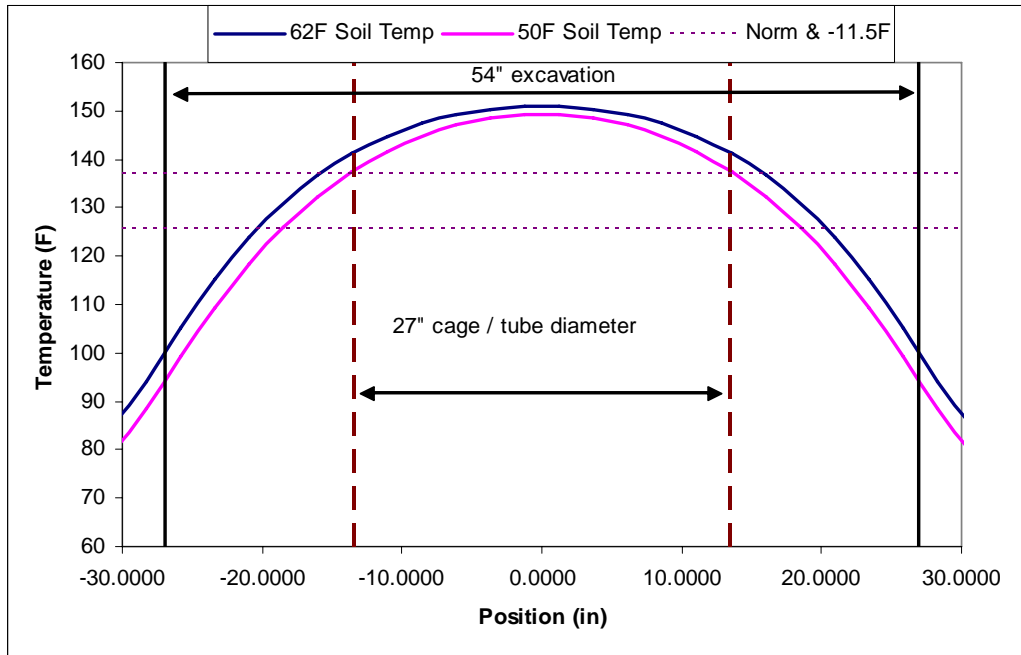
Figure 3-42. Cage alignment in 54" excavation at a depth of 70 ft.

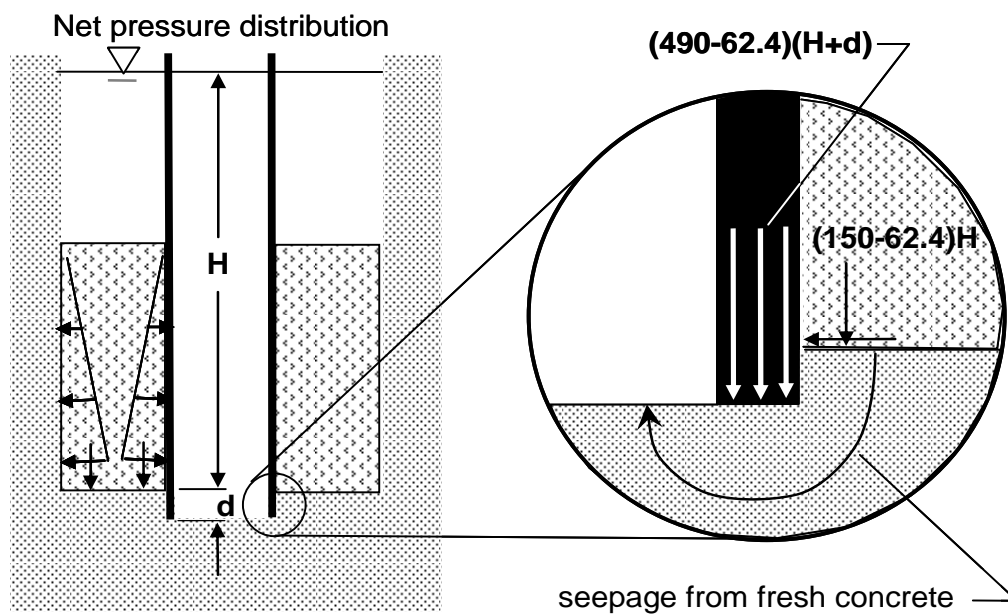
Figure 4-2. Net hydrostatic pressure distribution during construction

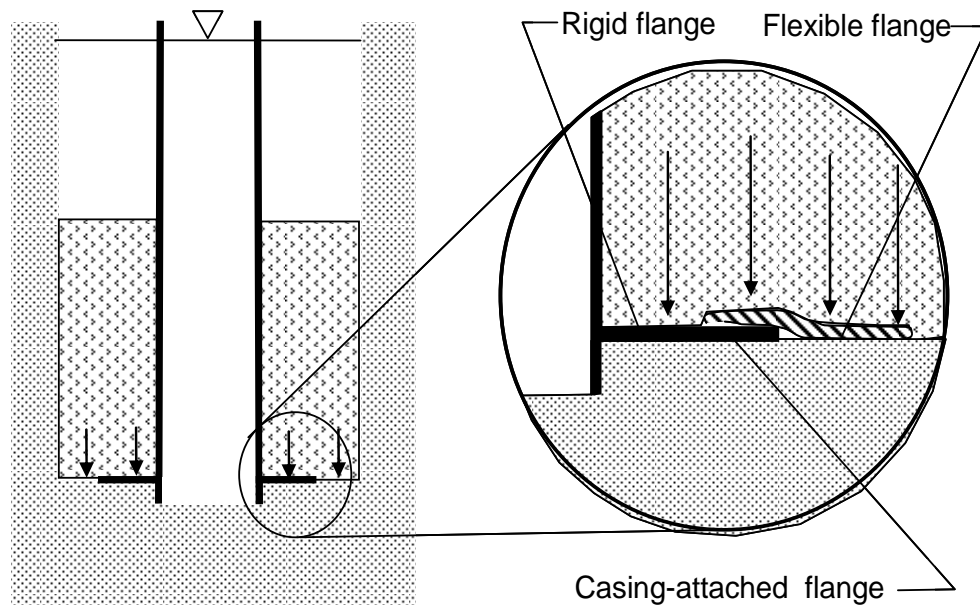
Figure 4-3. Figure 8. Rigid and flexible combination sealing flange is attached to the void casing, and engaged by the slurry and concrete load.

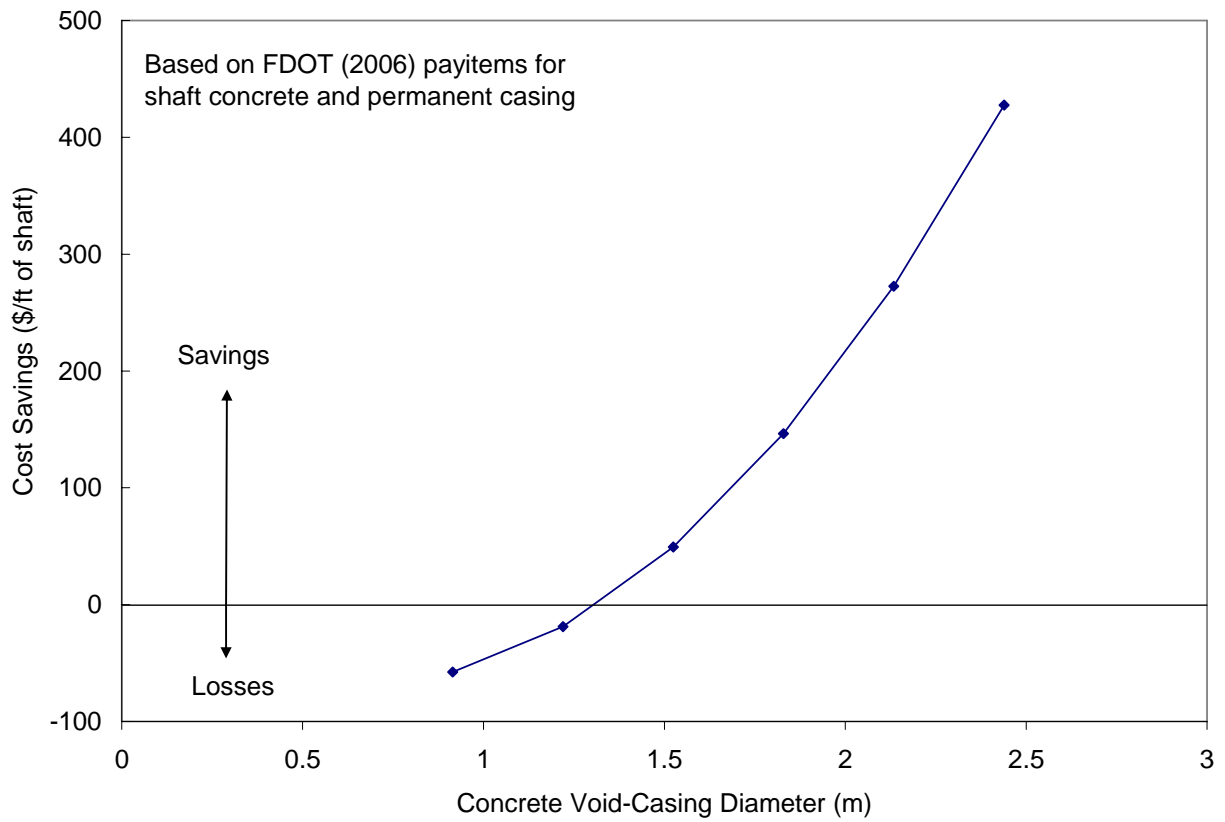
Figure 4-7. Cost savings per ft of void diameter from unused concrete, including the inner casing, which is assumed permanent.

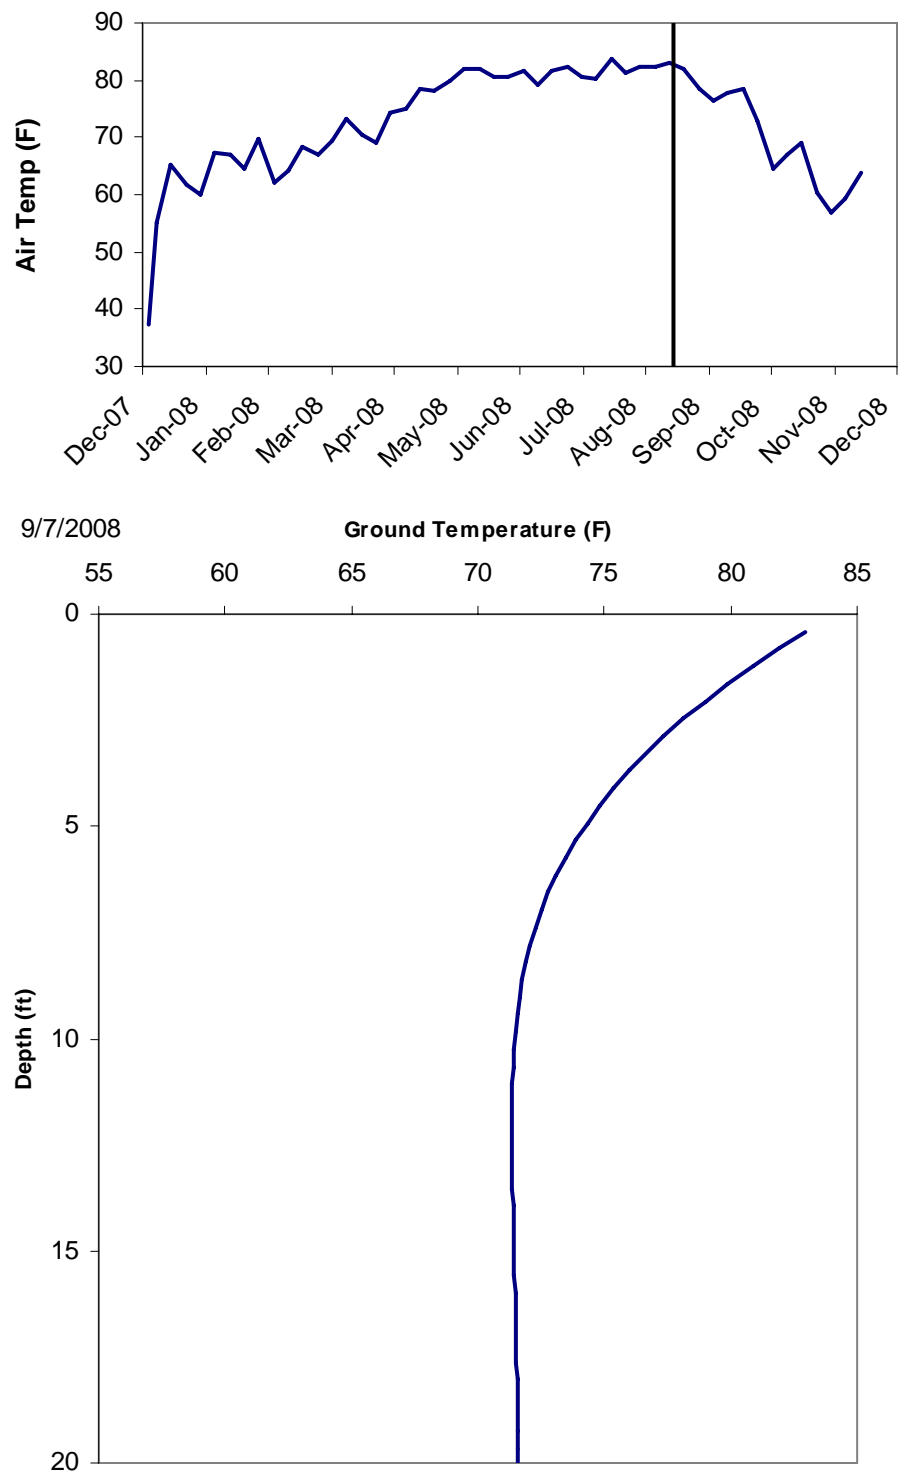
Figure 4-8. Hottest summer conditions occur in September for both the air and soil.

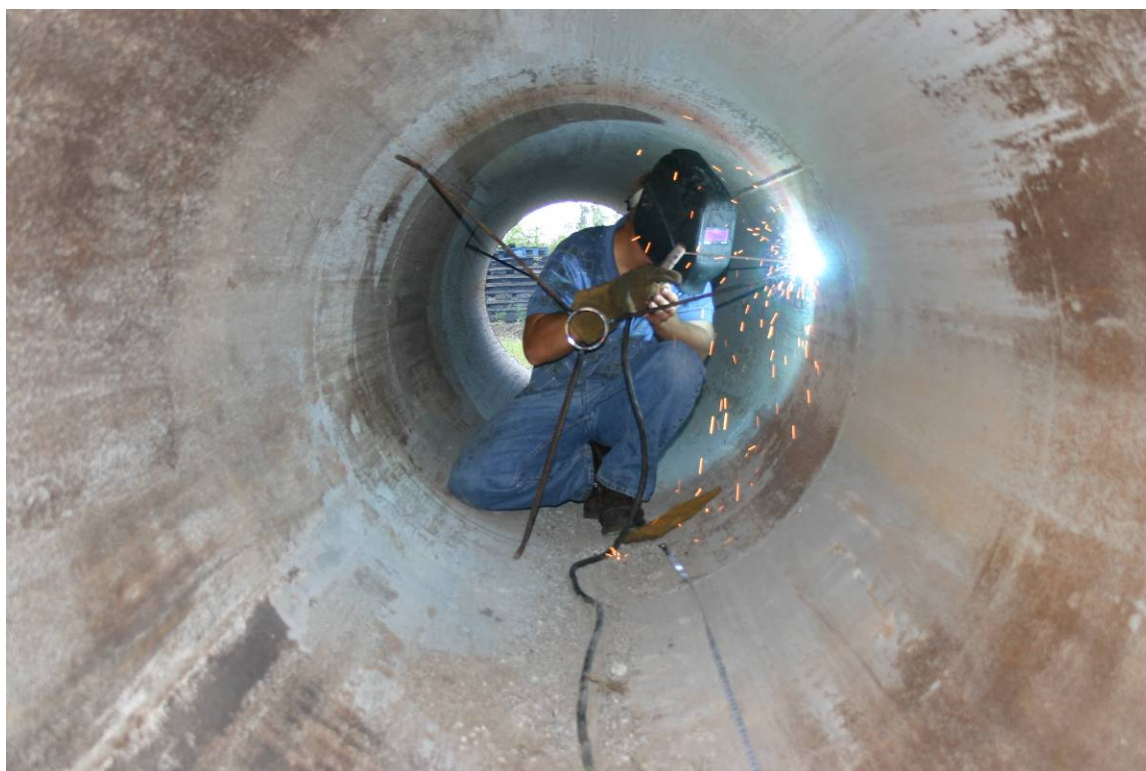
Figure 4-12. Voided shaft center casing access tube supports.

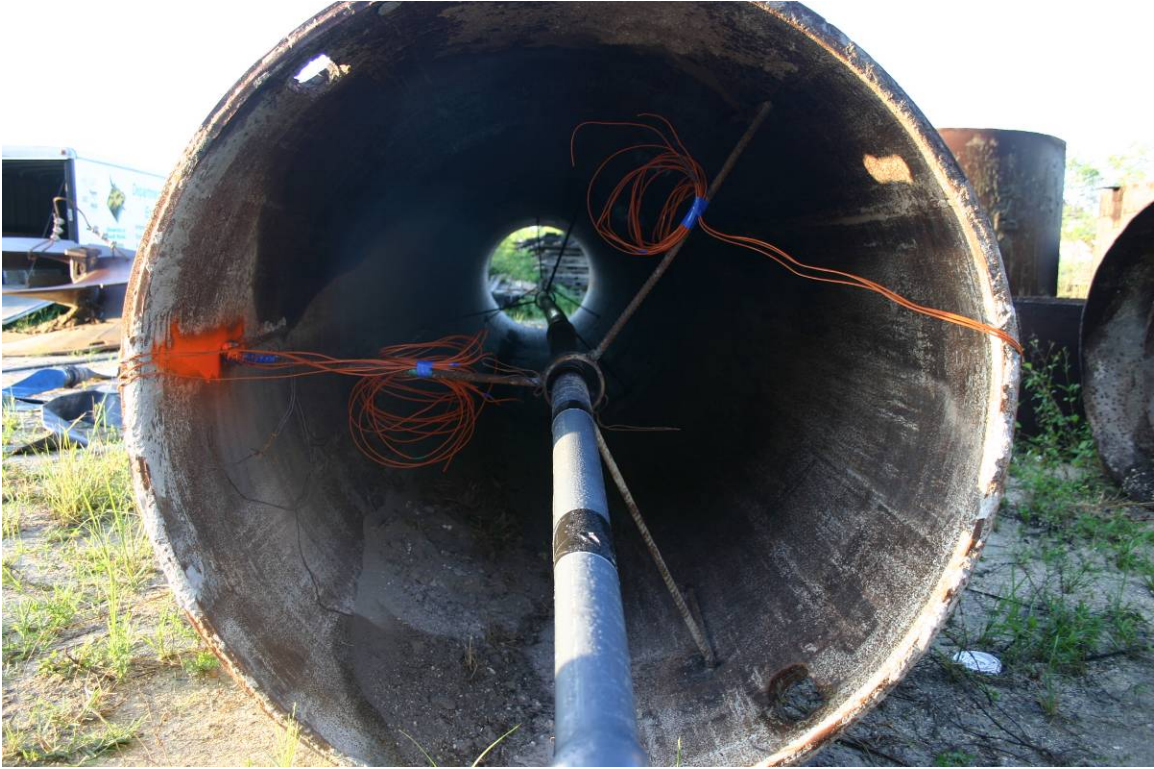
Figure 4-13. Thermocouples and access tube Installed in center casing.

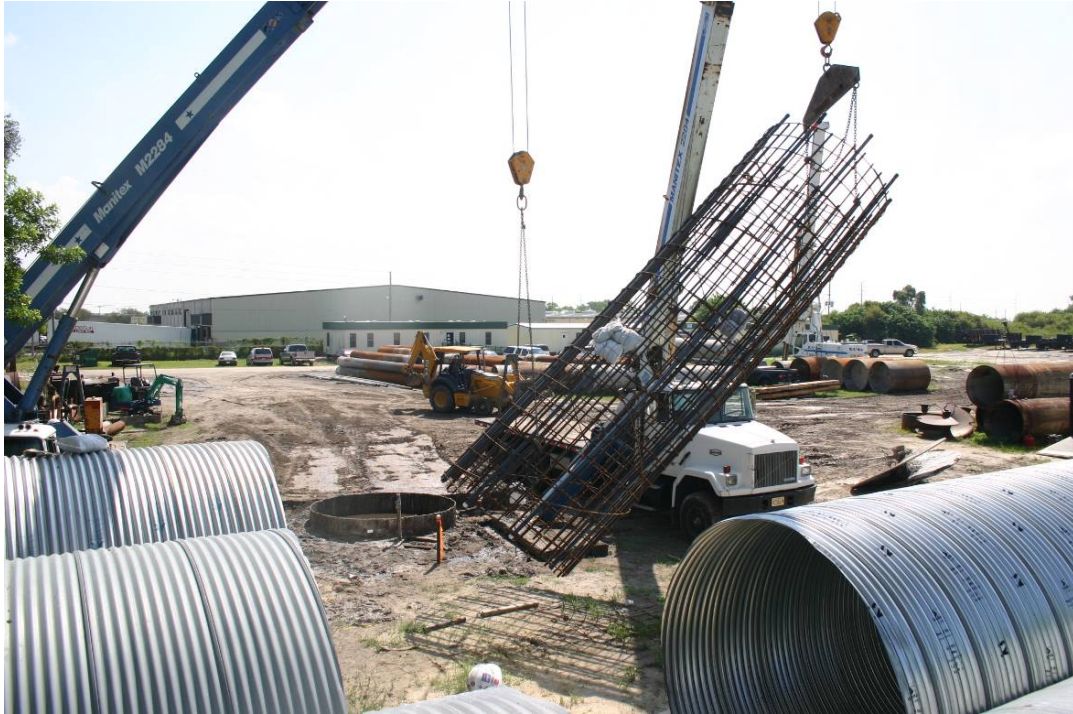
Figure 4-15. Lifting reinforcement cage.

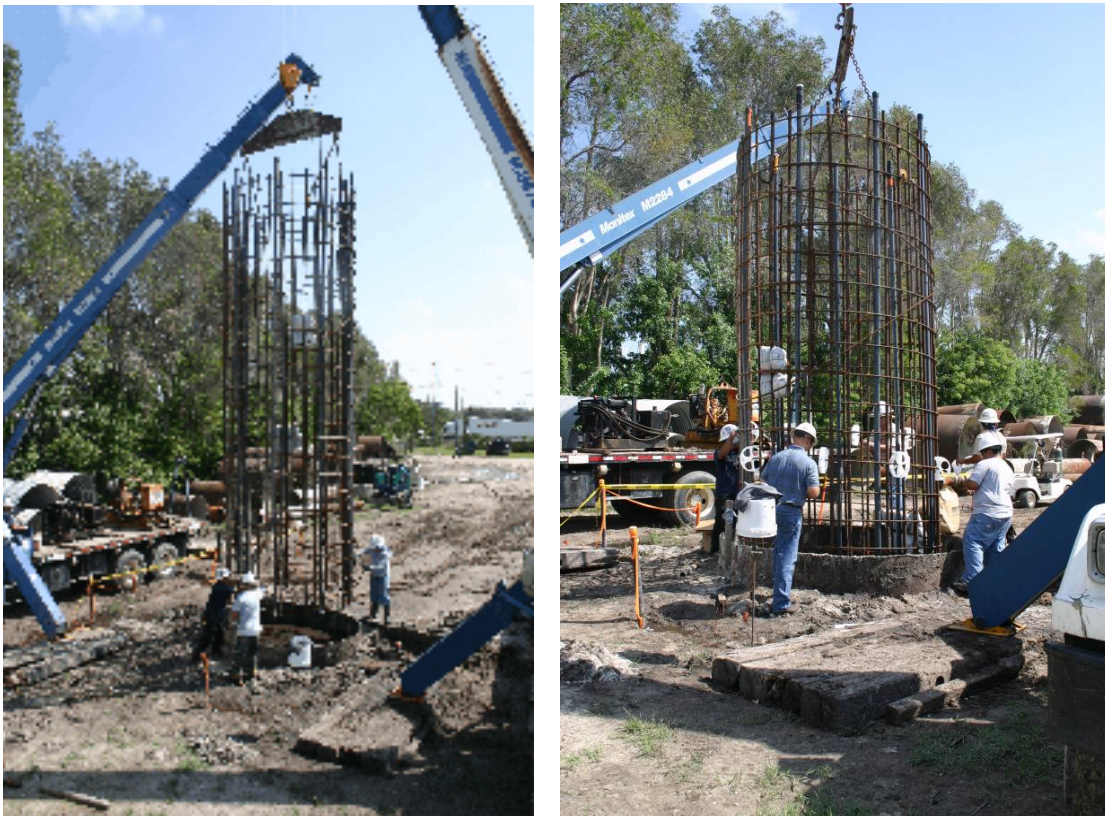
Figure 4-16. Placement of reinforcement cage with 12in diameter wheel spacers.

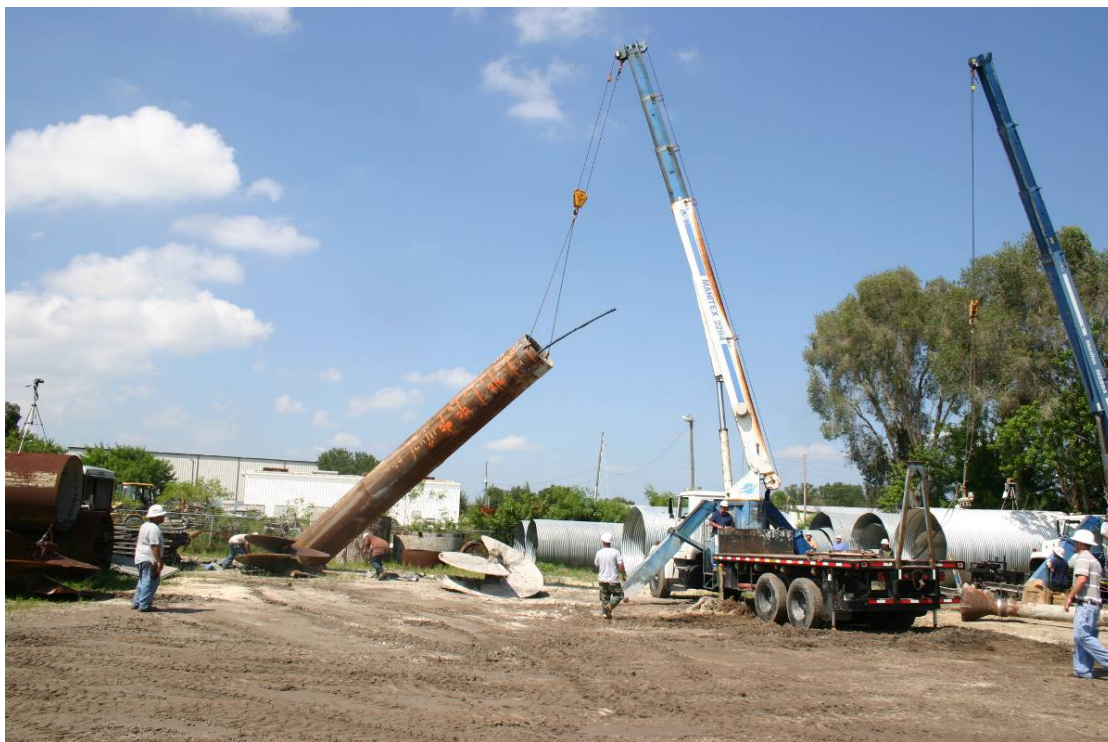
Figure 4-17. Lifting central casing.

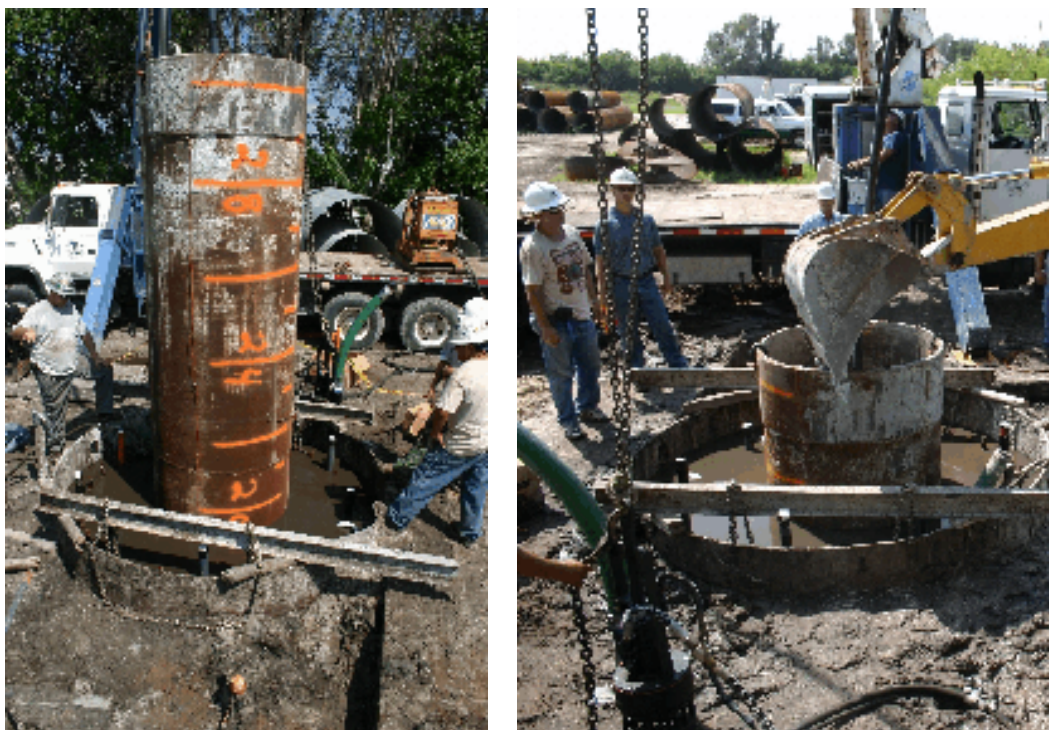
Figure 4-18. Placing and securing central casing.

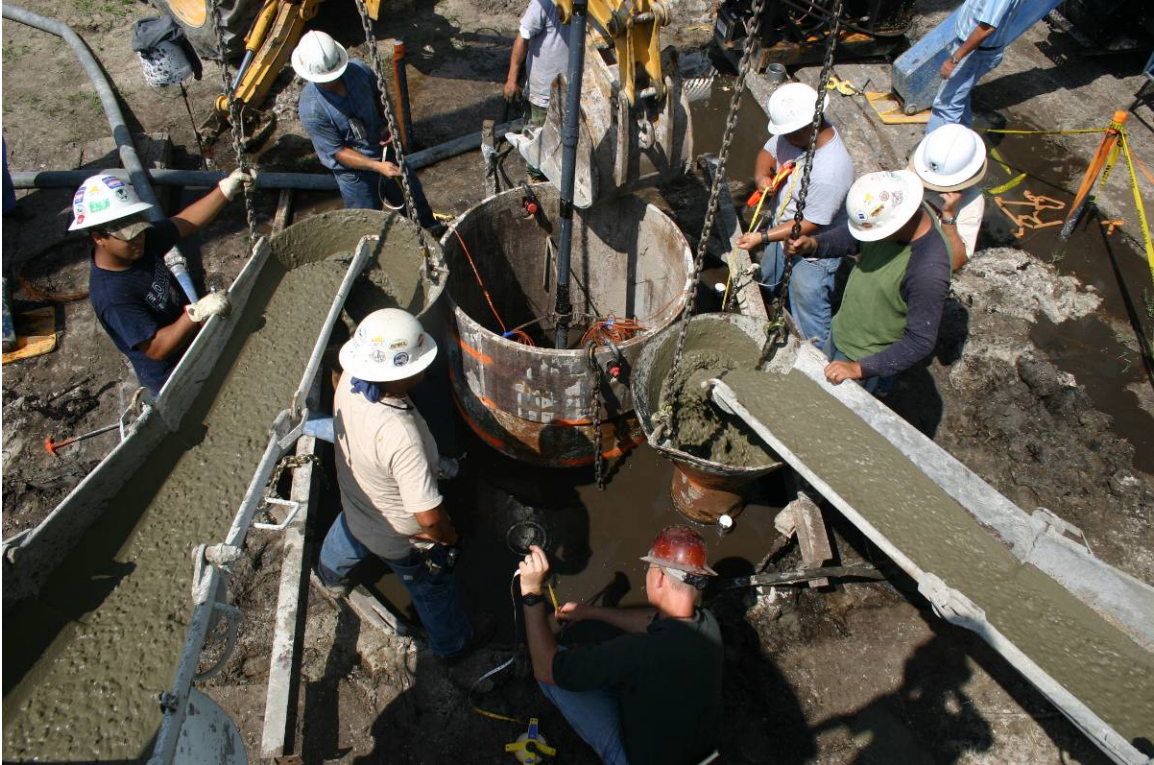
Figure 4-19. Concrete placement using two tremies.

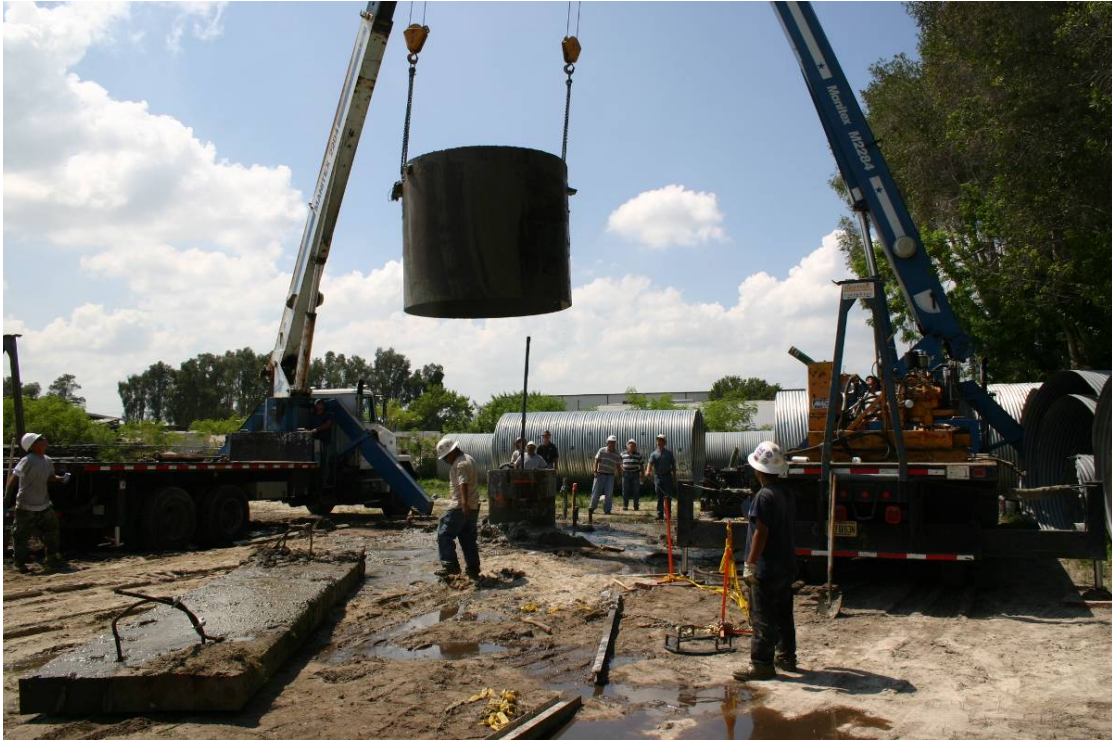
Figure 4-20. Temporary casing extraction.

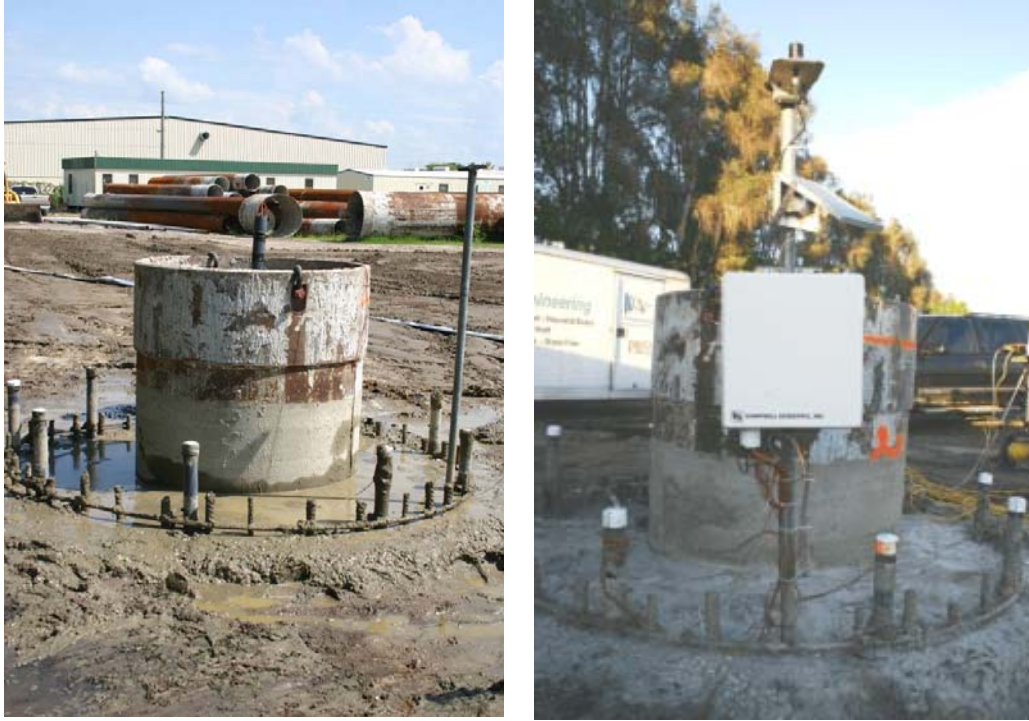
Figure 4-21. Finish shaft with data acquisition system in place.

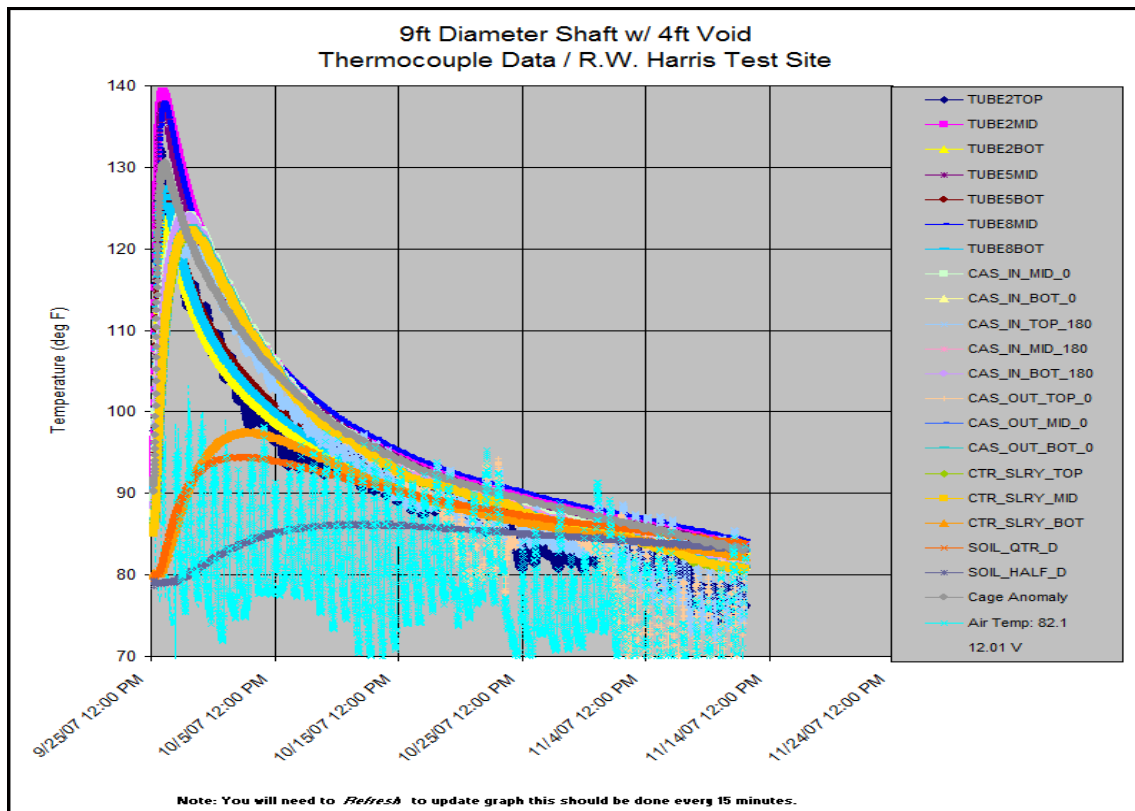
Figure 4-22. Realtime thermocouple data as posted on USF webpage.

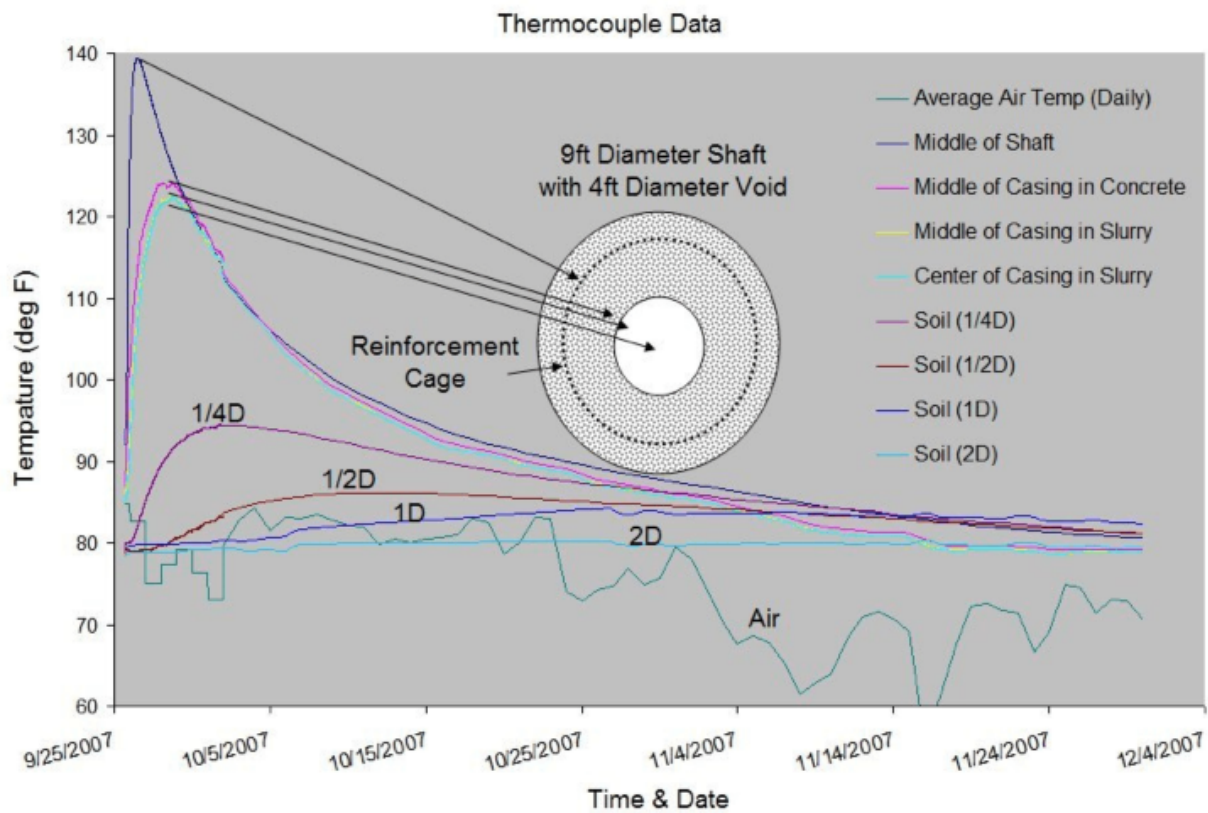
Figure 4-24 Annotated data from the voided shaft and surrounding vicinity.

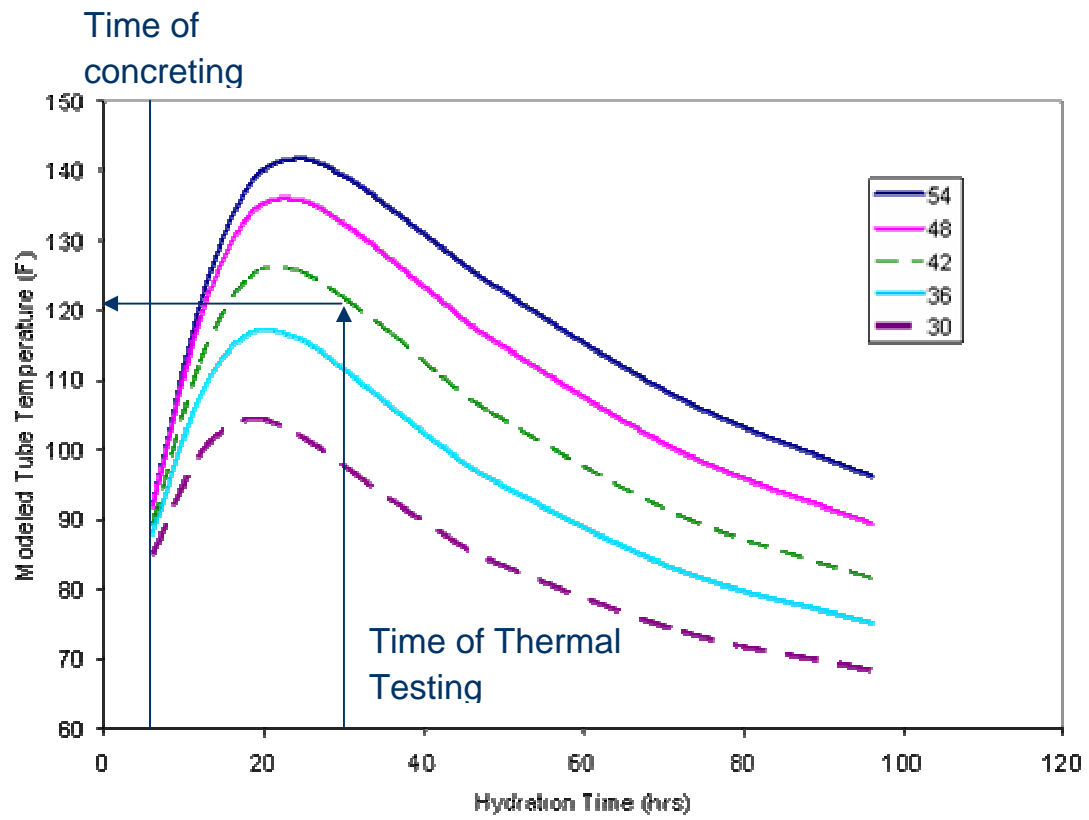
Figure 5-2. Expected access tube temperatures for various sizes of shaft and testing times.

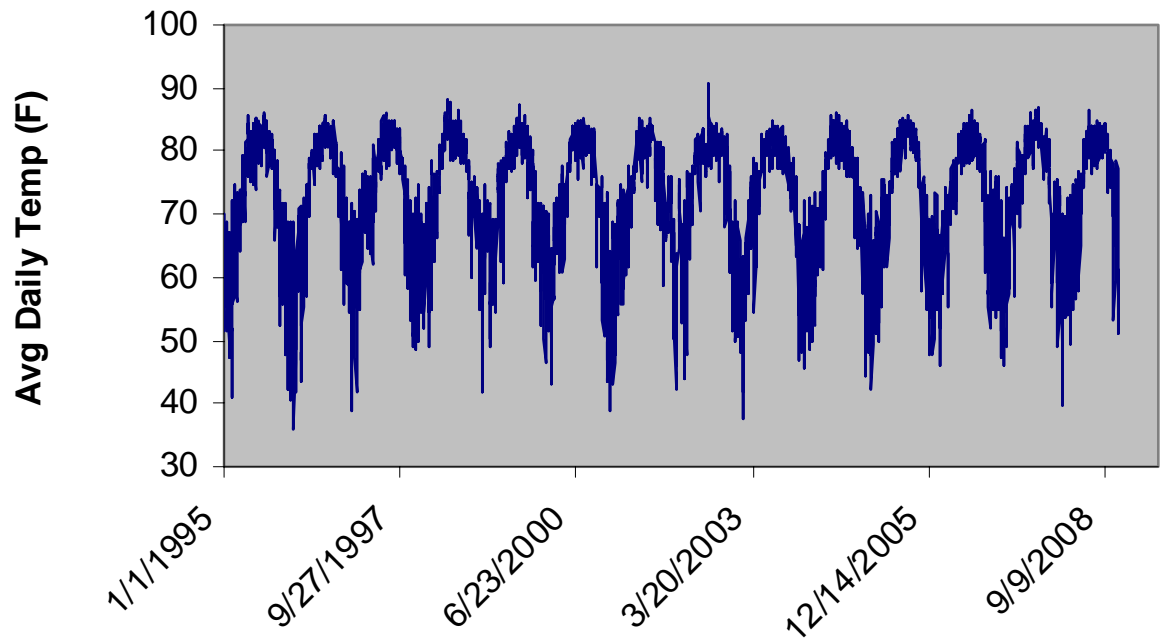
Figure 5-4. Average daily temperature for the Tampa / St. Petersburg, FL area.

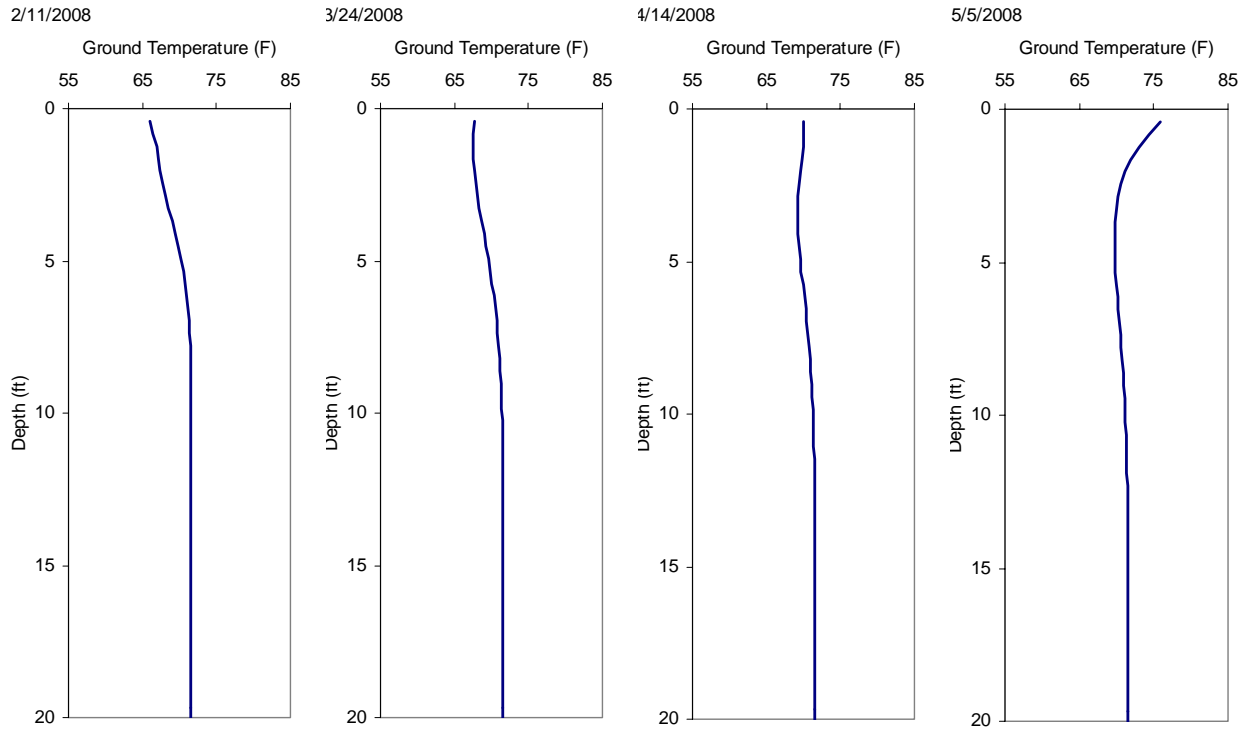
Figure 5-6a. Modeled ground temperature profile (Feb to May).

Figures 5-6a through 5-6c show the ground temperature profiles determined from long-term model runs incorporating the air temperature time series from Figure 5-5. Notice there are two times a year when the ground temperature is relatively uniform, April and Oct/Nov. At all other times the ground is either heating or cooling lagging behind the air temperature trends.

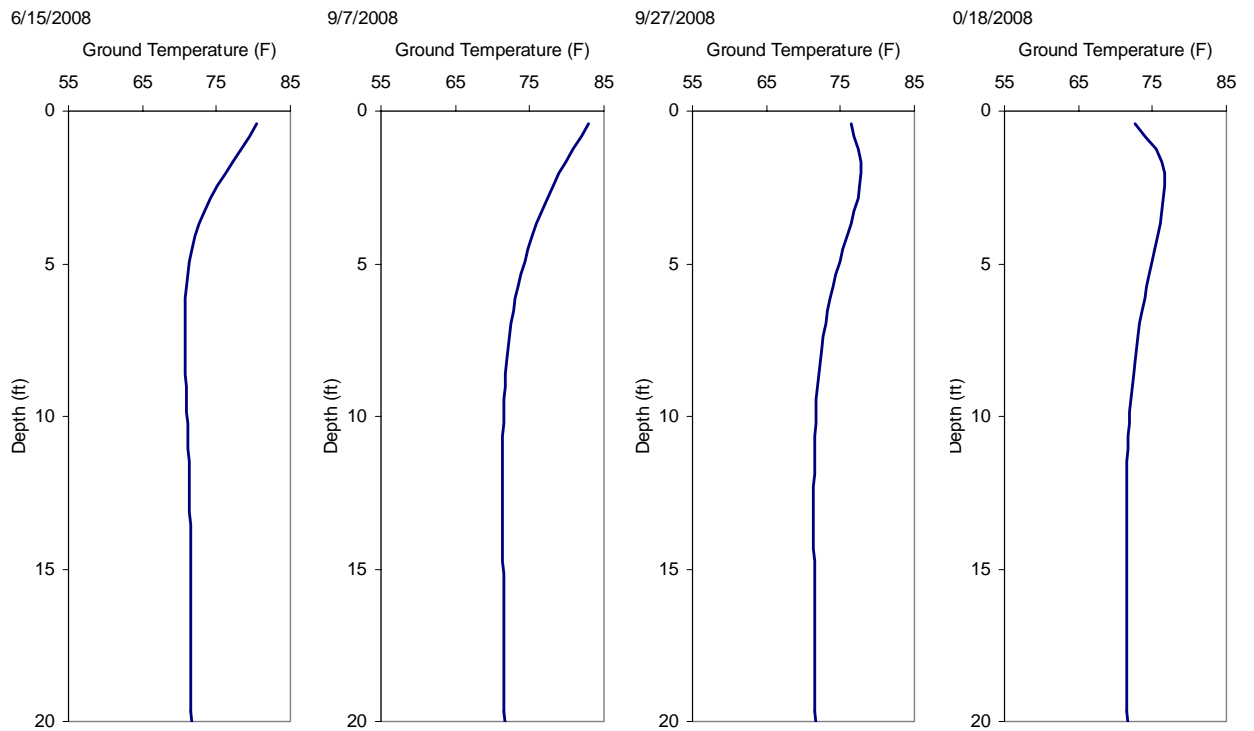
Figure 5-6b. Modeled ground temperature profile (June to October).
