**ATTENUATING MASS CONCRETE EFFECTS IN DRILLED SHAFTS  
BD-544-39**

**DRAFT FINAL REPORT**

June 2009

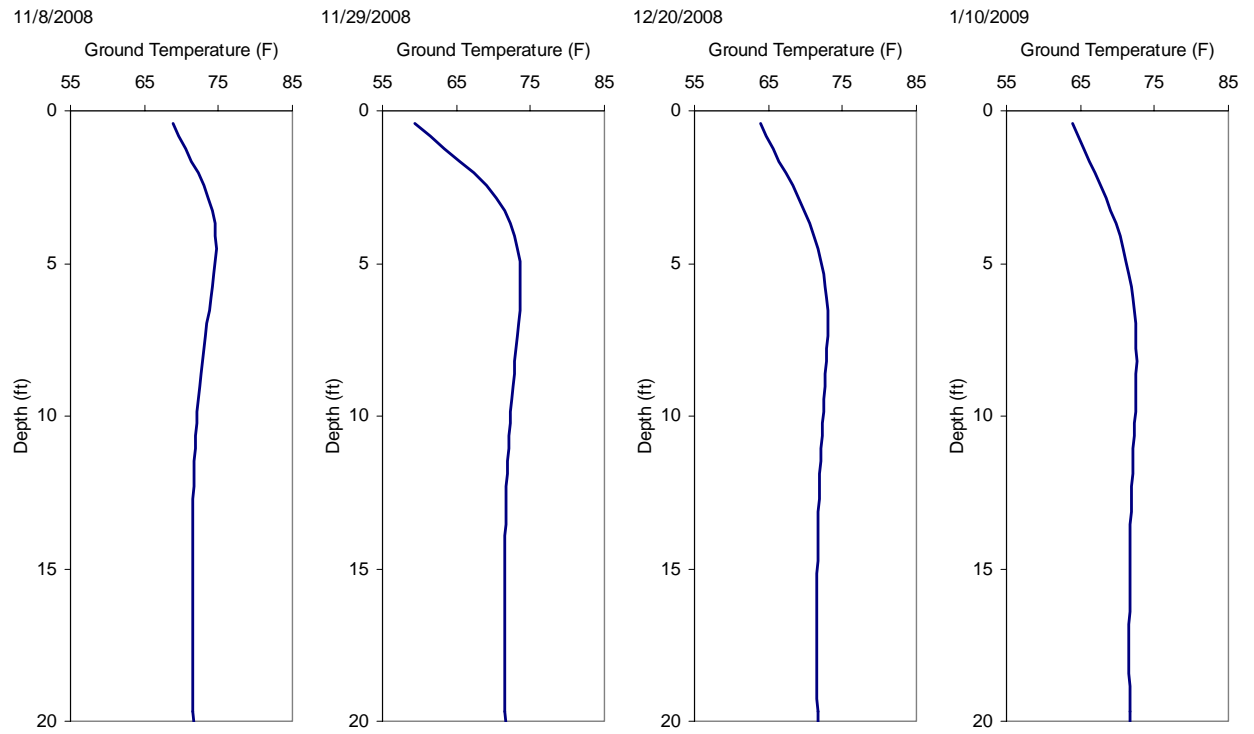
Figure 5-6c. Modeled ground temperature profile (November to January).

Figures 5-6a through 5-6c show the ground temperature profiles determined from long-term model runs incorporating the air temperature time series from Figure 5-5. Notice there are two times a year when the ground temperature is relatively uniform, April and Oct/Nov. At all other times the ground is either heating or cooling lagging behind the air temperature trends.

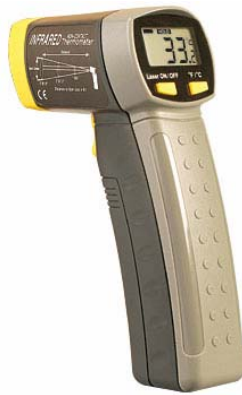
Figure 6-1. Economical hand-held infrared thermometer.

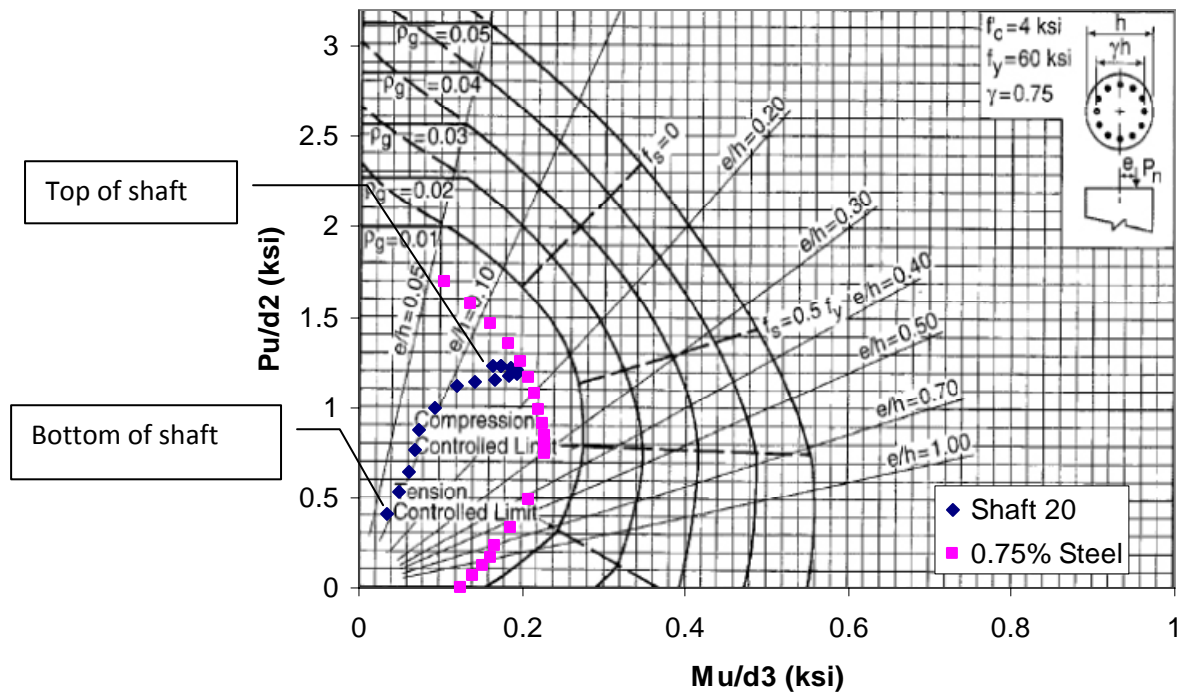
Figure 6-2. Example shaft capacity usage as a function of position in shaft.

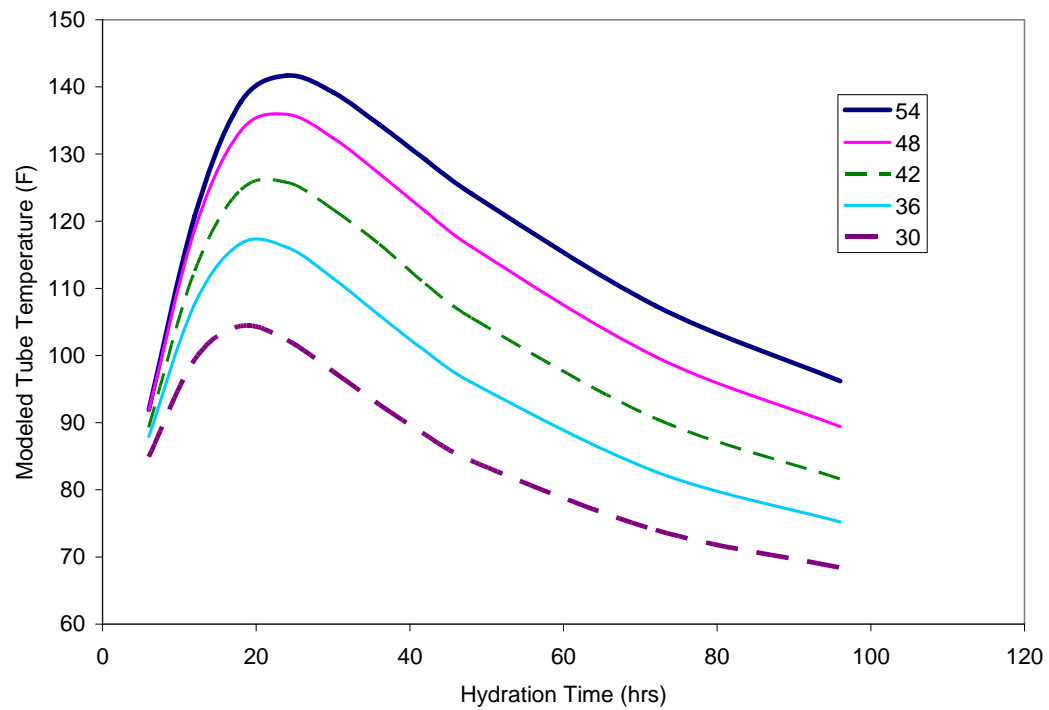
Figure 6-3. Normal integrity tube temperatures as a function of shaft diameter and hydration time.
