**THERMAL INTEGRITY SYSTEM FOR
AUGERED CAST-IN-PLACE PILES
(PART II, IMPLEMENTATION PLAN)**

BDV25-977-34

DRAFT FINAL REPORT

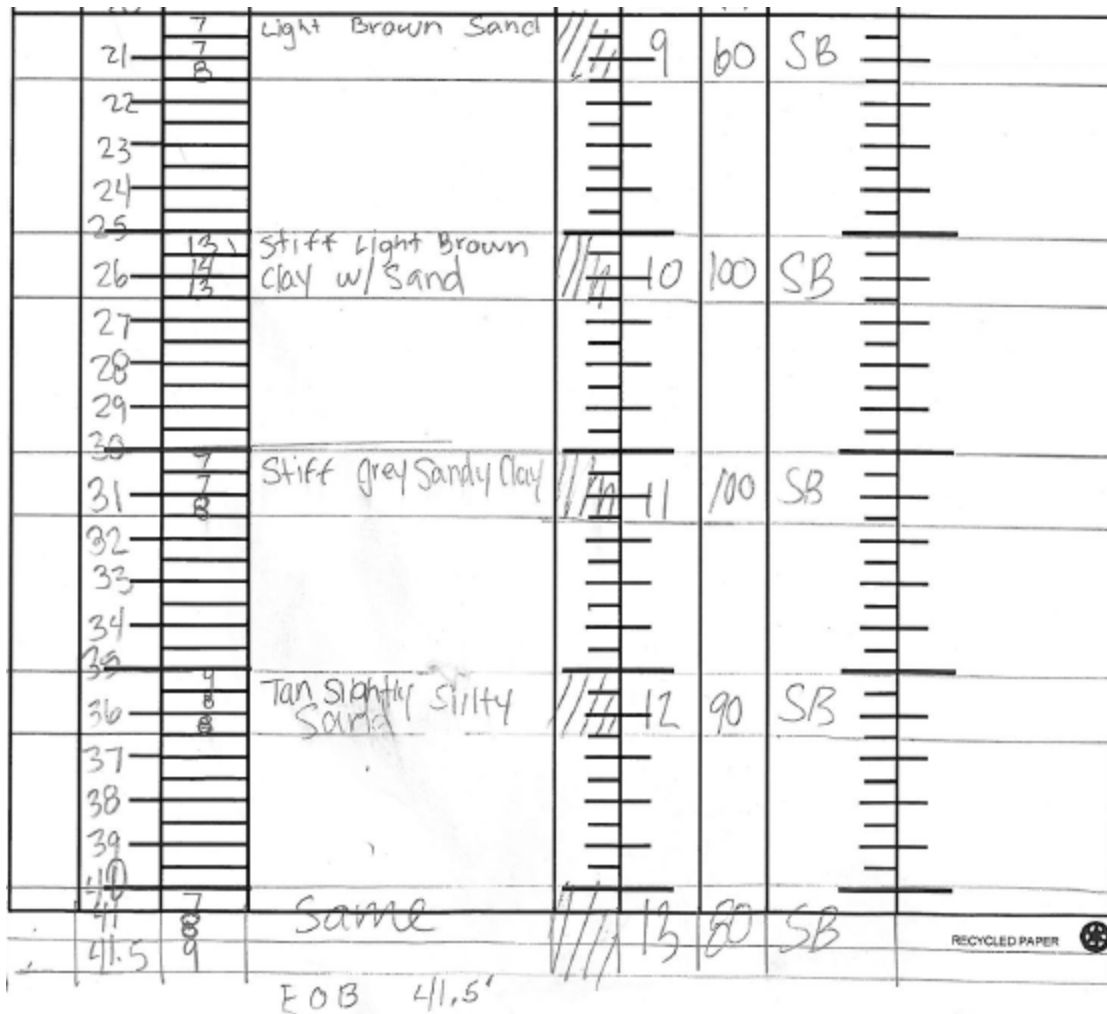
Figure 2.3 SPT boring log data for DFI test site.

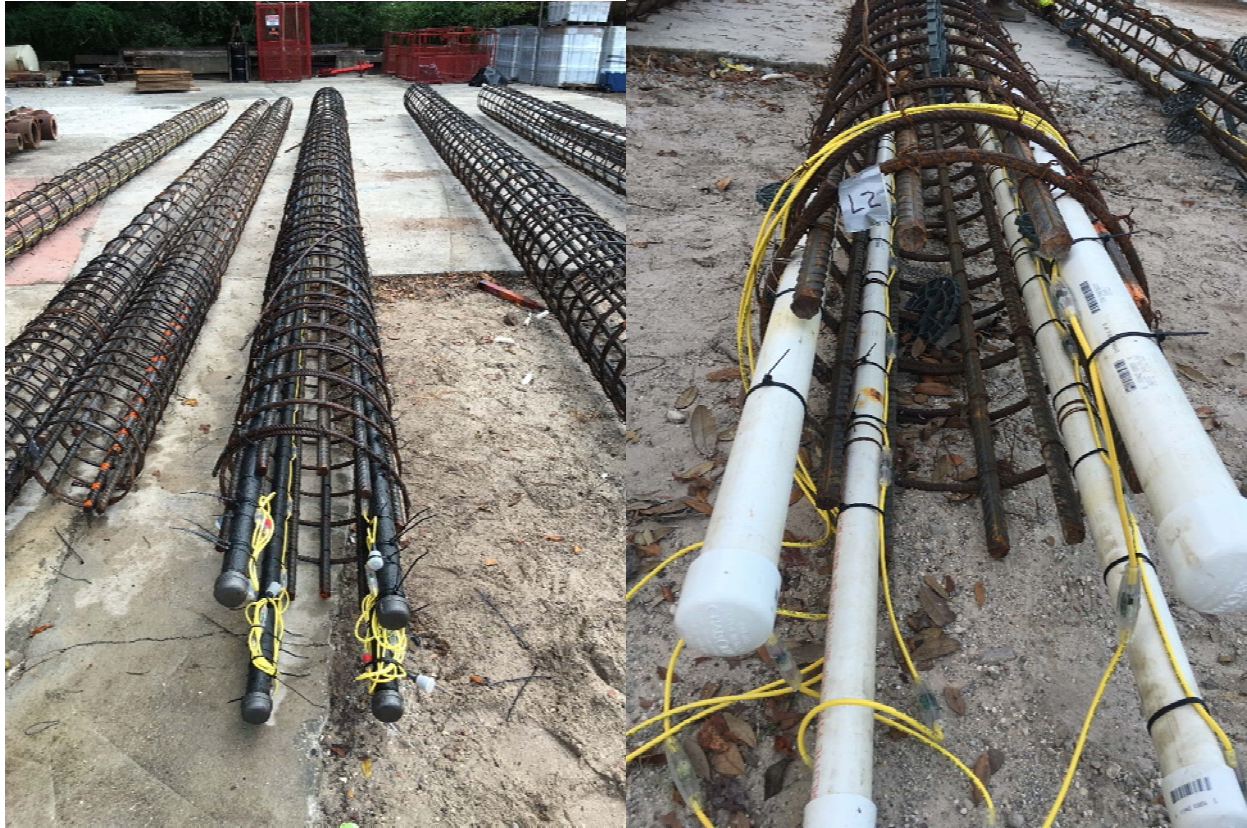
Figure 2.5 Bottom end view of reinforcement cages for 24in piles C2 (left) and L2 (right) instrumented with thermal wires and access tubes for thermal probe testing.

for 18in piles). Excess wire length was bundled and attached to either the top of the access tubes or reinforcing bars (Figure 2.5). Figures 2.5 - 2.8 show each of the five reinforcing cages and the center bars that were instrumented with a single wire similarly secured with two ties per sensor.

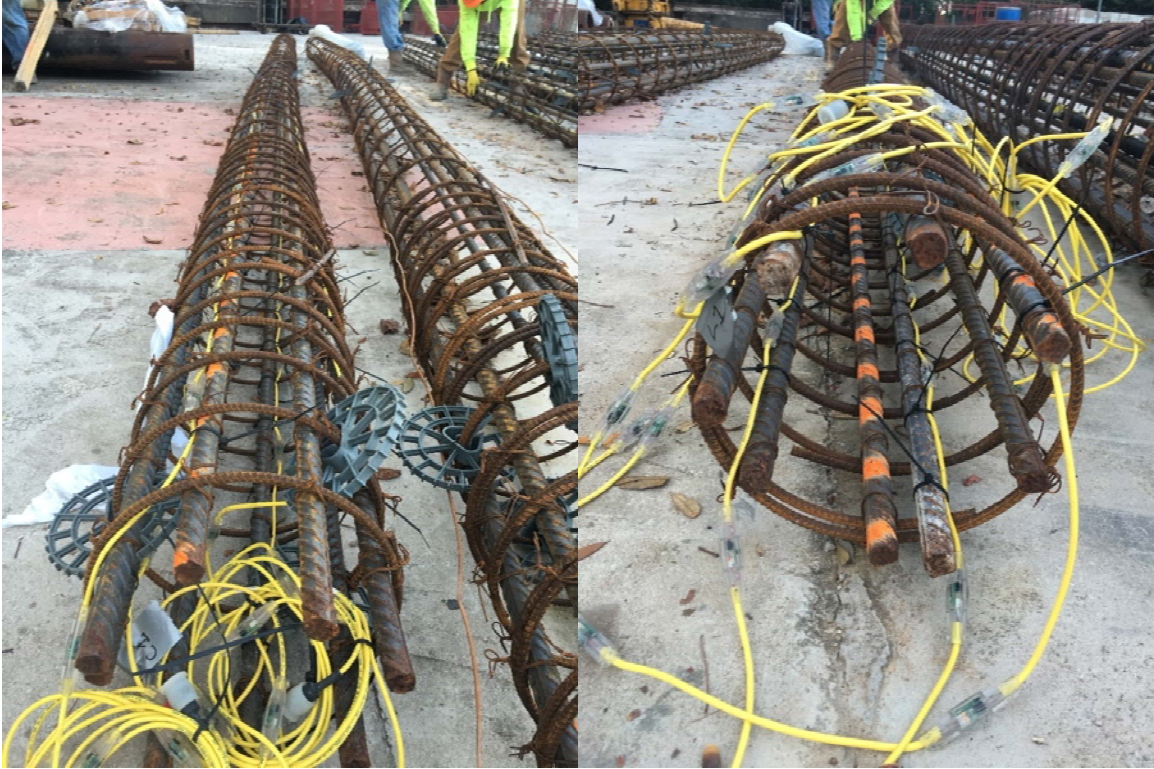
Figure 2.6 Top end of piles C1 (left) and L1 (right) reinforcement cages instrumented with thermal wires.

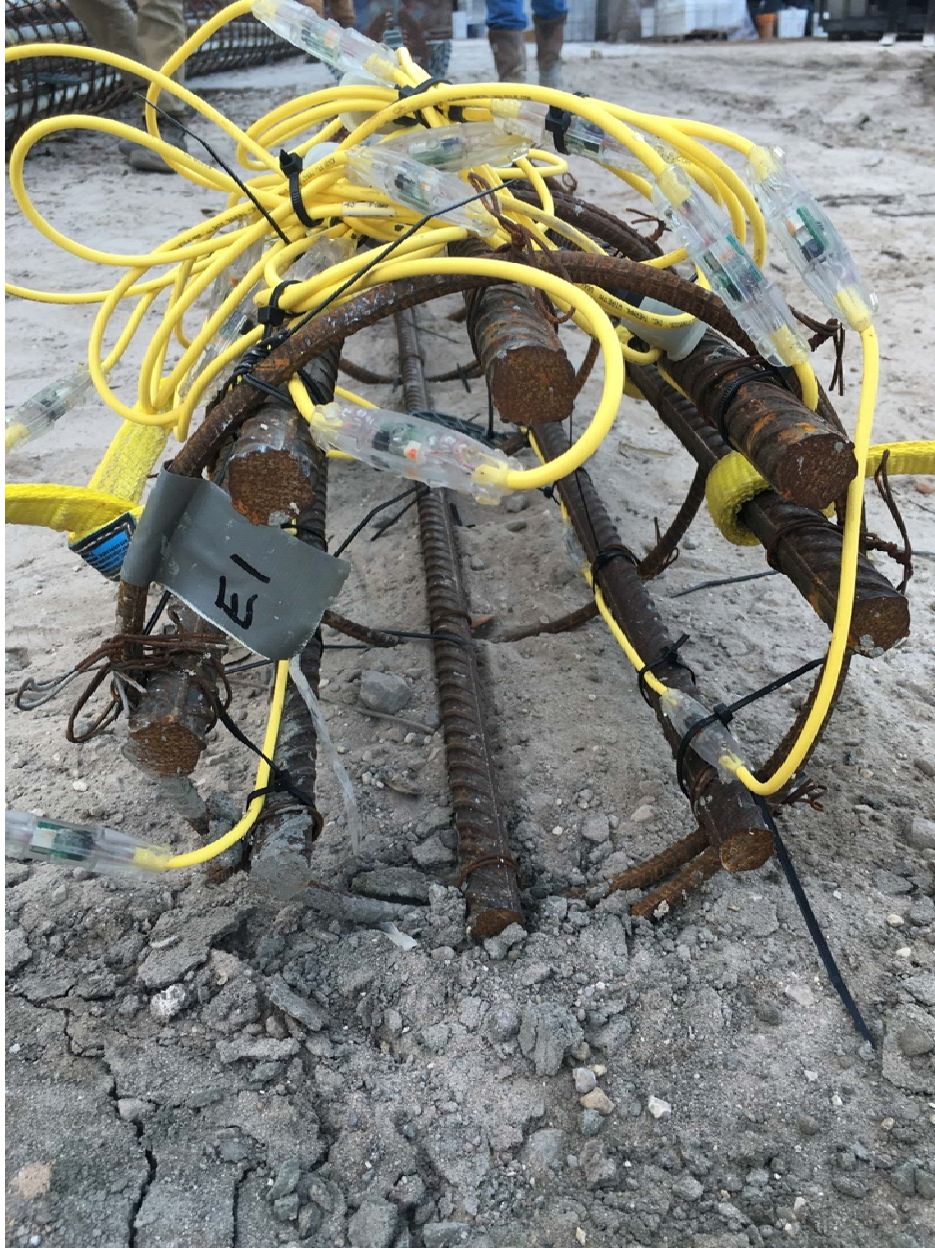
Figure 2.7 Pile E1 reinforcing cage with thermal wires attached.

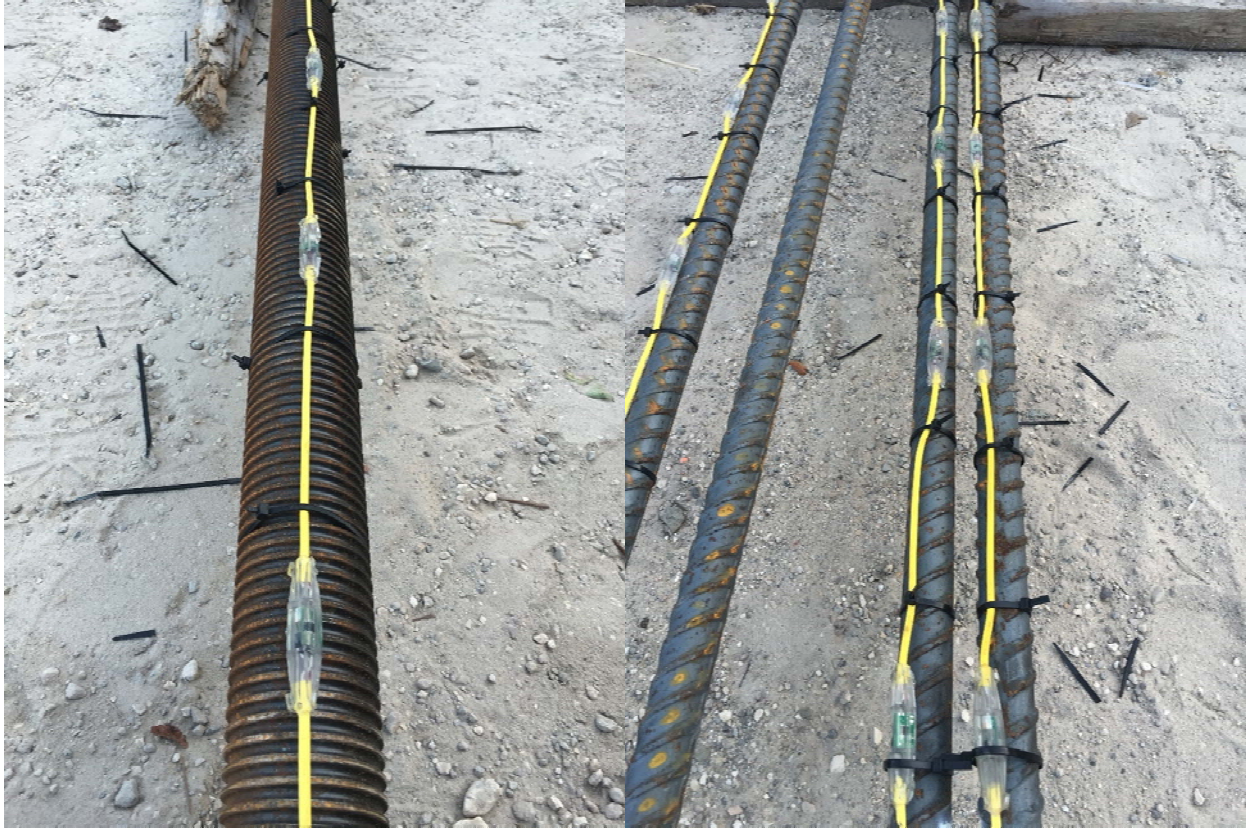
Figure 2.8 3in center bars (left) and #11 center bars (right) instrumented with thermal wires.

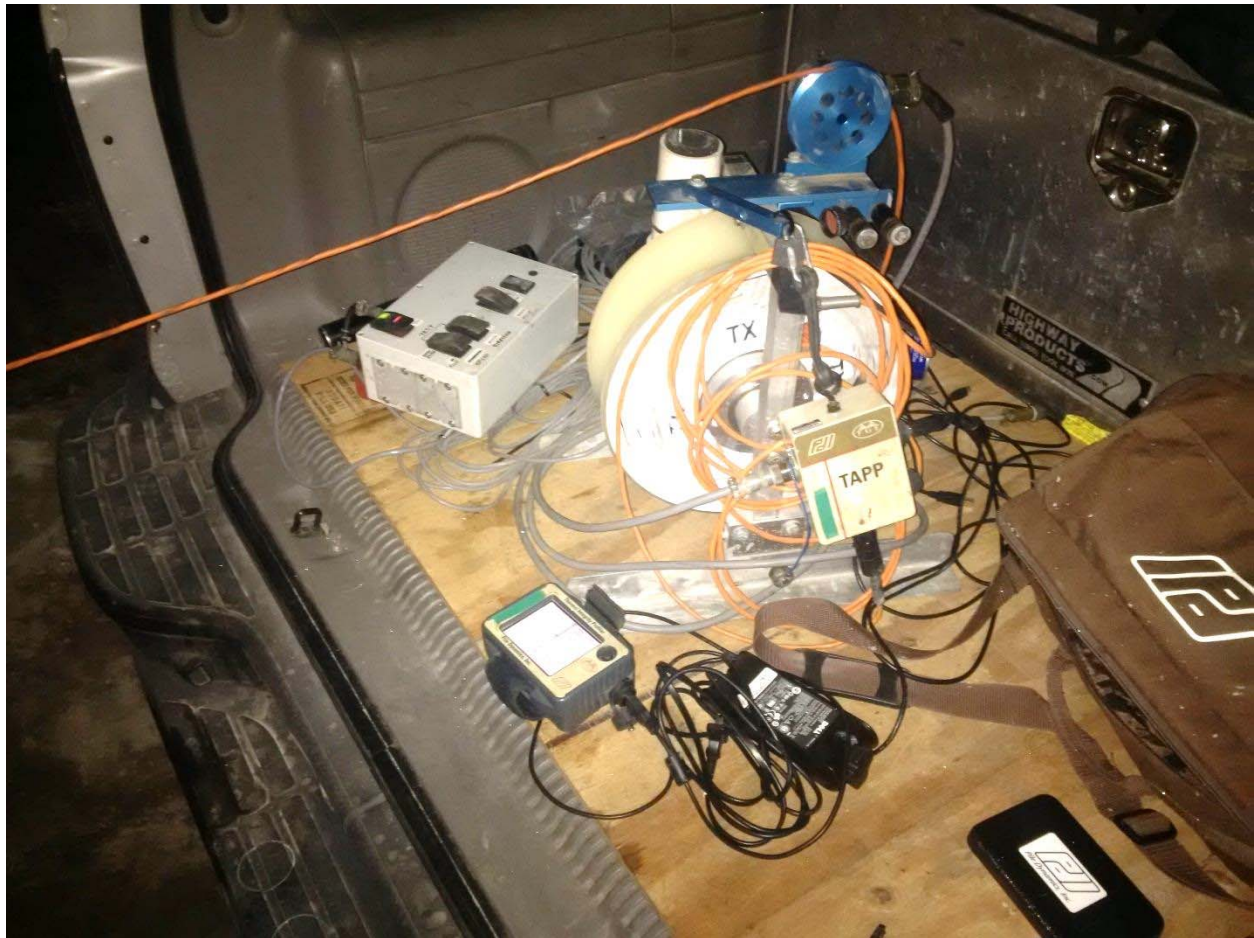
Figure 2.9 Automated reel and data collection system used for probe testing.

Probe testing is usually only performed once, at a time that is near the peak temperature (ASTM 2014). At that time, the quality of the data is immediately evaluated by the testing engineer (or technician). If all profiles are clear and the data meaningful, then no more testing is required. However, for this study probe testing was performed on 6hr intervals starting 6hrs after the piles were cast and continued up to 24hrs after casting. Each tube was profiled twice during each 6hr interval/visit. Figures 2.9 - 2.11 show probe testing being performed at various stages of the curing/hydration process. For these tests an automated, reel-type system was used which frees the testing engineer to perform multiple field functions at once.

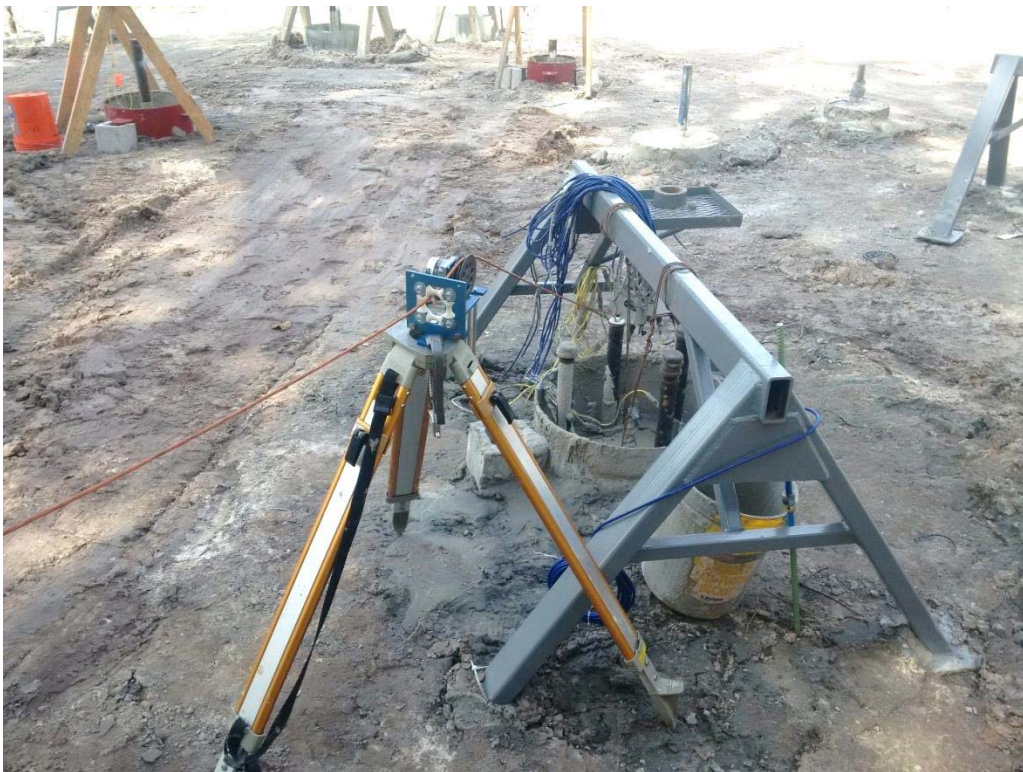
Figure 2.11 Probe testing pile C2 at approximately 24hrs after pile installation.

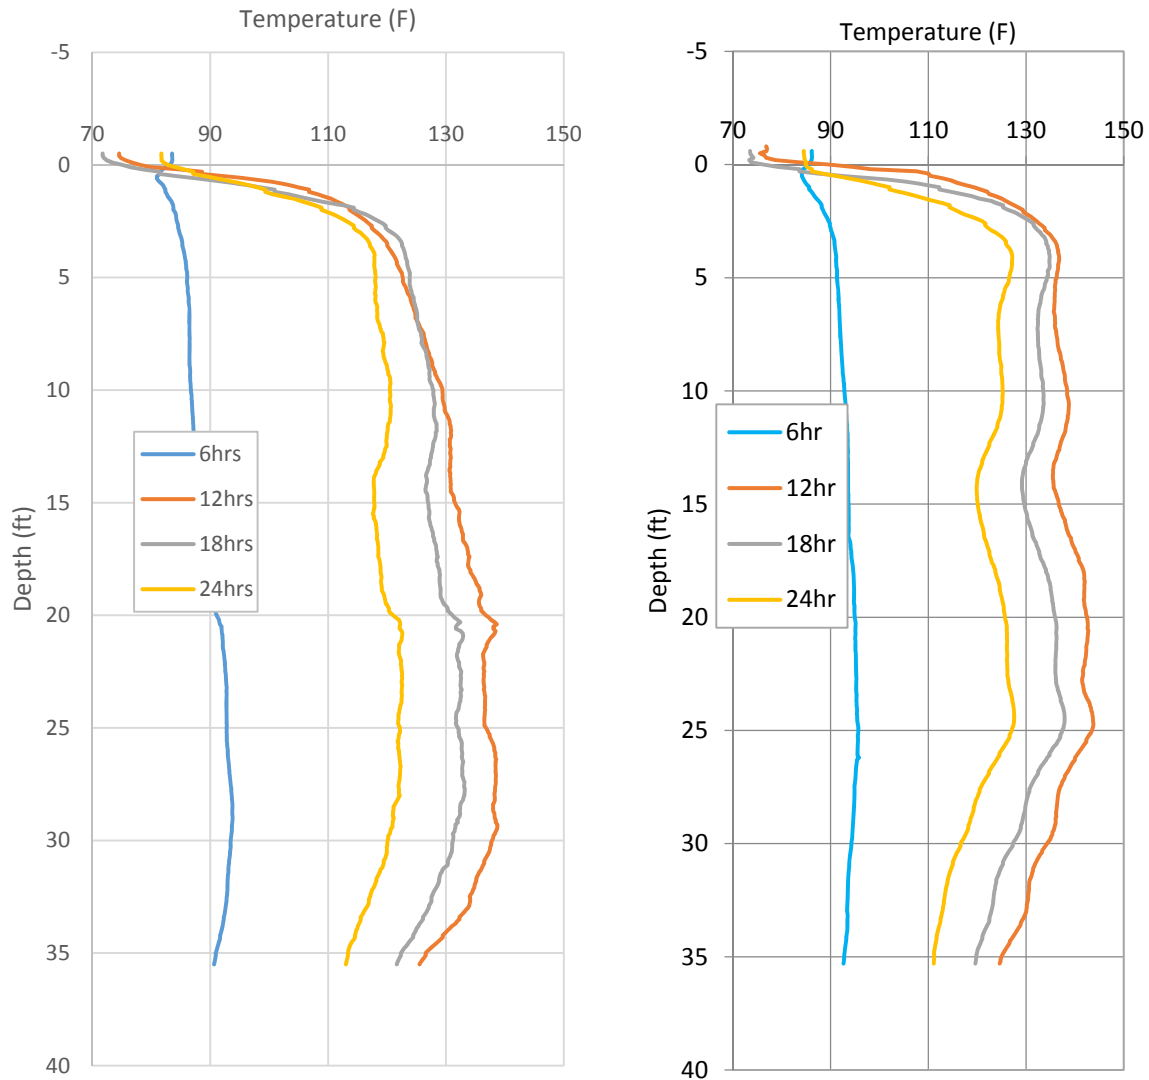
Figure 2.14 Pile C2 (left) and L2 (right) profiles from probe data taken on 6hr intervals.

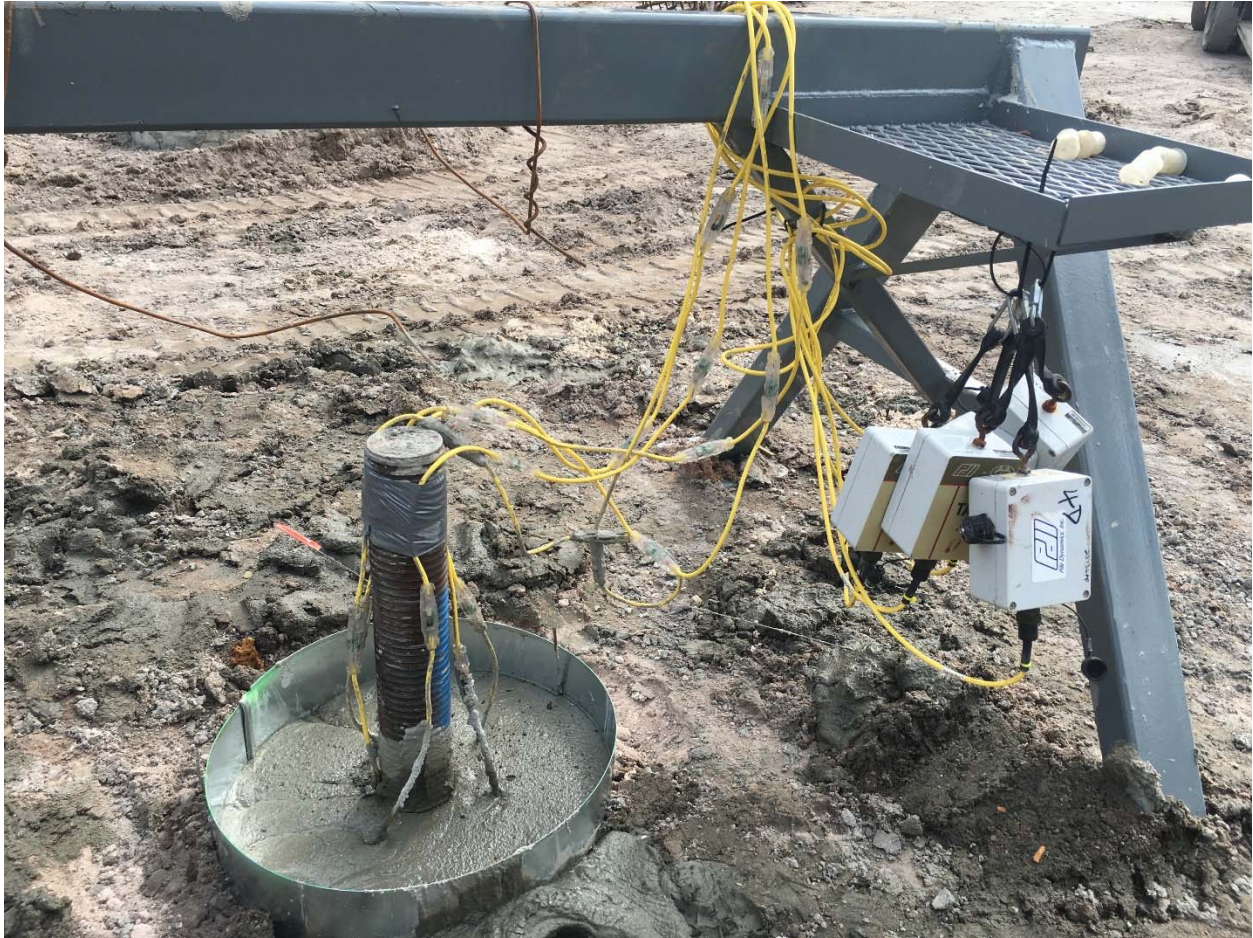
Figure 2.15 Pile E1 with thermal wires and attached TAP units.

Thermal wire testing has the inherent advantage to the field technician in that no planning is necessary to ensure on-site presence aligns with the anticipated peak temperature timeframe. Rather, data collectors (TAP units / **T**hermal **A**ccess **P**orts) are attached to the wires immediately after casting or as soon as access is granted and data is continuously taken up to and beyond the peak temperature occurrence. The disadvantage is that the quality of the data is not known until after retrieval of the TAP units and the data is downloaded. Figures 2.15 – 2.21 show the TAP units attached to each of the test piles.

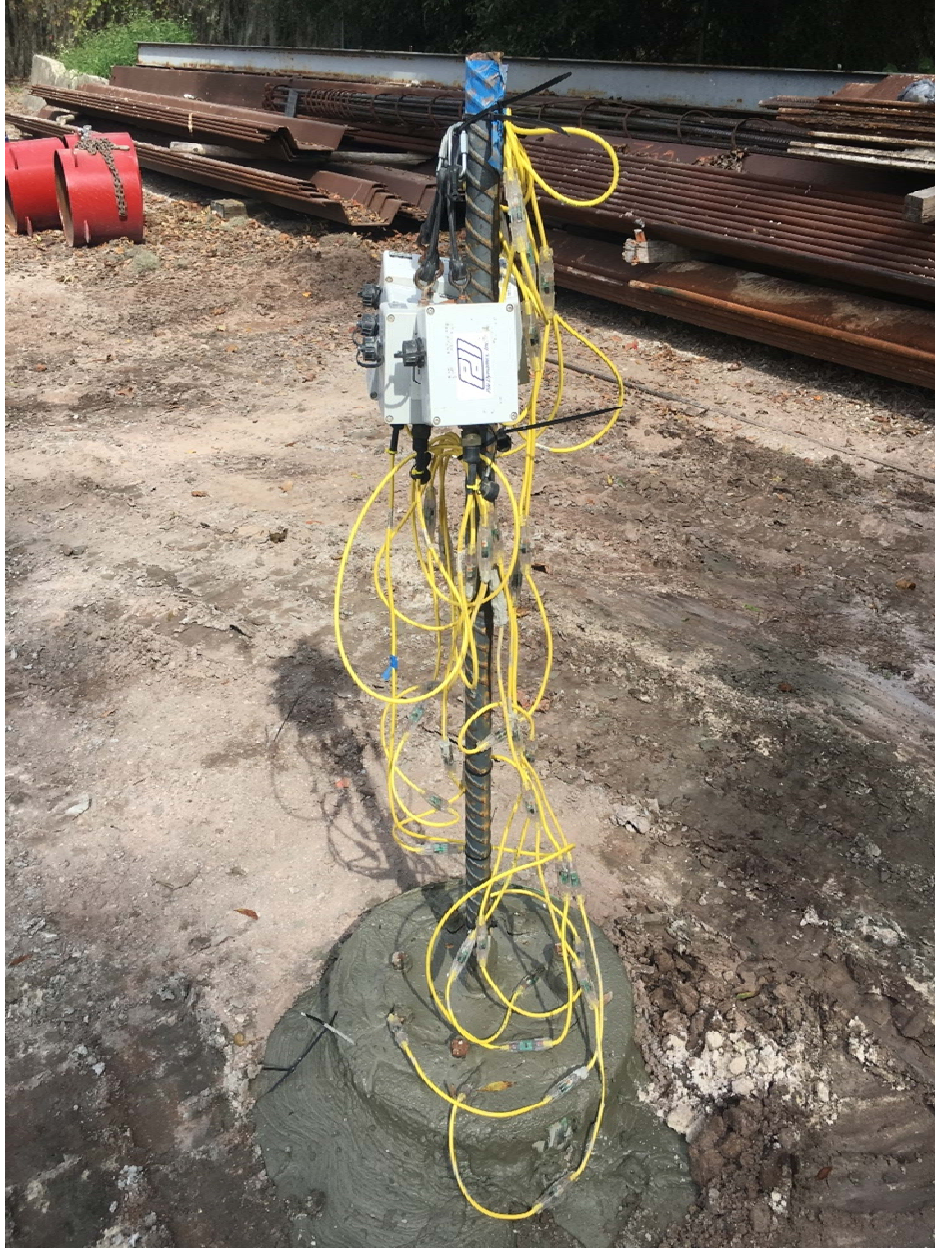
Figure 2.16 Pile L1 with thermal wires and attached TAP units.

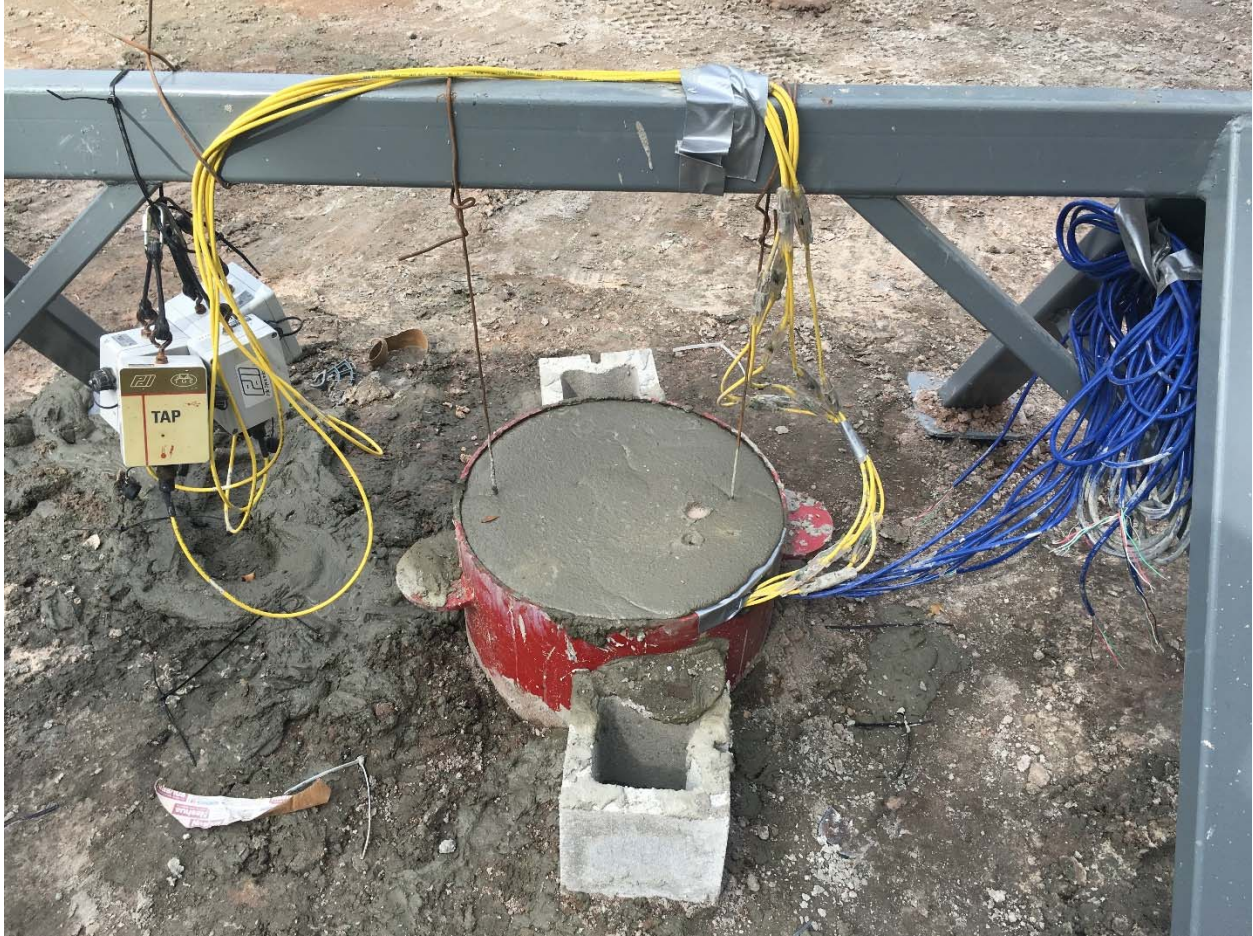
Figure 2.17 Pile C1 with thermal wires and attached TAP units.

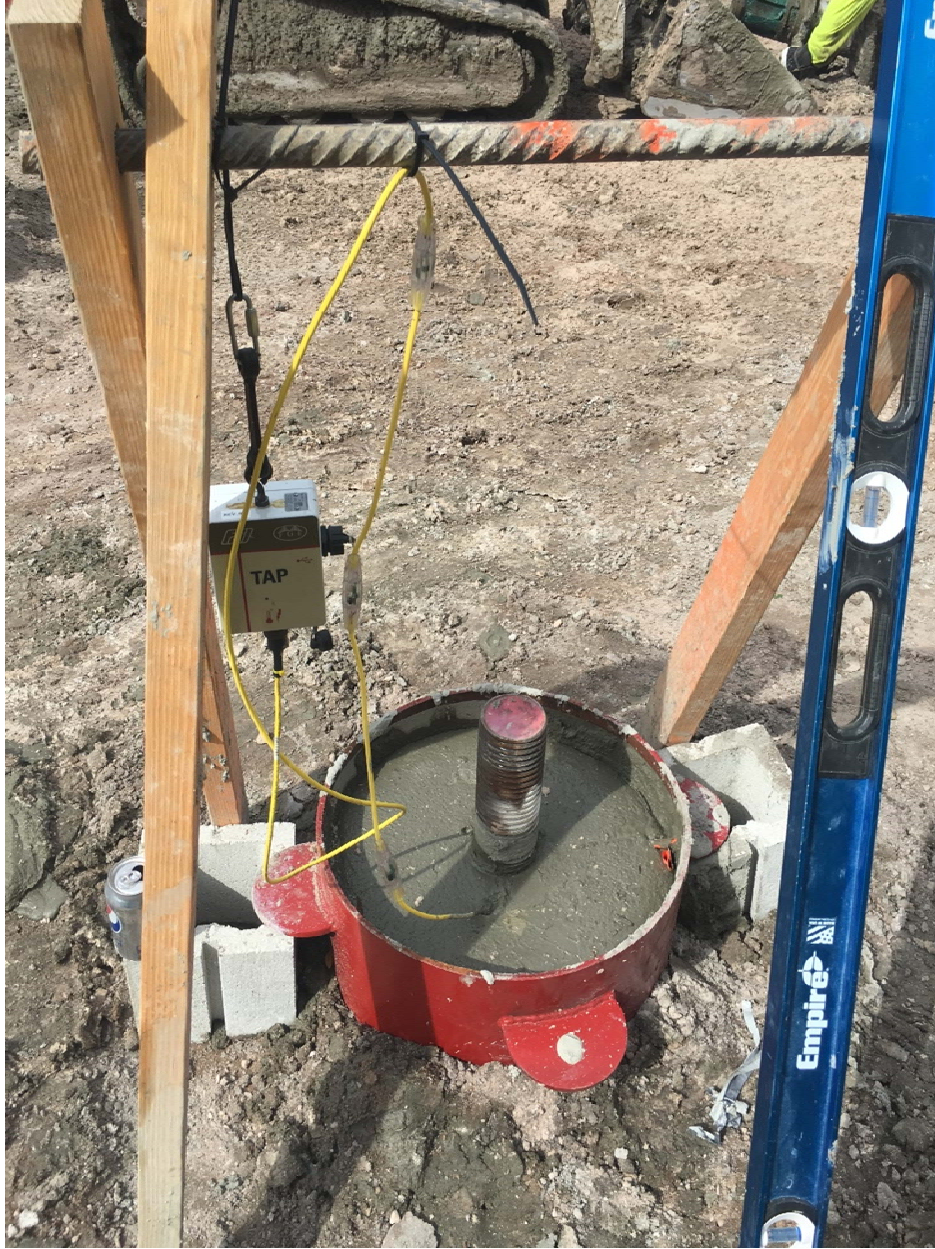
Figure 2.18 Pile T1 with thermal wires and attached TAP unit.

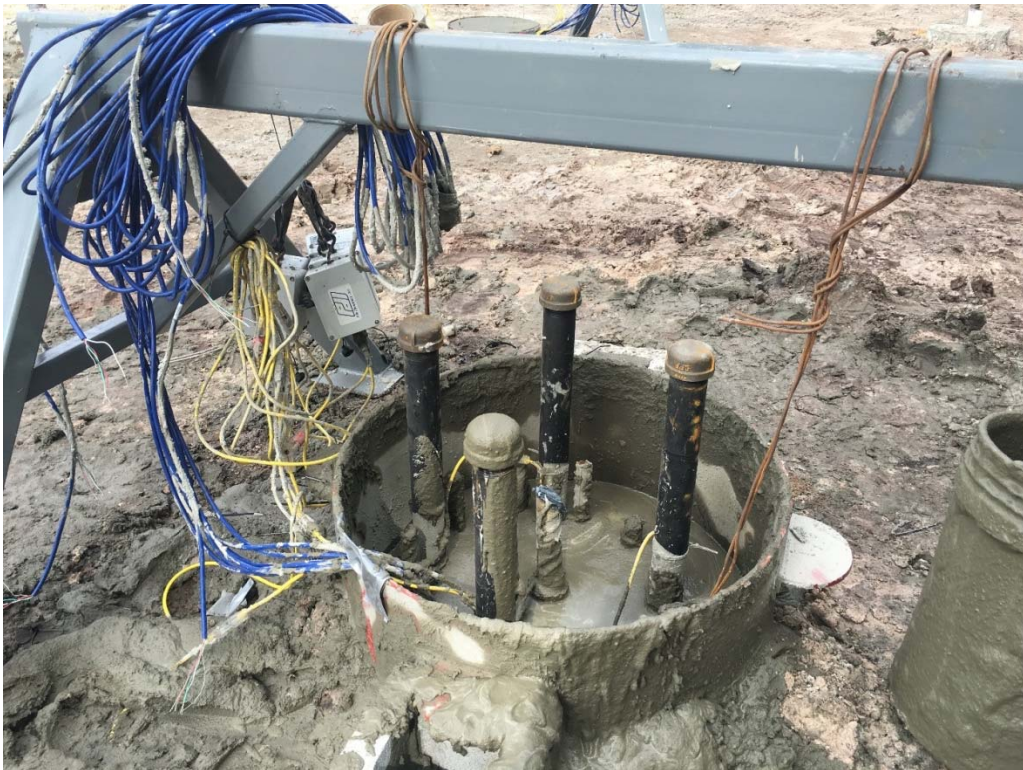
Figure 2.20 Pile C2 with thermal wires and attached TAP units.

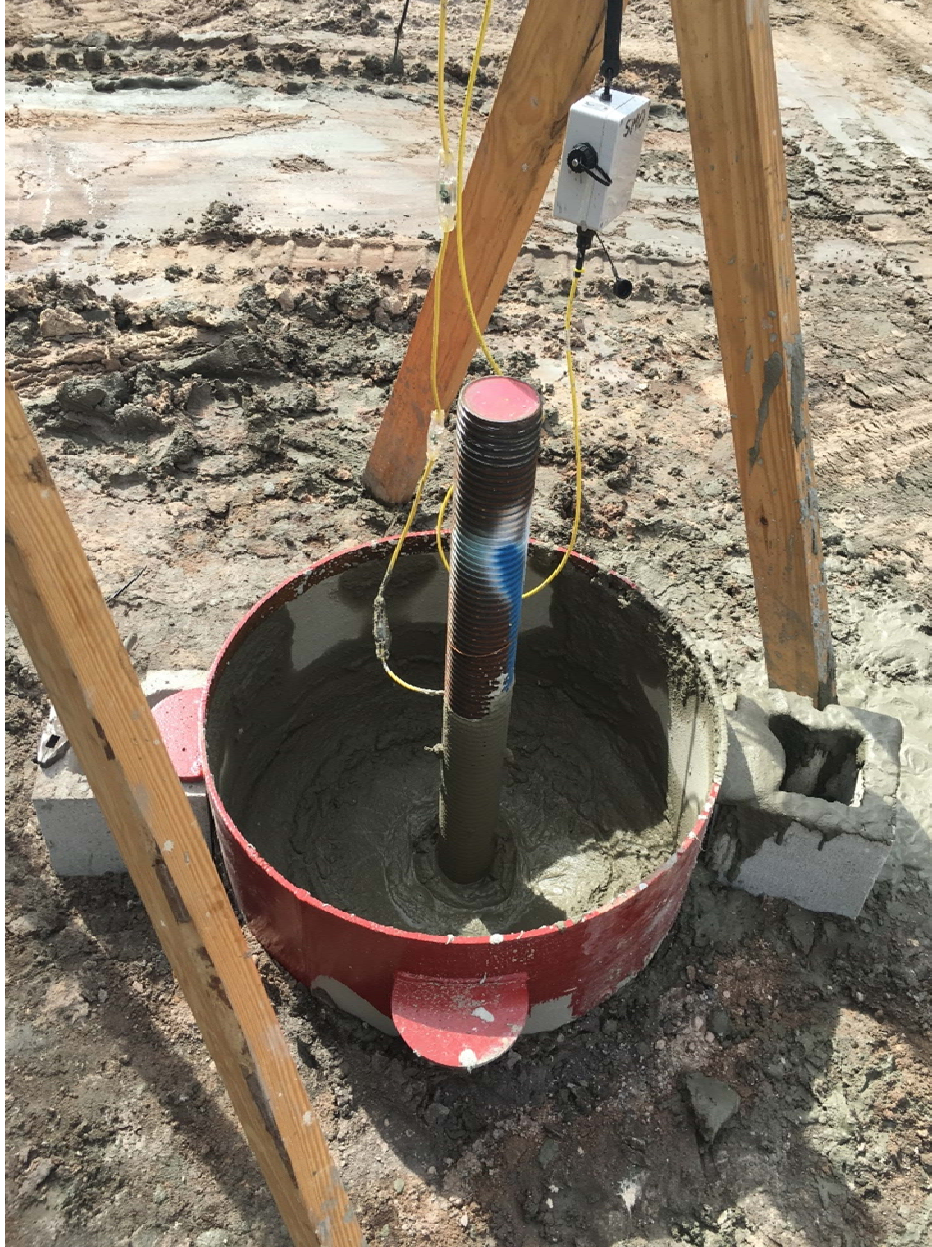
Figure 2.21 Pile T2 with thermal wires and attached TAP unit.

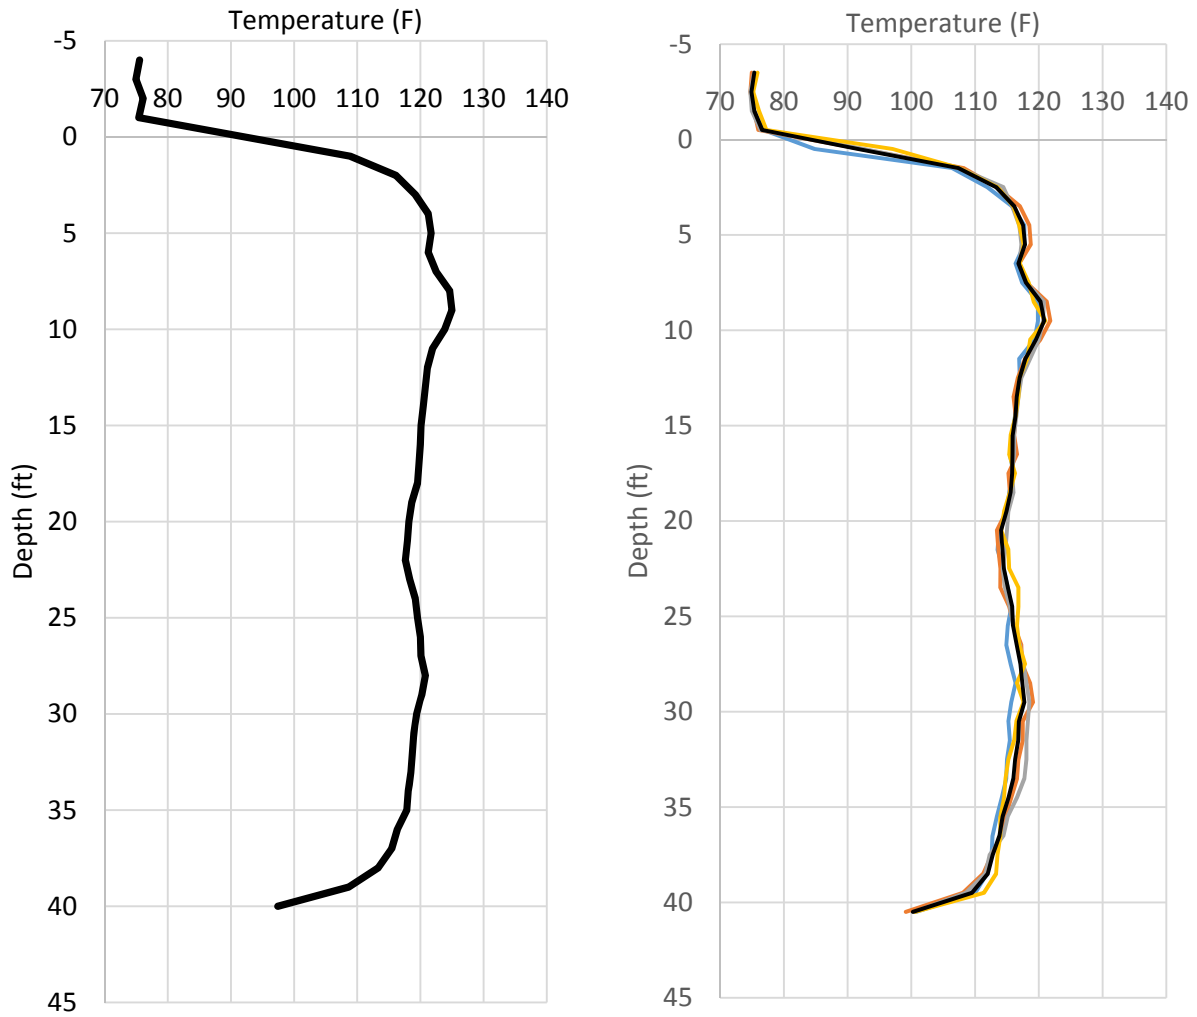
Figure 2.22 Pile E1 center bar thermal wire data (left); cage wire data (right) at 15hrs

Due to the continuous data collection feature of thermal wire data, not only can thermal profiles be collected, but also time vs temperature relationships can be produced. Figures 2.22 and 2.23 show examples of thermal wire data collected from one of the test piles and the associated temperature trace from a selected elevation, respectively. All thermal profiles from wires and temperature traces from each pile are included in Appendix A.

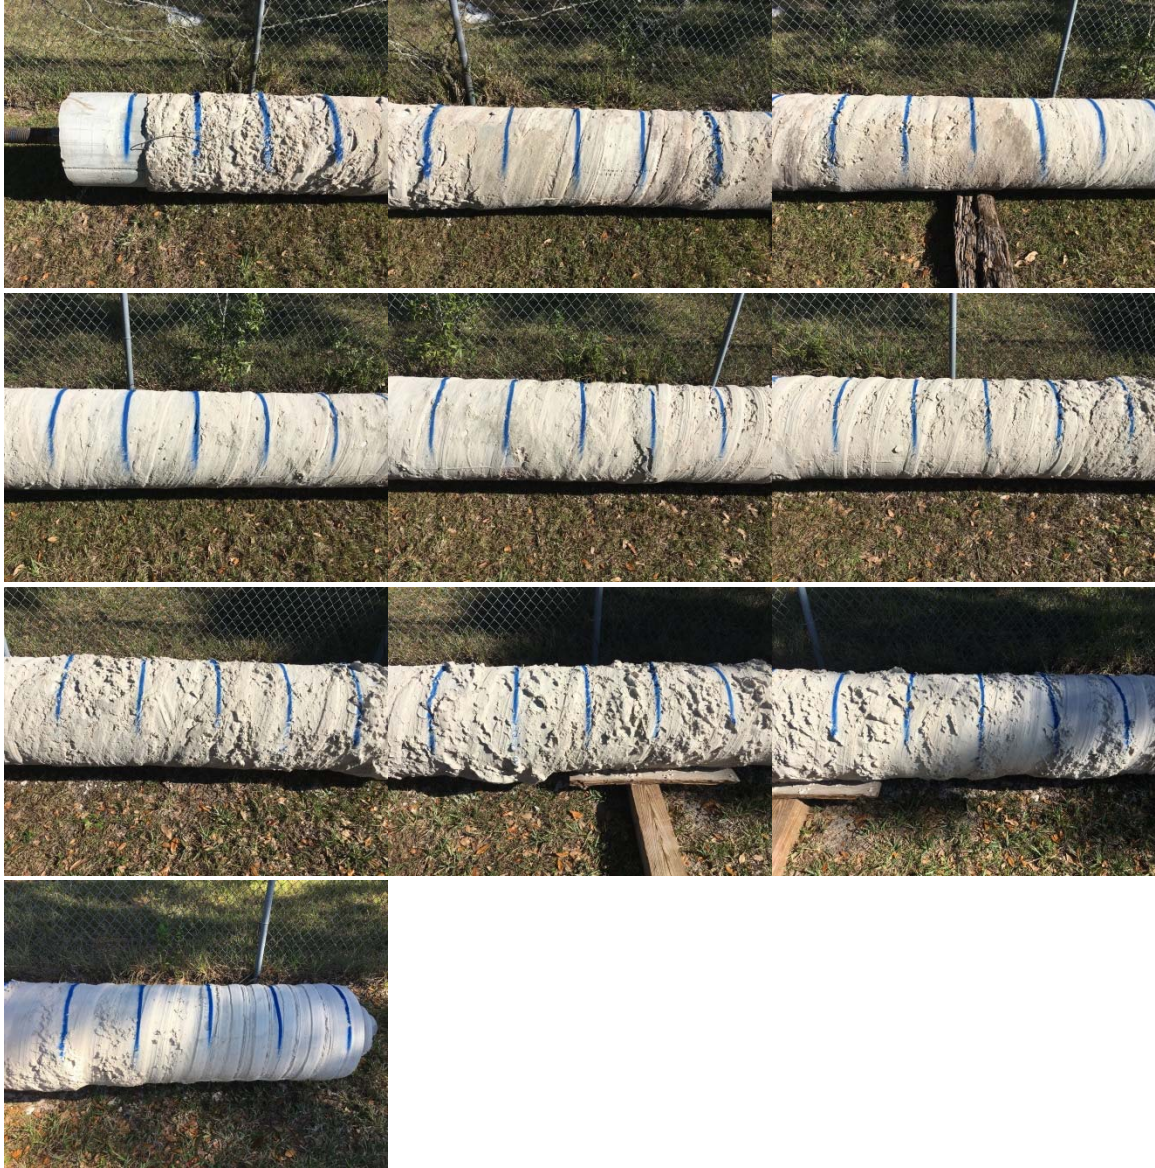
Figure 2.24 Extracted pile shape from top to bottom (left to right and down).

Only one of the test piles was extracted for evaluation of as-built dimensions. Four relief holes were drilled around pile E1 to reduce side shear and the pile was removed using the central threaded bar. The pile was cleaned and measured via manual measurements. Two different teams measured the circumference on one foot length intervals down the pile. These measurements were then converted to the equivalent diameter which assumed the pile was circular in section and that there were no significant voids or bulges. Using a large-scale caliper, direct measurements of diameter were taken at 90 degree locations down the length of the pile (i.e. two measurements per depth location). The results of the actual diameter were then used to assess the true as-placed volume of the pile and then compared to the predicted volume per pump strokes and the automated installation recorder. These data are presented and discussed in Chapter 3. Figure 2.24 shows the extracted pile marked on one foot intervals from top to bottom.

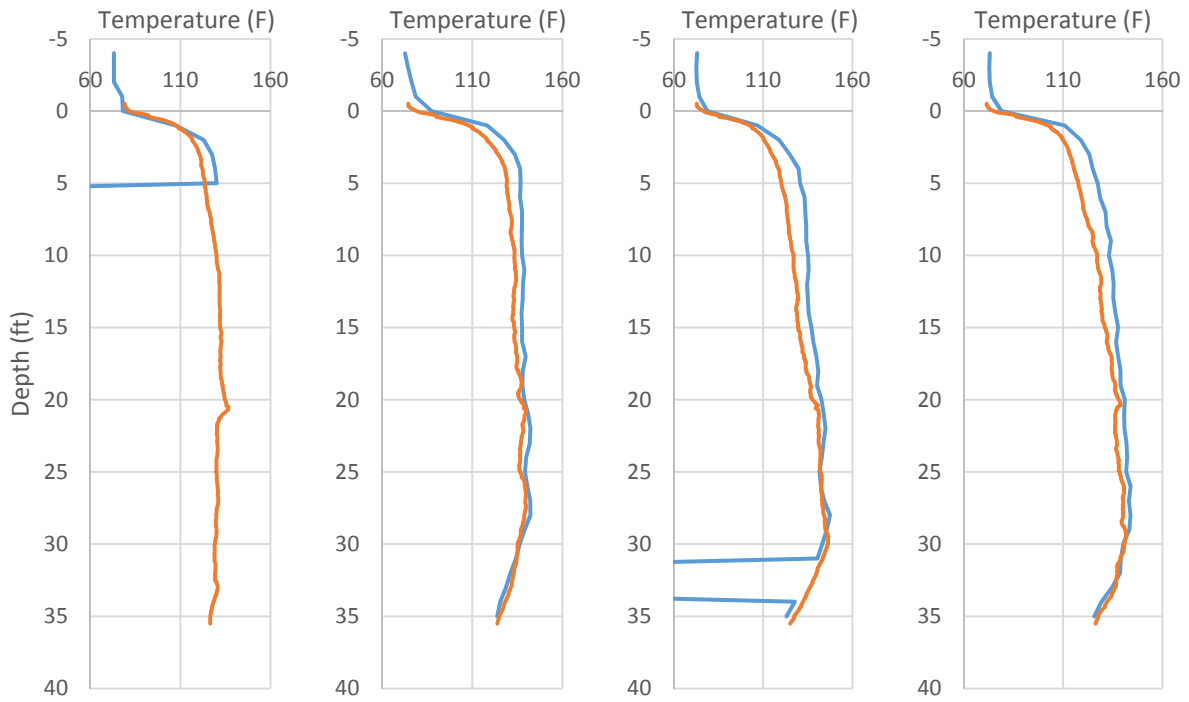
Figure 3.1 Pile C2, probe in steel (orange) and wire (blue) measured thermal profiles for each tube 1 – 4 (left to right) near peak temperature.

For this project, piles C2 and L2 were equipped with both access tubes and thermal wires. For both piles, four access tubes were installed where wires were attached to each tube such that they would lie along the same radial position as the center of the tubes (i.e. same radial distance from center). Both piles also had a center bar that was only instrumented with a wire so no comparison between center access tubes and wires could be made. Figures 3.1 and 3.2 show the thermal profiles for piles C2 and L2, respectively, measured using both the probe and wire methods. Recall the wires were tied along the side of the access tubes such that the wire position radius would be the same as the center of the tubes relative to the center of the cage. In some of the wire profiles sensor failures occurred; wire 1 on pile C2 experienced failures for all nodes below 5ft, and wire 3 experienced failures for nodes at 32 and 33ft.

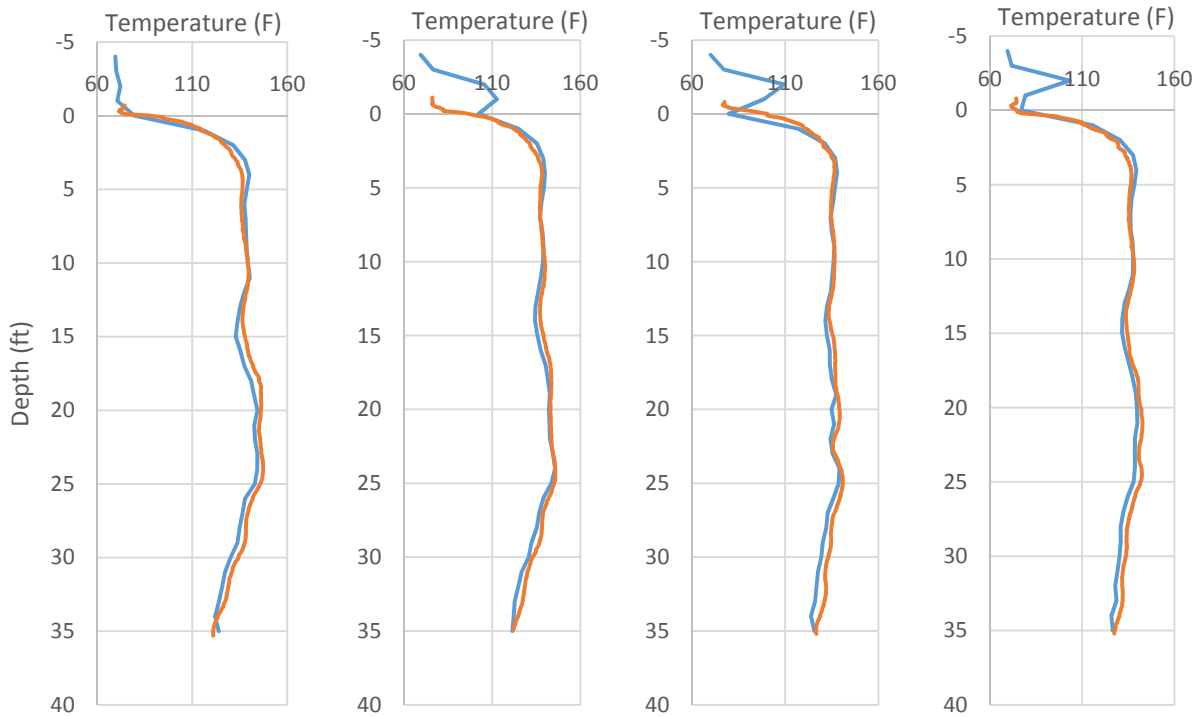
Figure 3.2 Pile L2, probe in PVC (orange) and wire (blue) measured thermal profiles for each tube 1 – 4 (left to right) near peak temperature.

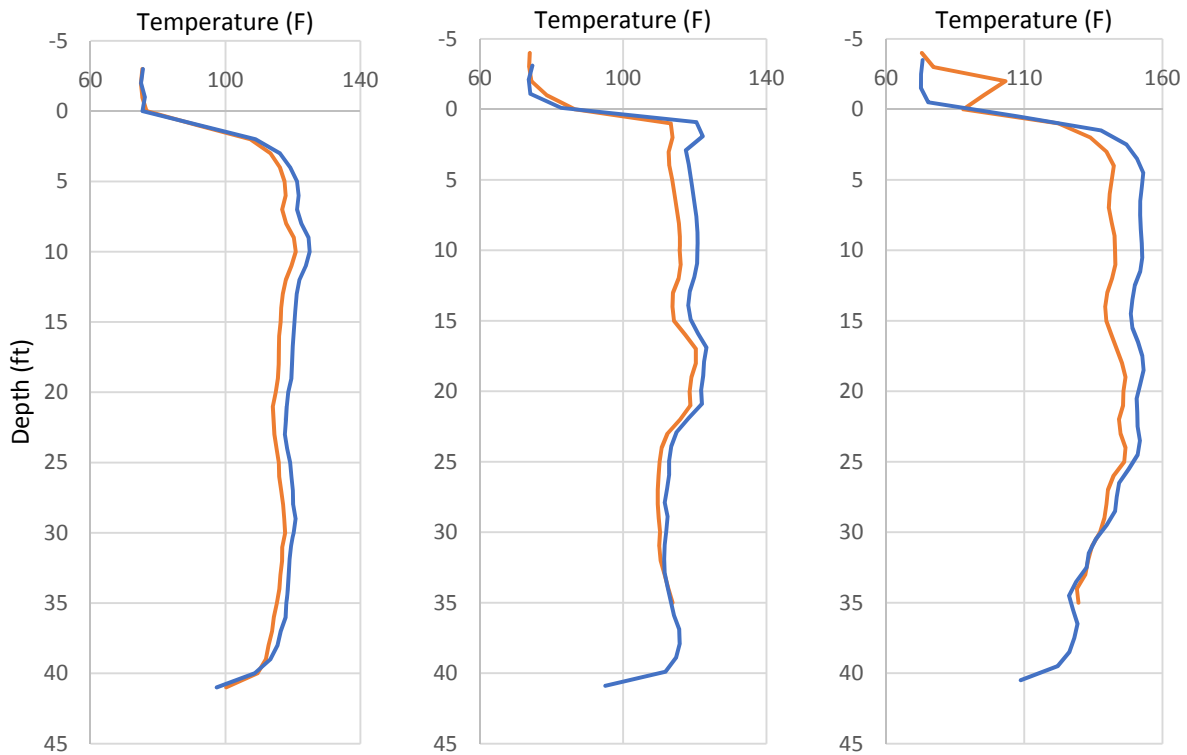
Figure 3.4 Pile E1 (left), L1 (center), and L2 (right) – average cage wire data (orange) compared with center bar wire data (blue).

Five of the seven test piles were instrumented with both center bar and cage position temperature systems (two of which also included access tubes on the cage as noted above). Based on normal temperature distributions within a cylindrical hydrating foundation element, it is well understood that the center most positions will be warmer than more peripheral positions closer to the surrounding cooler soil. This is especially true for smaller diameter ACIP piles and for Pile E2 this phenomenon was clearly demonstrated where the center bar temperatures were consistently and uniformly warmer than the cage temperatures (Figure 3.4). However, for several other piles the average of cage located measurements were consistently cooler near the surface (normal), but came to the same temperature as the center bar at depth. This showed that the center bar was not centered.

Piles C1 and C2 could not be used to produce reliable average profiles due to missing data from malfunctioning wire sensors; those comparative graphs were not prepared. However, the same basic trends can be seen in Figures A.3 and A.4 where the center bar was generally warmer than cage position measurements (Appendix A).
