**THERMAL INTEGRITY SYSTEM FOR
AUGERED CAST-IN-PLACE PILES
(PART II, IMPLEMENTATION PLAN)**

BDV25-977-34

DRAFT FINAL REPORT

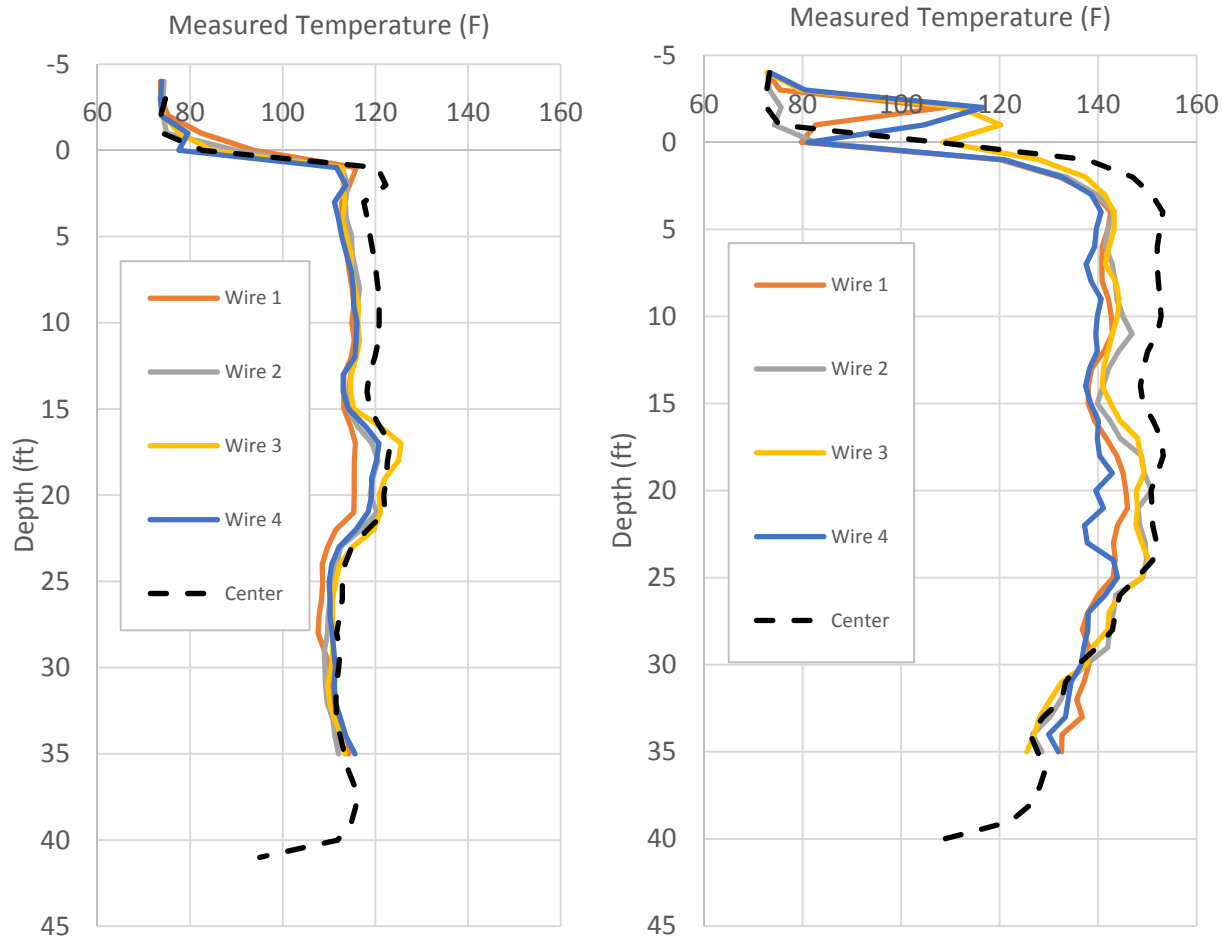
Figure 3.5 Pile L1 (left) center bar temperature aligns with cage from 15ft downward; Pile L2 (right) from 20ft downward.

Overall, the 18in piles can be quickly identified relative to the 24in piles due to the normal cage temperature (115F for 18in or 140F for 24in) and center bar temperatures (120F and 150F, respectively) which were 25 to 30F cooler.

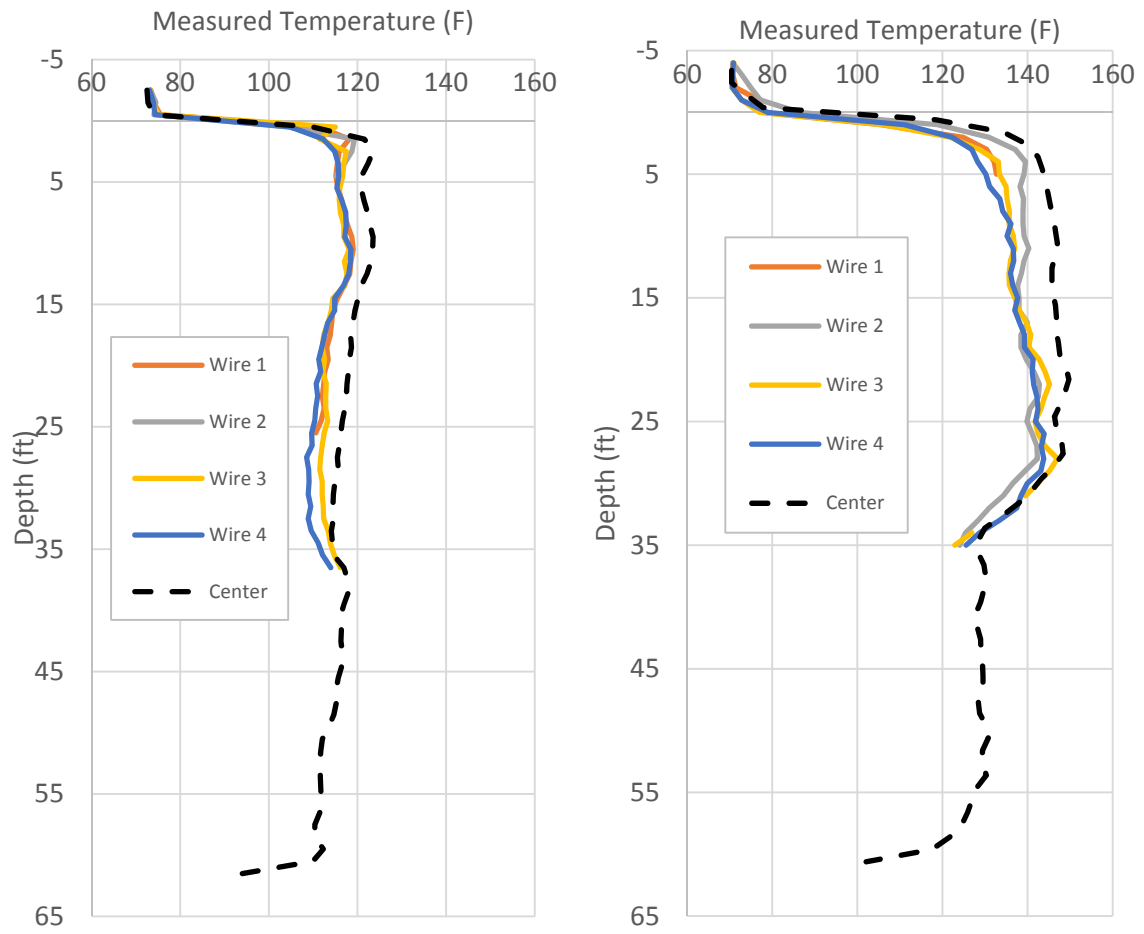
Figure 3.6 Center and cage measurements for Pile C1 (left) and C2 (right).

- Pile C1, the center bar and Wire 3 have the same temperature at 35ft, so the center bar is part of the cage at that depth (Figure 3.6, left); cage offset cannot be evaluated due to missing opposite side measurements within the cage.

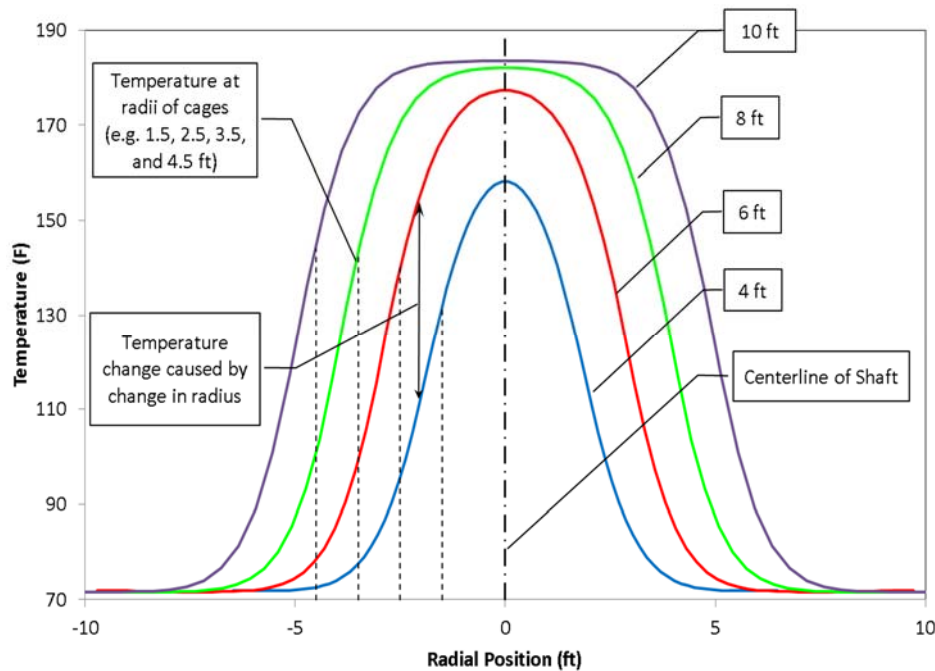
Figure 3.8 Typical temperature / radius plot or bell-curves (Part I, Figure 2.11; Mullins, 2012a).

Alternatively, simple field calibration of the hydration energy can be used where the average overall shaft or pile temperature is equated to the average shaft or pile radius. This is the method used for drilled shafts, but cage measurements on a shaft are considerably farther away from the center than in ACIP piles. This means that shaft cage measurements are in a strongly linear portion of the temperature / radius, bell curve (Figure 3.8).

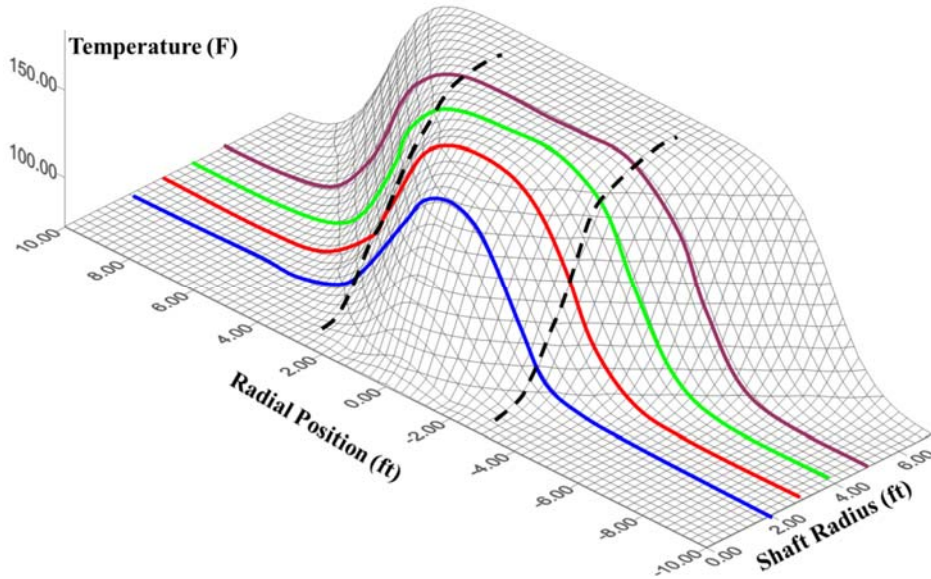
Figure 3.9 Relationship between cage position, shaft size, and temperature (Part I, Figure 2.12; Mullins, 2012a)

The shape of the bell curve is similar to the temperature reduction that occurs at the top and bottom of the shaft (or pile) as the temperature profile transitions to the air or soil, respectively. The effect of radius increase or decreases also follows the same trends as shown in Figures 3.9 and 3.10. Figure 3.9 shows the overall effect of all shaft sizes and measurement locations, while Figure 3.10 shows a shaft specific temperature / radius (T-R) relationship where the measurement position within the foundation element is fixed dependent on the cage radius relative to the shaft radius. In both figures, the dashed black lines denote the T-R relationship at the location of the cage which is 6in smaller than the shaft for all FDOT shafts. In other states, a smaller cover may be permissible or prescribed based on the shaft diameter.

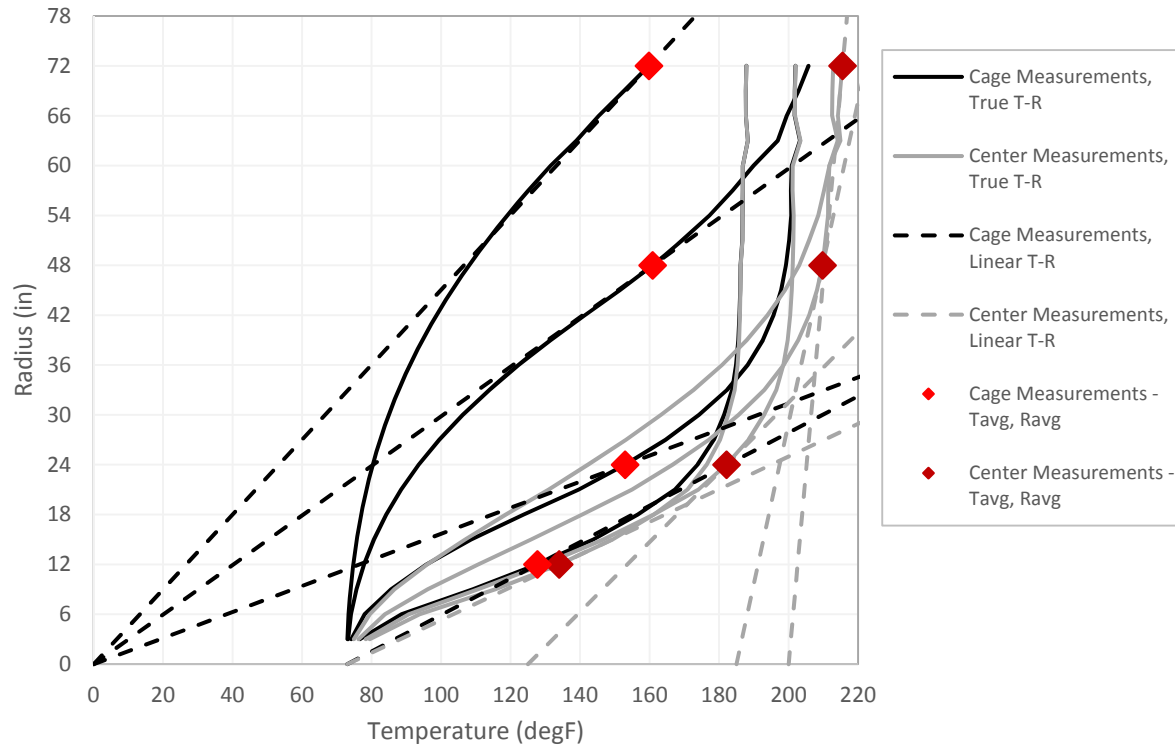
Figure 3.11 T-R relationships for varying foundation element sizes with both cage and center measurement locations.

In the Part I report, center bar temperature measurements of ACIP piles were shown to be only mildly affected by diameter changes using the T_{soil} method and drastically underestimated true radial variations. Several alternate analysis methods were discussed for small piles with only center bar measurements; one did not require numerical modeling and is referred to in this report as the T_{soil} method. This method uses a modified version of the T_{zero} method where the linear T-R relationship is again defined using two points but the zero radius temperature value is defined by the local at-depth soil temperature: $(T_{soil},0)$ and (T_{avg},R_{avg}) . As an example, Figure 3.11 shows the modeled inverse hyperbolic tangent T-R relationships for 2, 4, 8 and 12ft diameter elements at the time of peak temperature. Recall, the T-R relationship is dependent on the location of measurement; the center of element and cage positions are shown as grey and black curves, respectively. The cage position relationships are fitted with the T_{zero} linear approximation passing through the T_{avg},R_{avg} point; the center of pile curves are fitted with the best linear relationship to represent the linear portion nearest the T_{avg},R_{avg} point. All elements were modeled with ACIP pile grout for comparison. The grout or concrete composition only affects the adiabatic core temperature and the rate at which it is achieved; it does not affect the hyperbolic T-R shape.

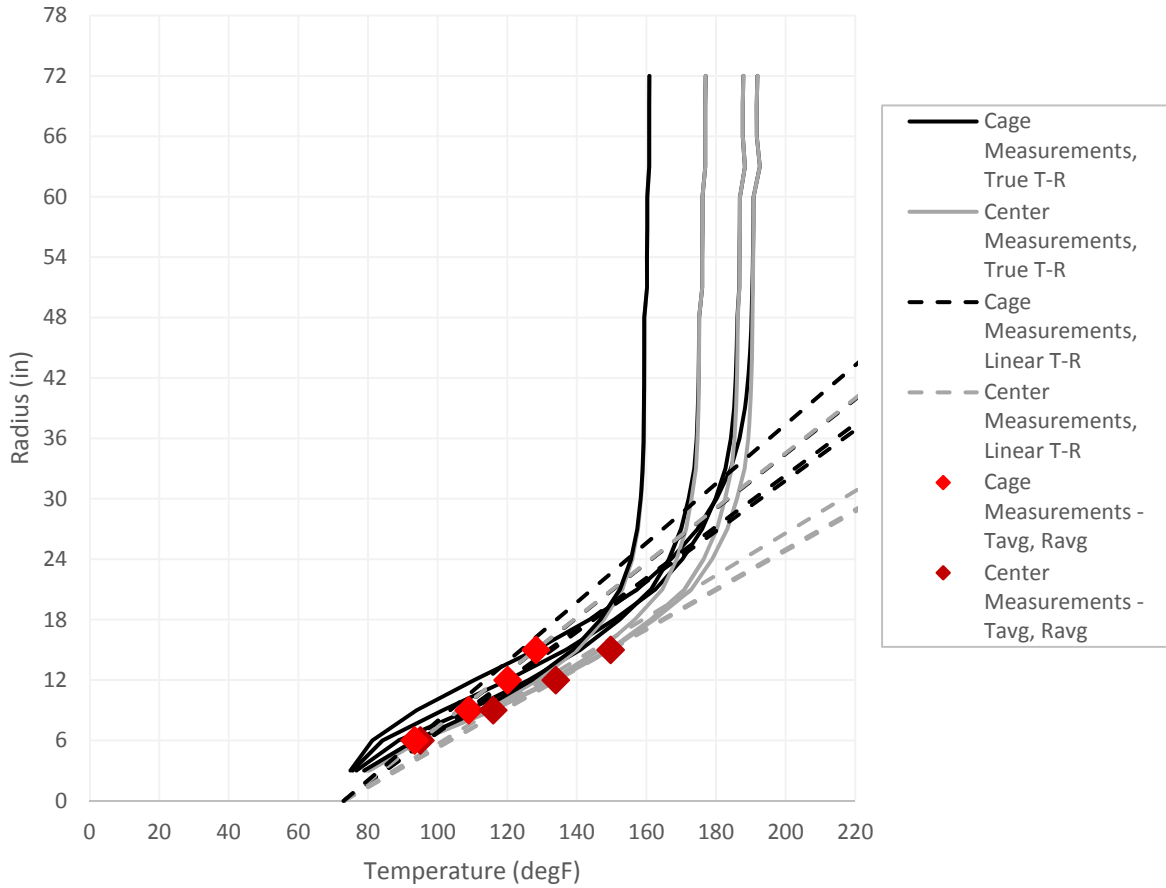
Figure 3.12 T-R relationships for smaller elements using T_{soil} method.

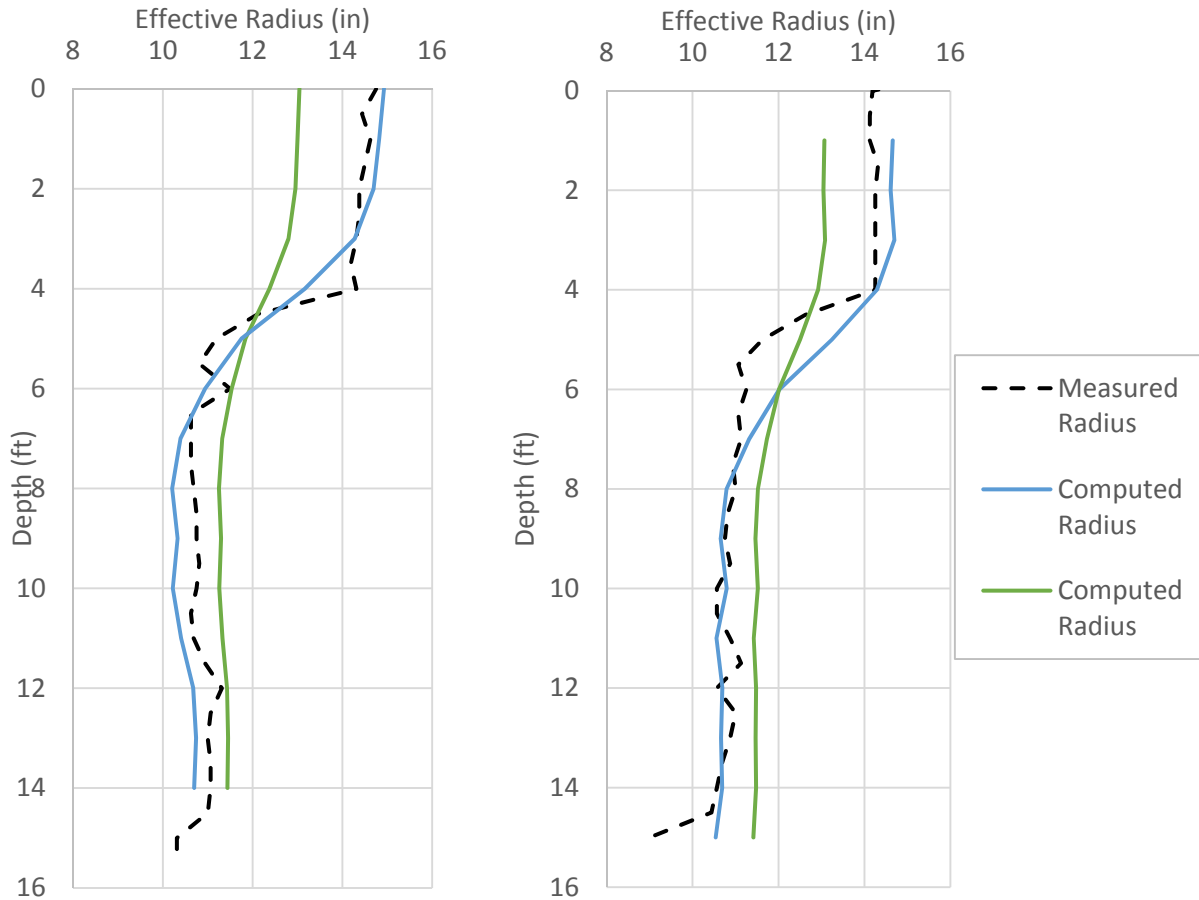
Figure 3.13 22in diameter drilled shafts with center bar measurements analyzed using T_{zero} (green) and T_{soil} (blue) methods shown with post-extraction as-built dimensions.

The measured step in each shaft (black dotted lines) was caused by an oversized surface casing and resulted in the shaft diameter transitioning quickly to the smaller auger diameter. Similar to end of pile transitions to air or soil, sudden steps in the shaft appear in the temperature profiles as inverse hyperbolic tangent transitions from warmer to cooler (or vice versa). For top and toe profiles these transitions are adjusted to reflect the proximity to the known end of pile effects. For mid shaft steps no adjustments are presently employed. Review of this data reveals the possible need for this type of algorithm although the use would need to be selectively used. *Note: similar mid shaft profile transitions can occur from drastic changes in the surrounding environment (i.e. cased shaft extending from soil through water to air). In those cases the effects of the surroundings are removed; in this case the effect of transition would be emphasized.*

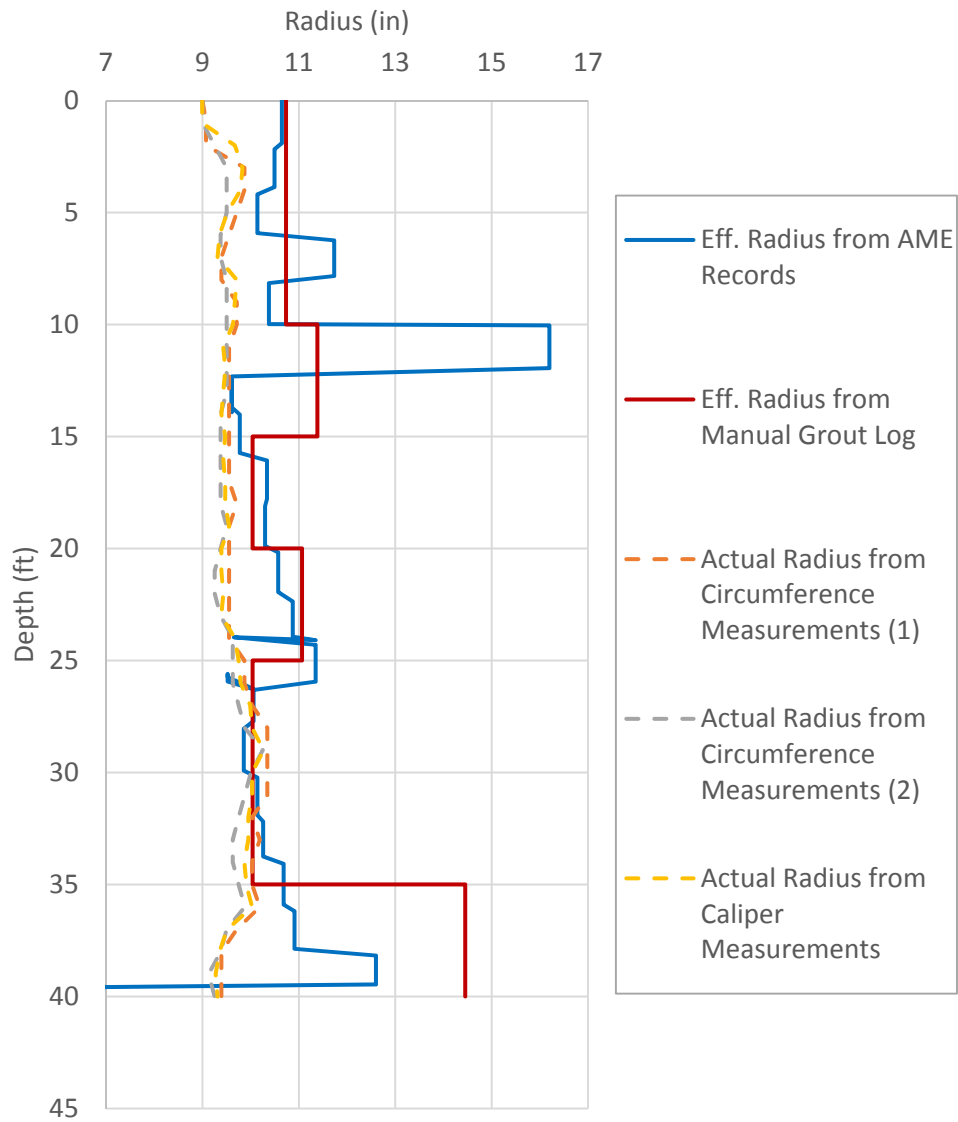
Figure 3.14 Radius computed from automated and manual grout log compared against actual radius measured after extraction for Pile E1.

Before extraction of the auger several pump strokes are applied which build pressure in the system (soil and all lines) and establish a concrete head similar to tremie placed concrete. Traditionally, this volume of grout is discounted when assessing the actual placed volume. The auger is then extracted while continuously pumping grout and hence a volume/length of pile relationship can be used to estimate the local diameter (or radius). Once near the surface, the pressurized grout reaches the surface before the full extraction of the auger which is noted in the field records as the depth when grout return was observed at the surface. Thereafter, grout volume placed could be used to account for further soil expansion, replacement of the auger volume or overflow at the surface. Discounting this volume completely is not reasonable but a portion should be. These records can be collected manually (on 5ft intervals or similar) or via automated on-board data collection systems (noted here as AME records).

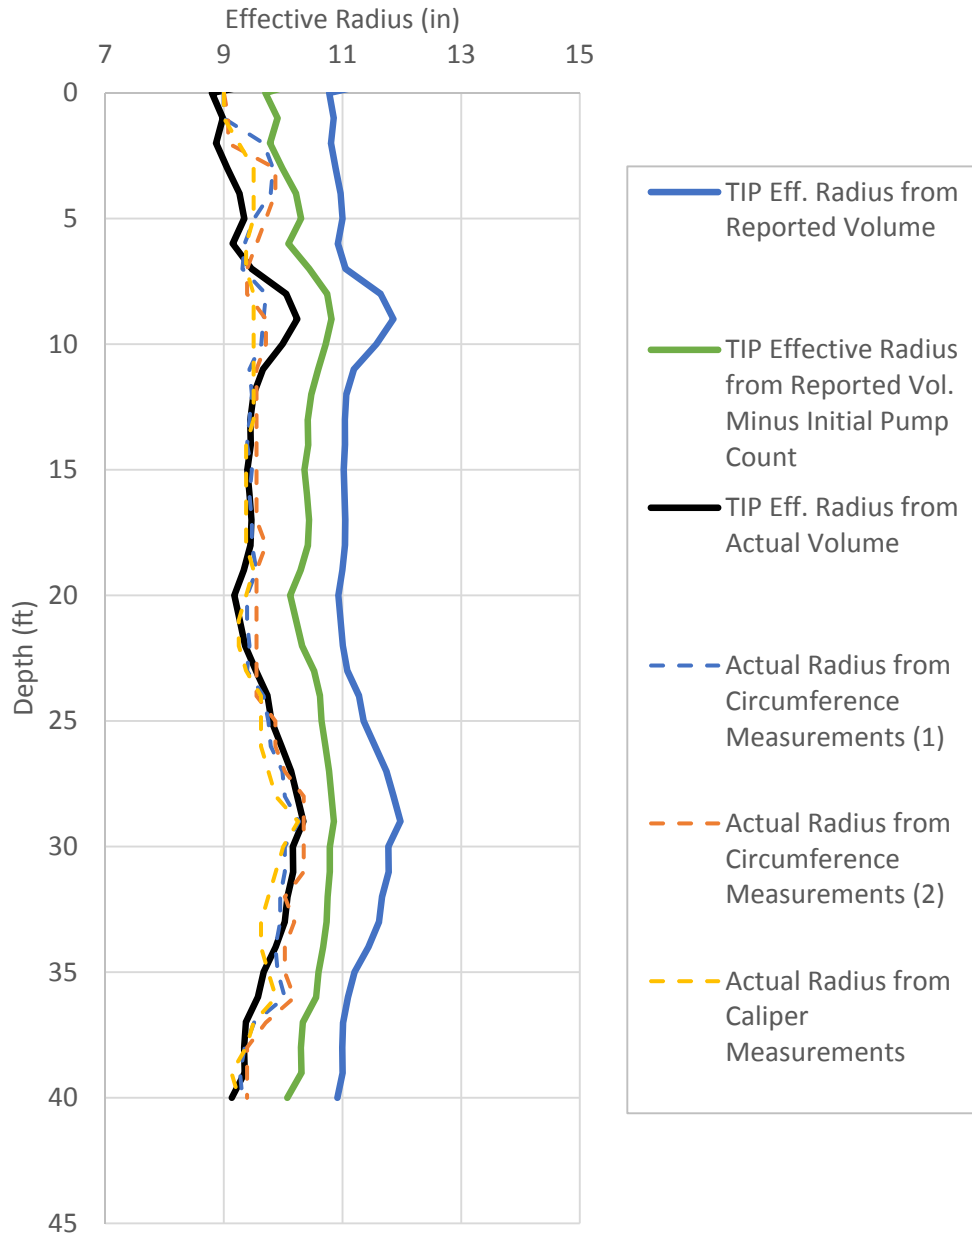
Figure 3.15 Effective radius from T_{soil} method compared to actual radius of Pile E1.

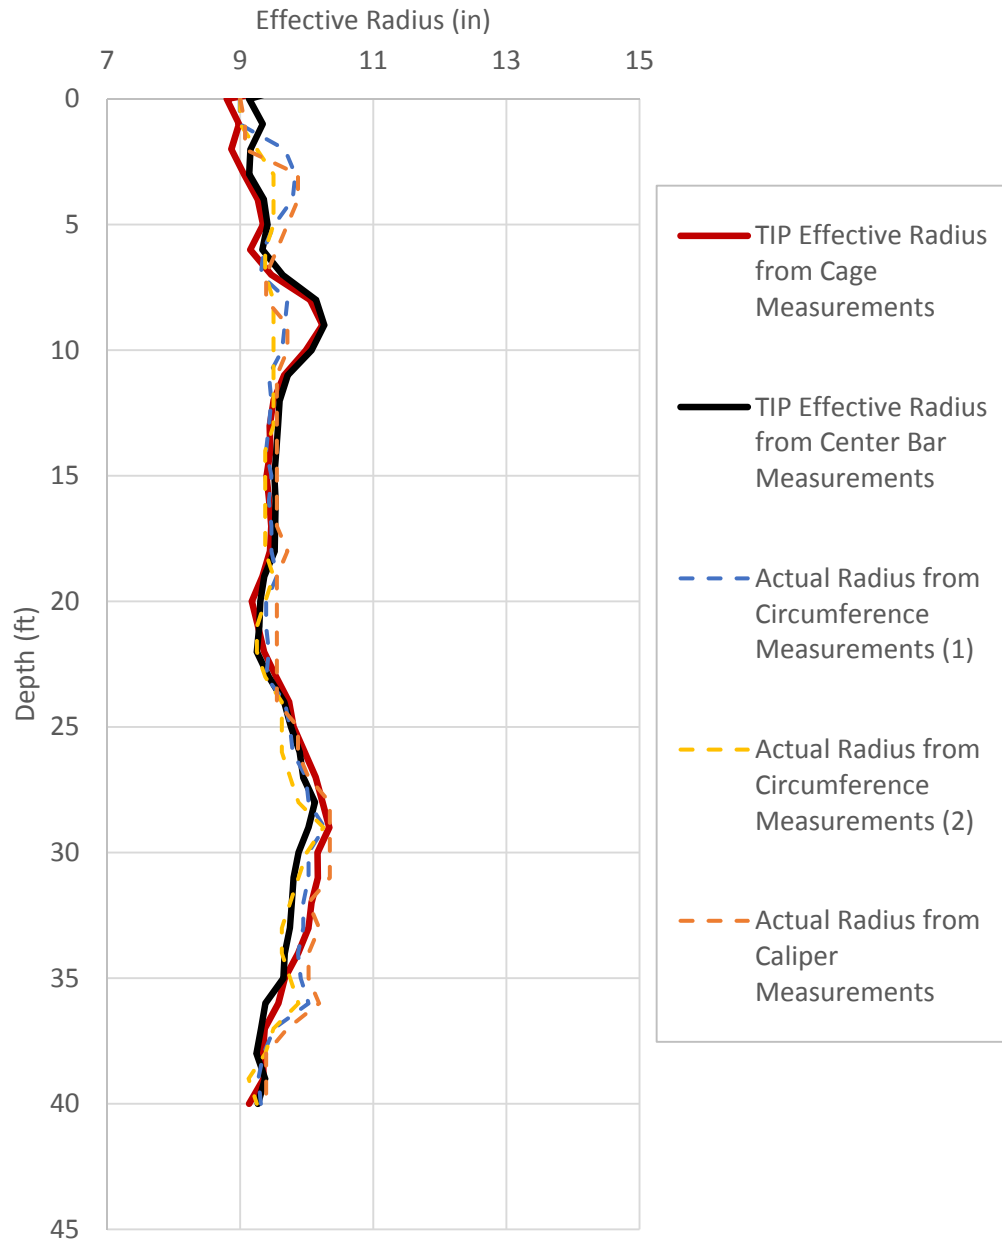
Figure 3.16 Pile E1 effective radius determined from cage measurements and center bar measurements compared to actual radius measured after extraction.

Using only the true volume, the effective radius profiles were estimated for both measurement locations from Pile E1 which showed close agreement with the as-built pile measurements (Figure 3.16). The magnitude of variation between the two estimated shapes is on the same order as that observed by different physical measurements conducted by two different teams (DFI contractor and USF researchers) or by using two different measurement methods (diameter from taped circumference vs localized diameter from calipers).

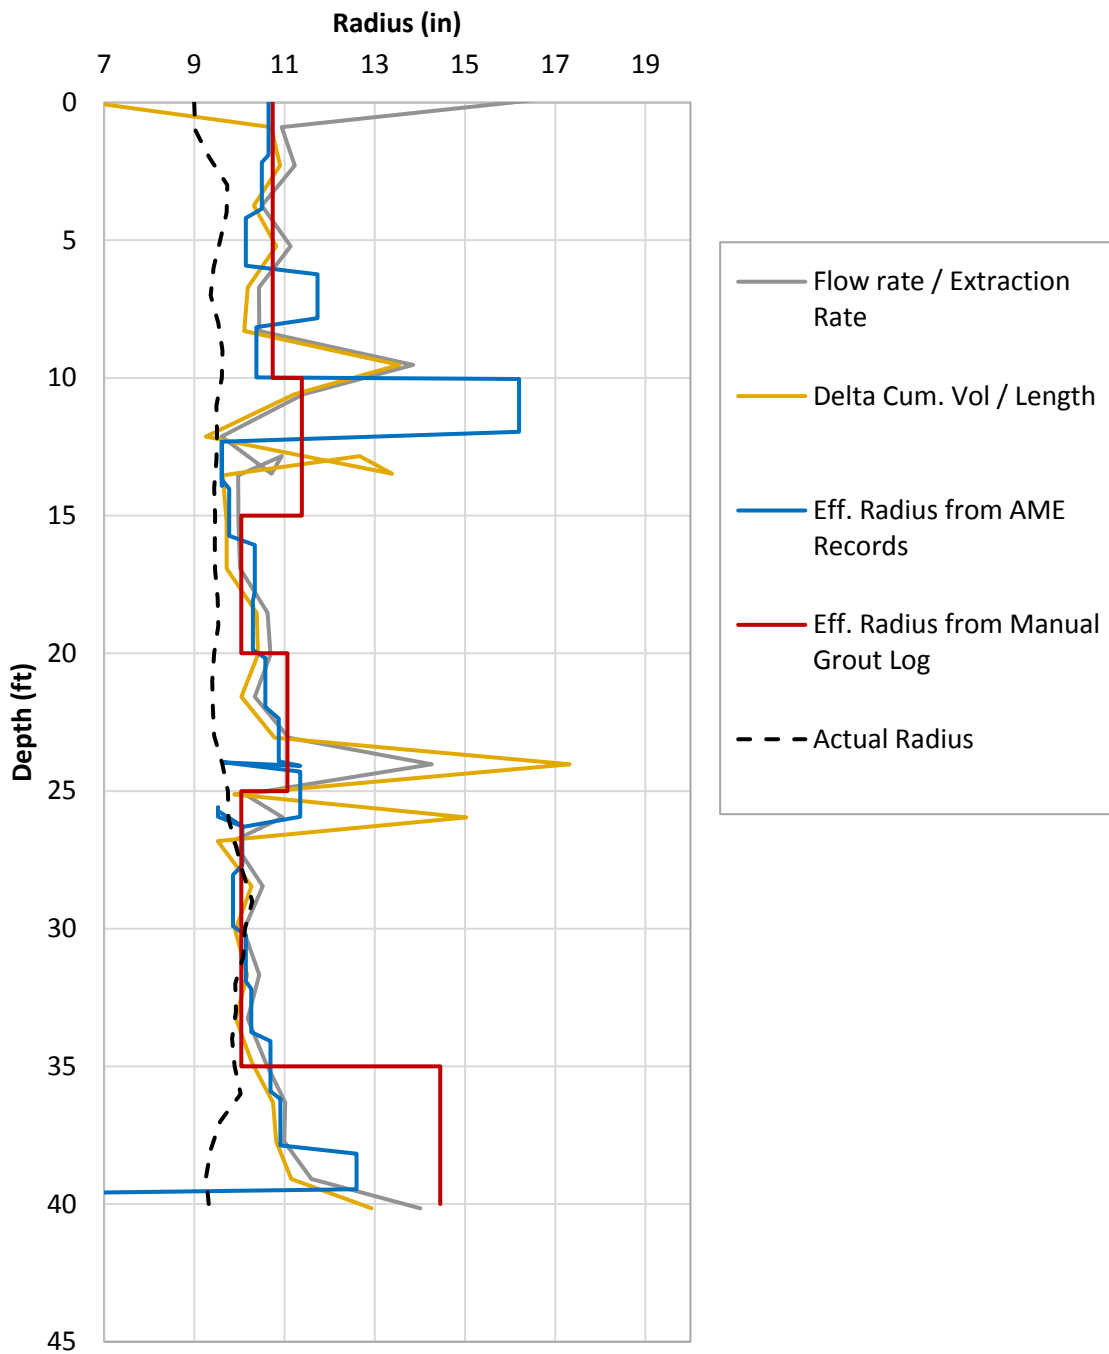
Figure 4.1 Radius predictions from grout volume measurements.

The total grout volume is essentially the area under the predicted radius vs depth curve times 2π . The various methods of determining radius place excess volume at different locations along the length of the pile making a simple rule for the exclusion of certain volumes difficult (e.g. initial pump strokes or some portion of the volume after return is observed). For Pile E1 the true volume of the pile was determined from manual measurements to be approximately 80cuft and the overall pumped grout was 109cuft. By subtracting the volume from initial pump strokes (10cuft) and the entire volume after grout return was observed (34cuft), the volume drops to 65cuft. Adding back the theoretical volume of the auger in the ground at the time return was noted (22cuft), the volume increases to 87cuft which is 7cuft too high (8.8%). This increases the actual average pile radius (9.6in) to a prediction of 10.4in. The most likely cause of this disparity is the amount of grout that mixes with the ground water and becomes unrecognizable as clean grout return.

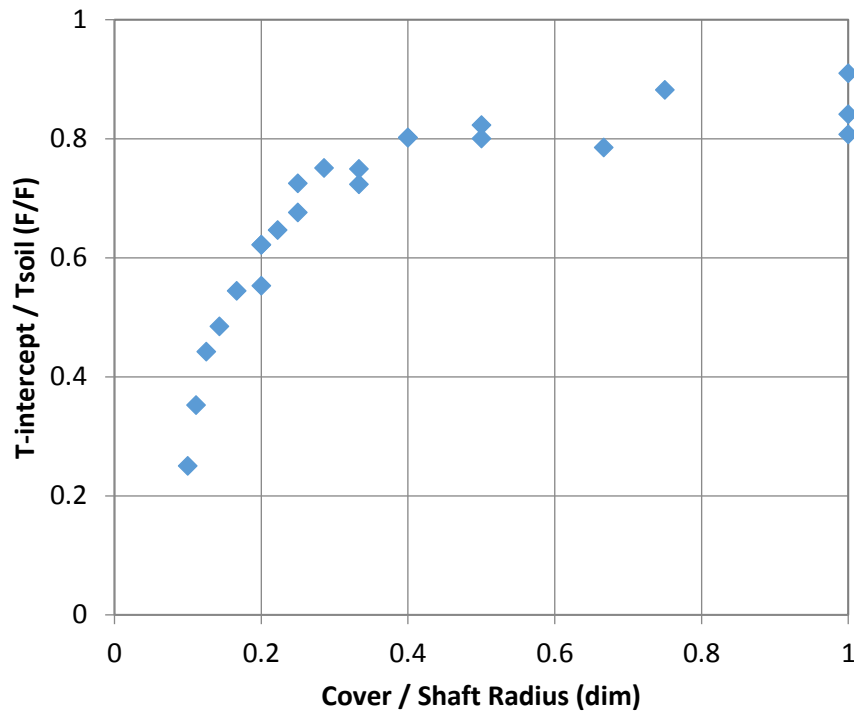
Figure 4.2 Intercept temperature as a function of measurement position.

The T_{zero} linearization of the hyperbolic T-R relationship was confirmed to be conservative for all diameters of foundation elements regardless of the measurement location. The T_{soil} method was shown to be a reasonable approximation for smaller elements for both center bar and cage position measurements. However, a subtle over prediction of radial variations results from its use. Figure 4.2 includes the model predicted best fit T-intercepts for cage based measurements in shafts greater than 2ft diameter with no more than 6in of cover, and for both center bar and cage measurements in piles 2ft diameter or smaller. For ACIP piles, the simplistic T_{soil} method could be refined based on these model results to use $0.9T_{soil}$ as the intercept value. In general any intercept selected that is less than that shown results in conservative radius variation predictions.

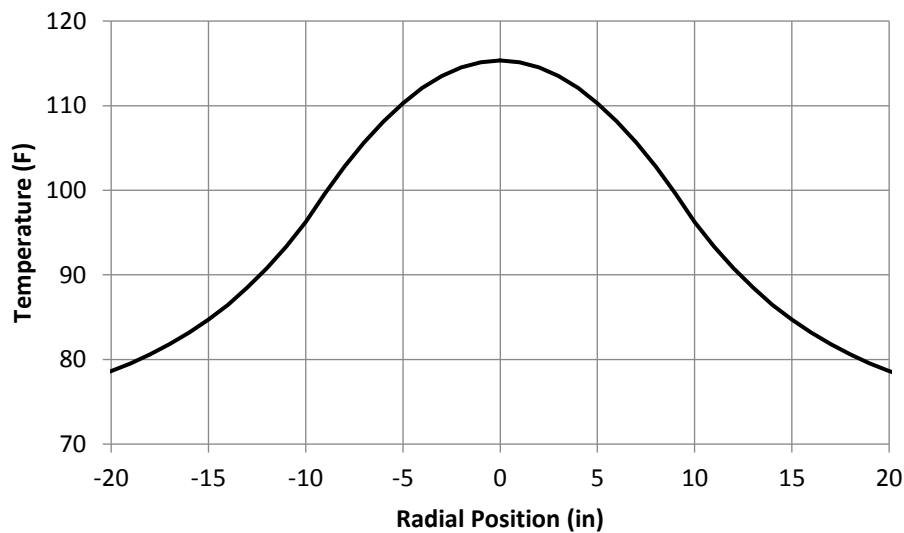
Figure 4.3 Radial temperature distribution in 18in ACIP pile (12hrs).

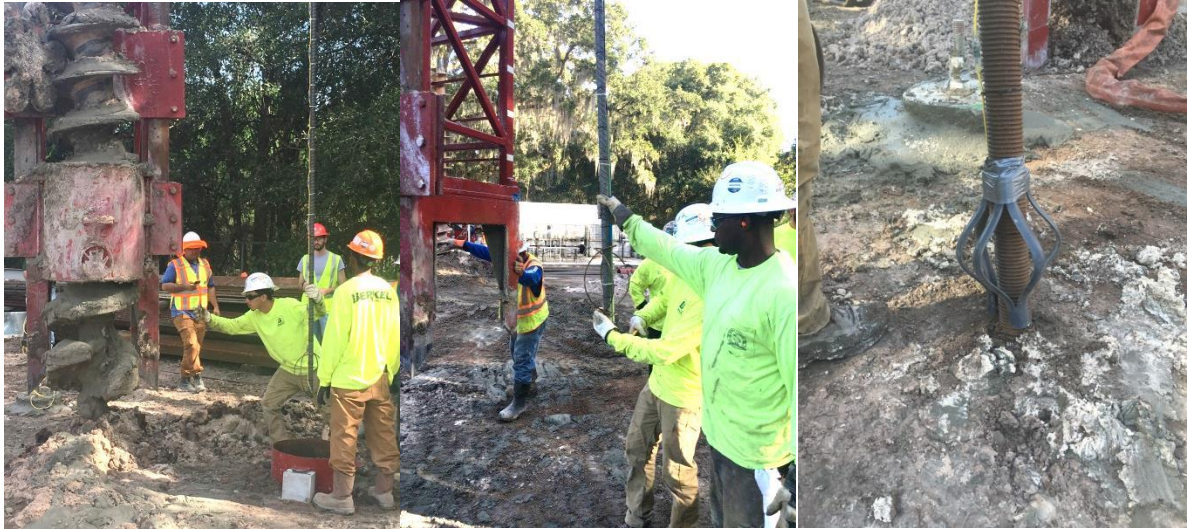
Figure 4.4 Number 8 bar with weak and widely spaced centralizers over 10ft (left).

However, piles tested in this study were confirmed to have moved up to 5.5in for 18in and 7.5in for 24in diameters. This translated into potential radius prediction errors of 1 to 2in based on the observed R/T slope of 0.25in/degF. These errors create both under and over predictions as the integrated temperature vs depth curve is equated to the placed volume; where one region of the pile under-predicts radius from low temperature, higher temperature regions must over-predict to balance the equation. These types of errors are preventable via use of more centralizers (Figure 4.4).

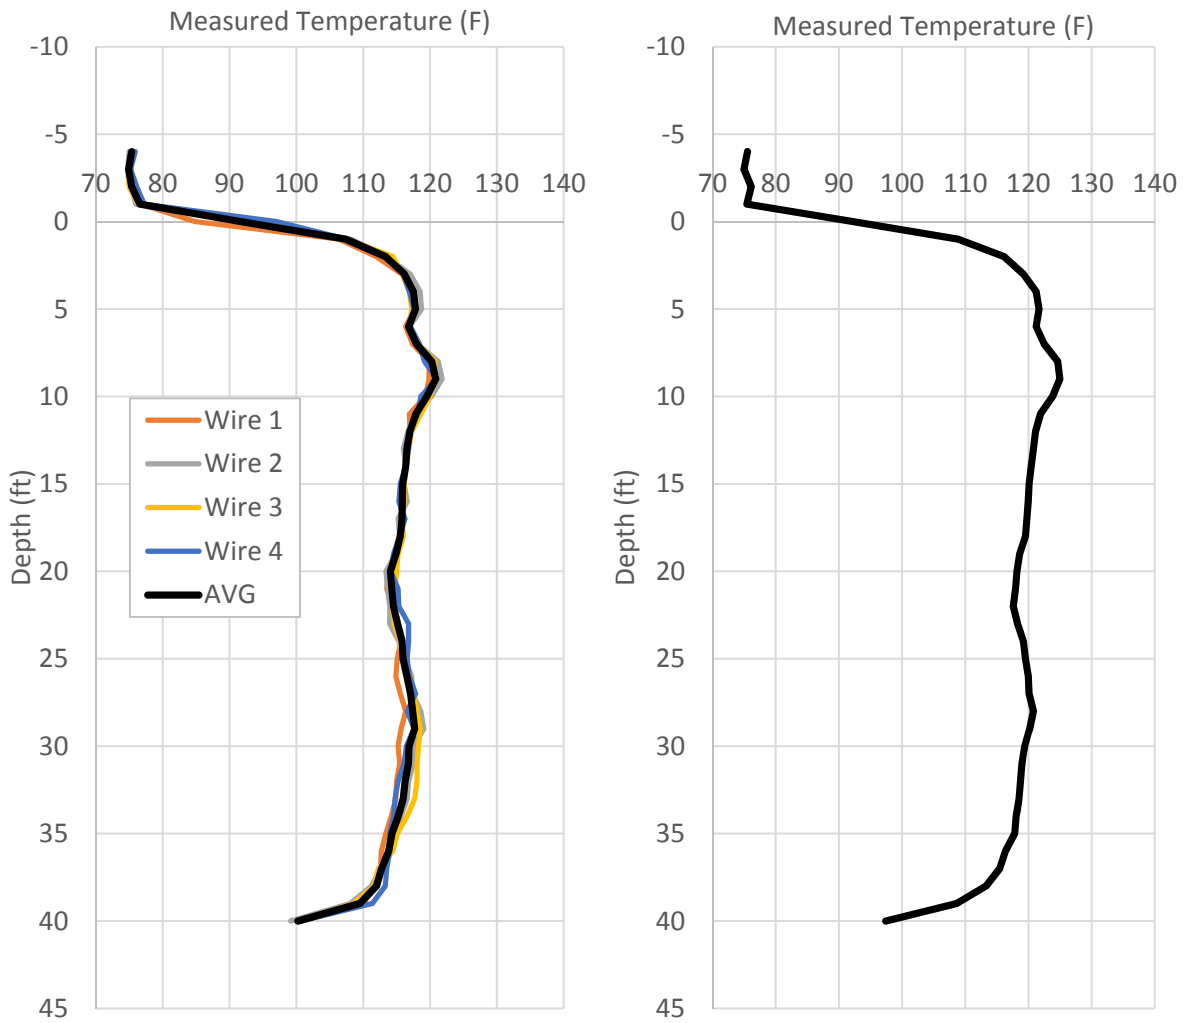
Figure A.1 TIP wire data for pile E1, at cage location (left) and center bar location (right).

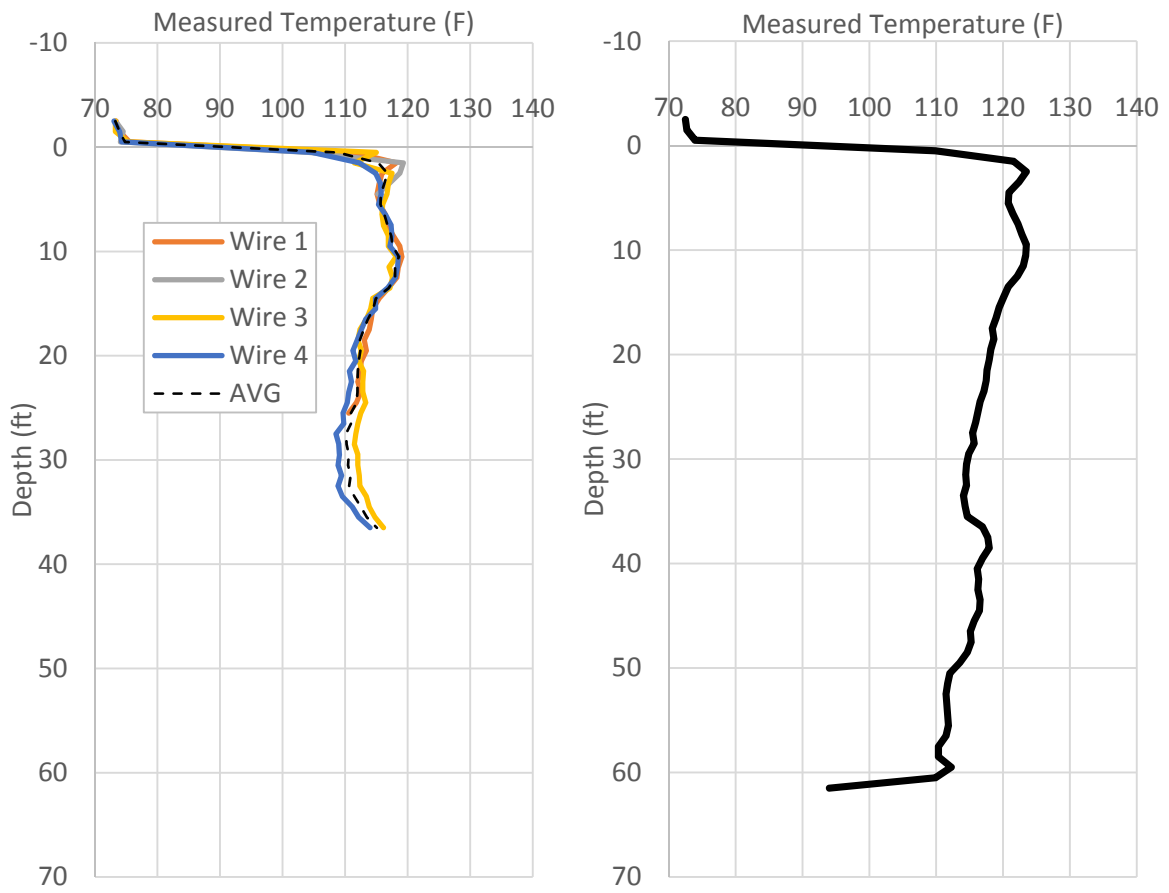
Figure A.3 TIP wire data for pile C1, at cage location (left) and center bar location (right).

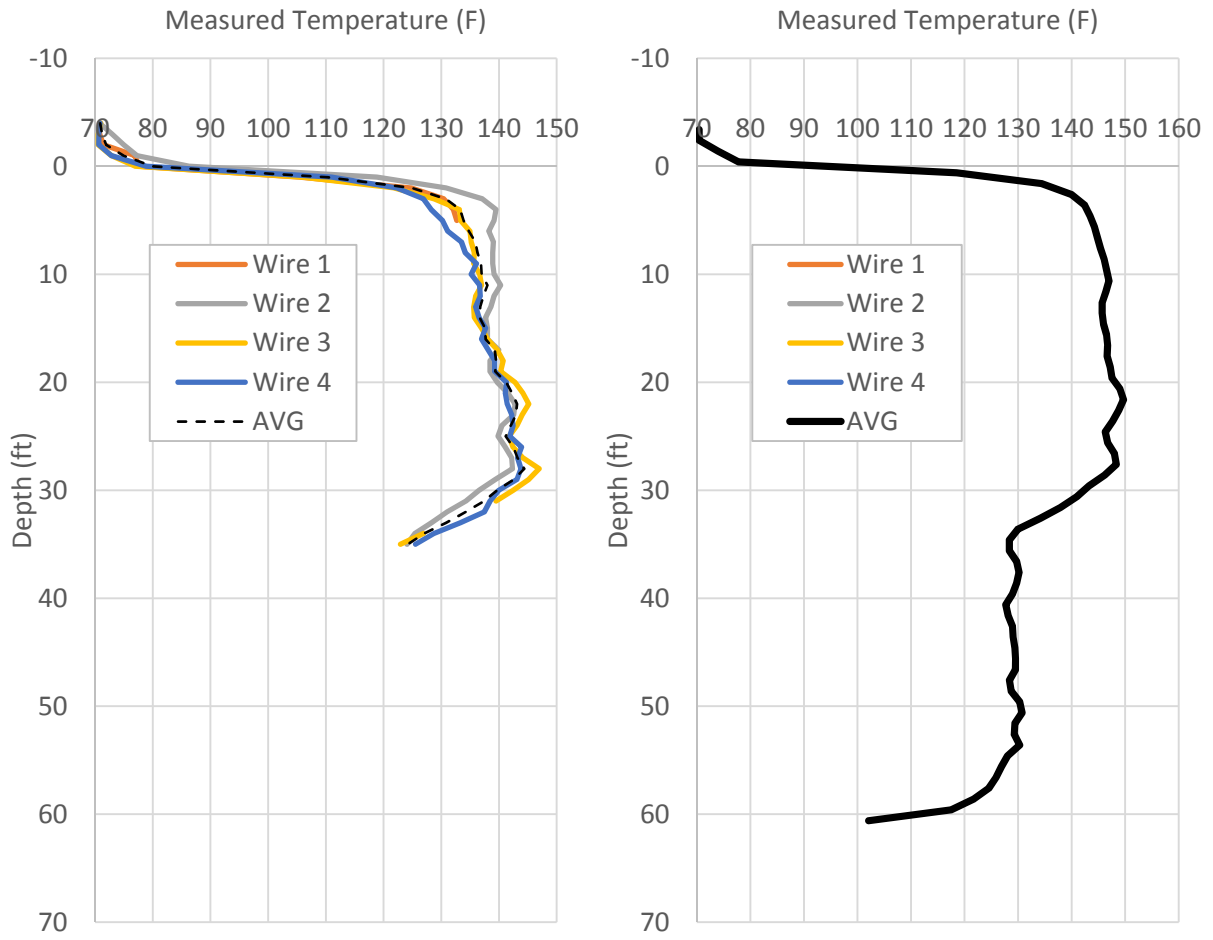
Figure A.4 TIP wire data for pile C2, at cage location (left) and center bar location (right).

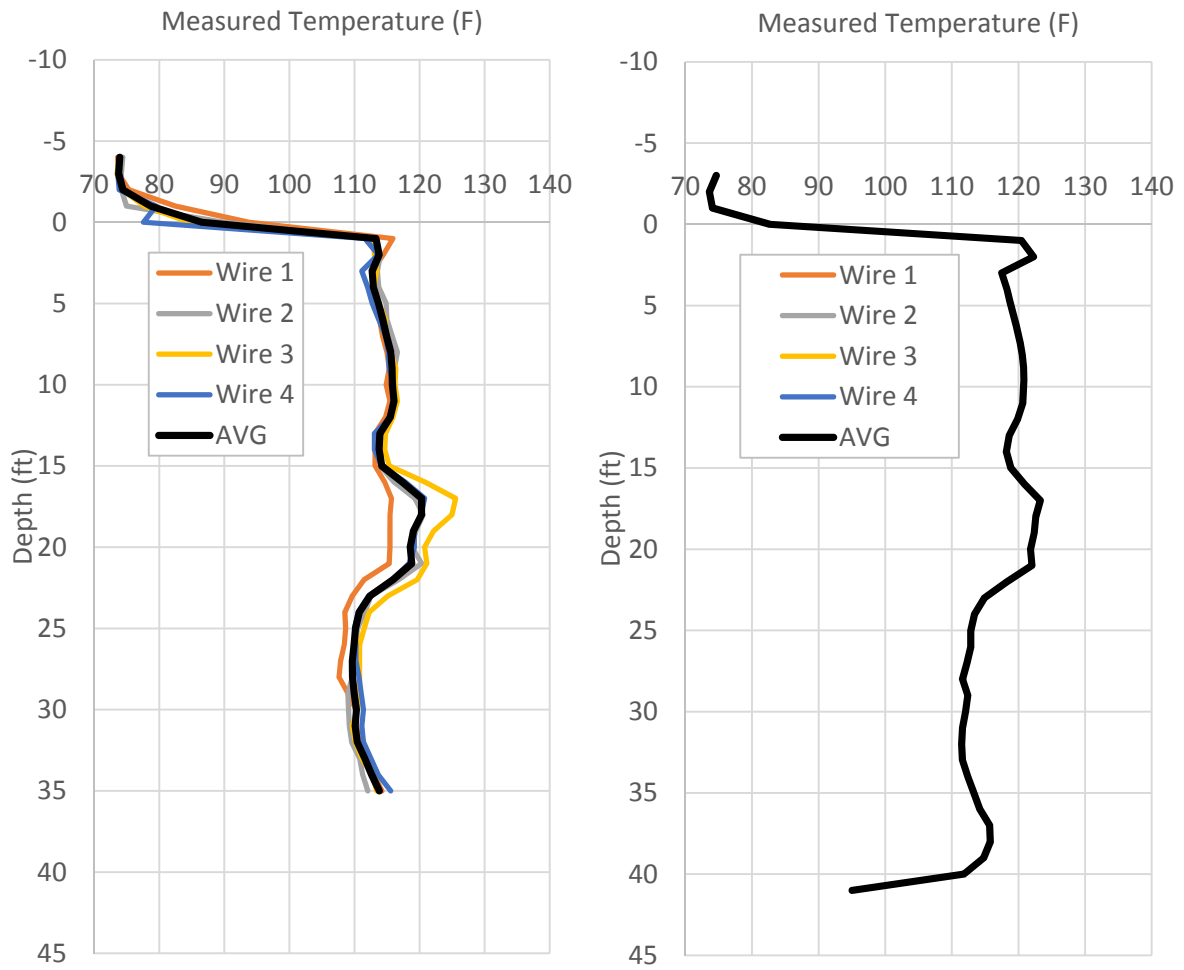
Figure A.5 TIP wire data for pile L1, at cage location (left) and center bar location (right).

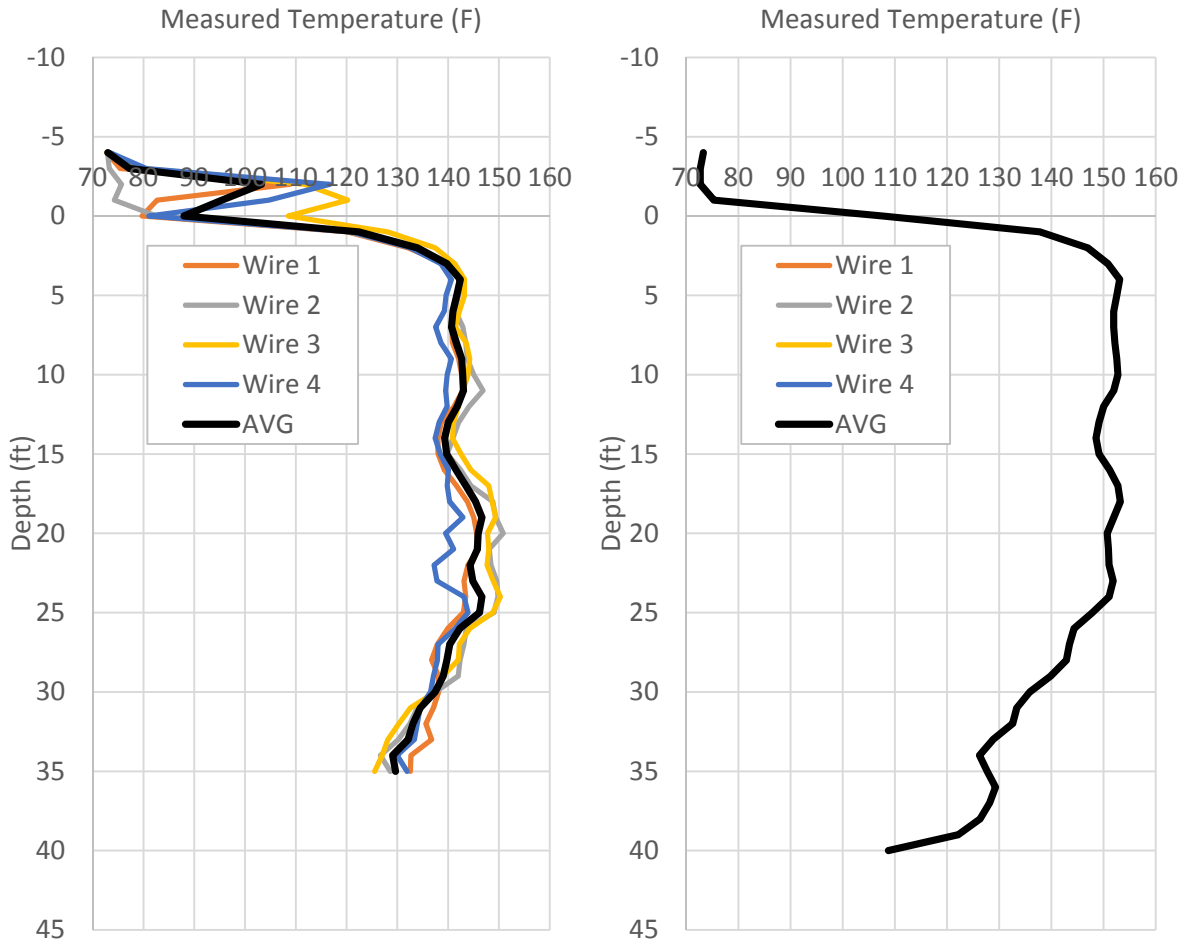
Figure A.6 TIP wire data for pile L2, at cage location (left) and center bar location (right).

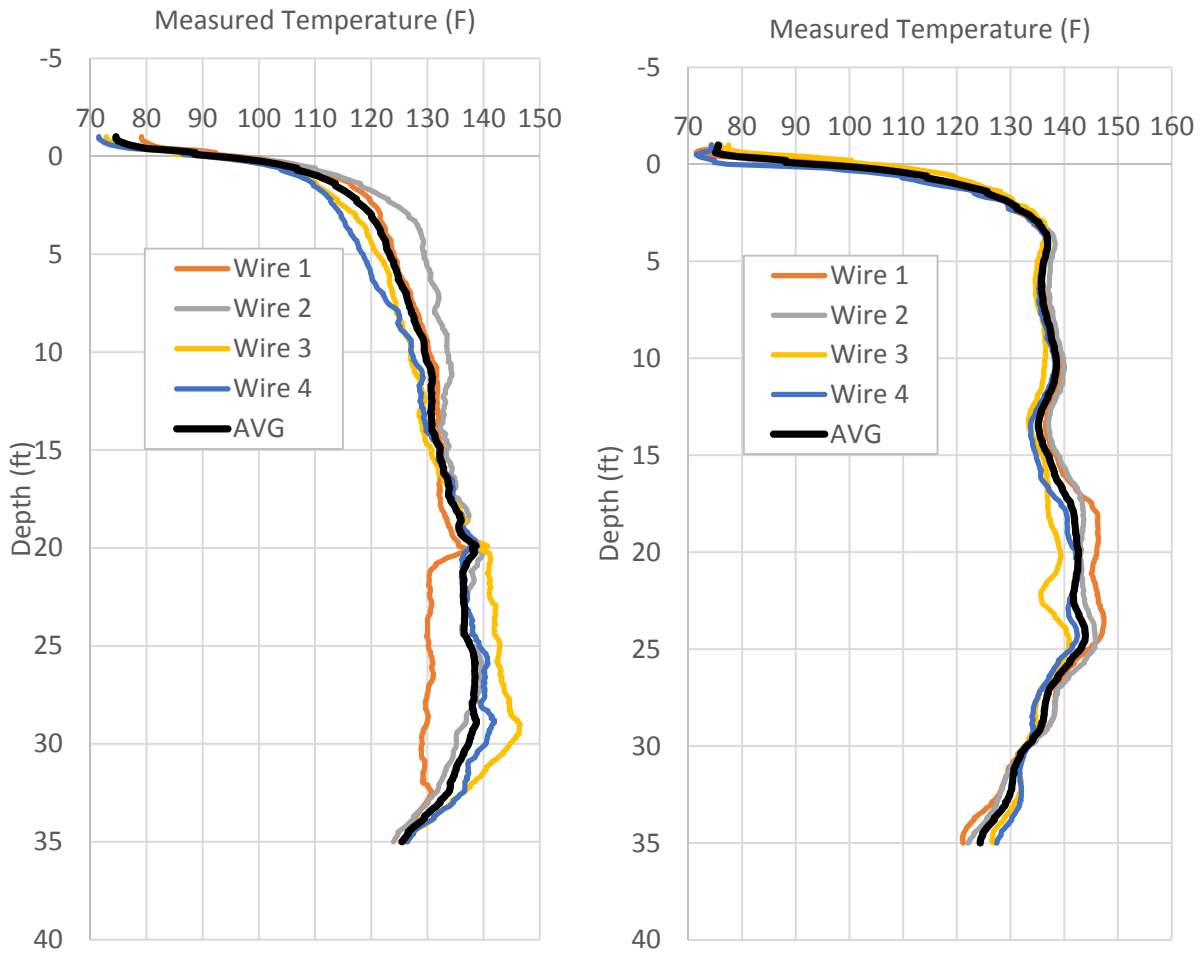
Figure A.7 TIP probe data for piles C2 (left) and L2 (right), at cage location.
