**THERMAL INTEGRITY SYSTEM FOR
AUGERED CAST-IN-PLACE PILES
(PART II, IMPLEMENTATION PLAN)**

BDV25-977-34

DRAFT FINAL REPORT

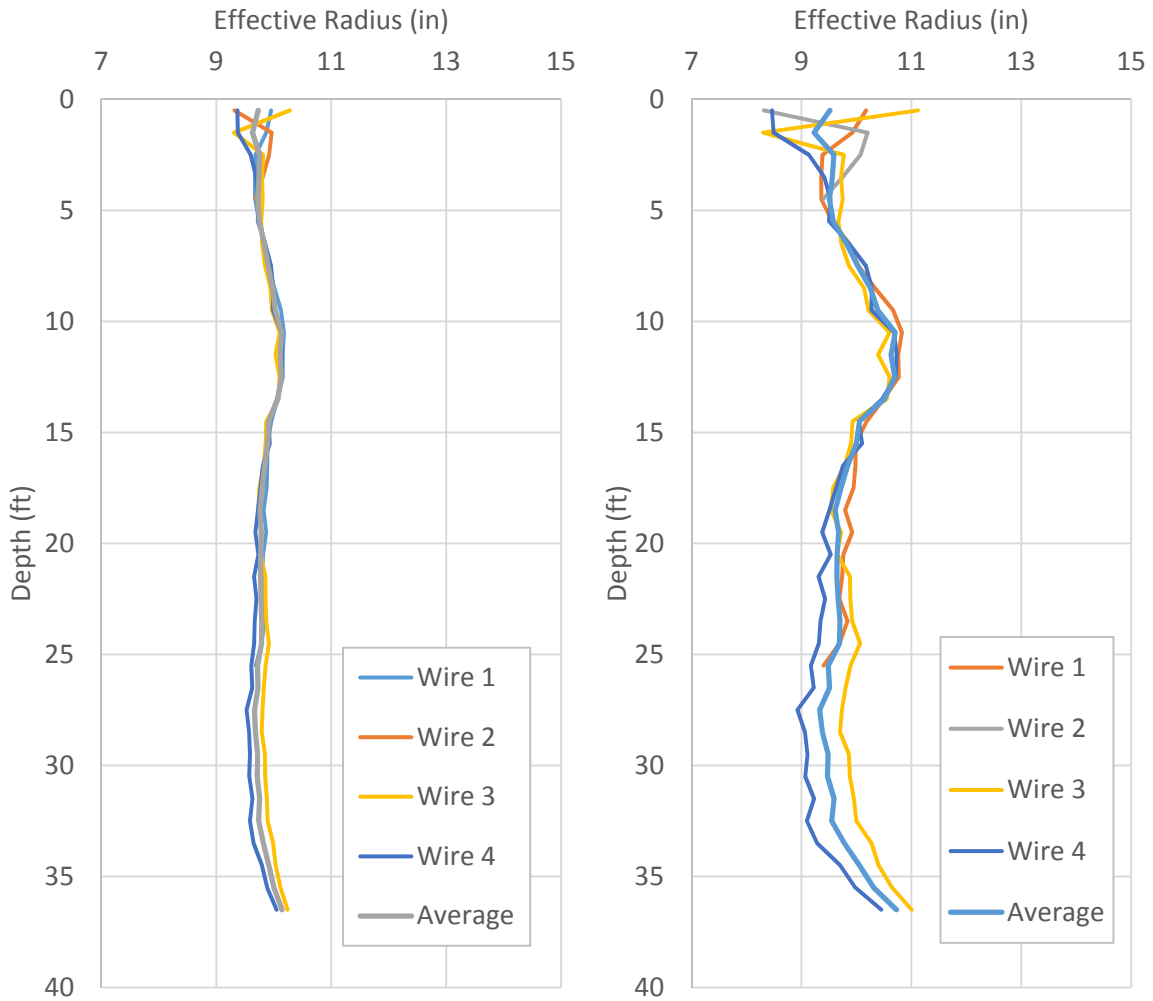
Figure B.1 Pile C1 effective radius from cage wire data, using T0 method (left) and Tsoil method (right).

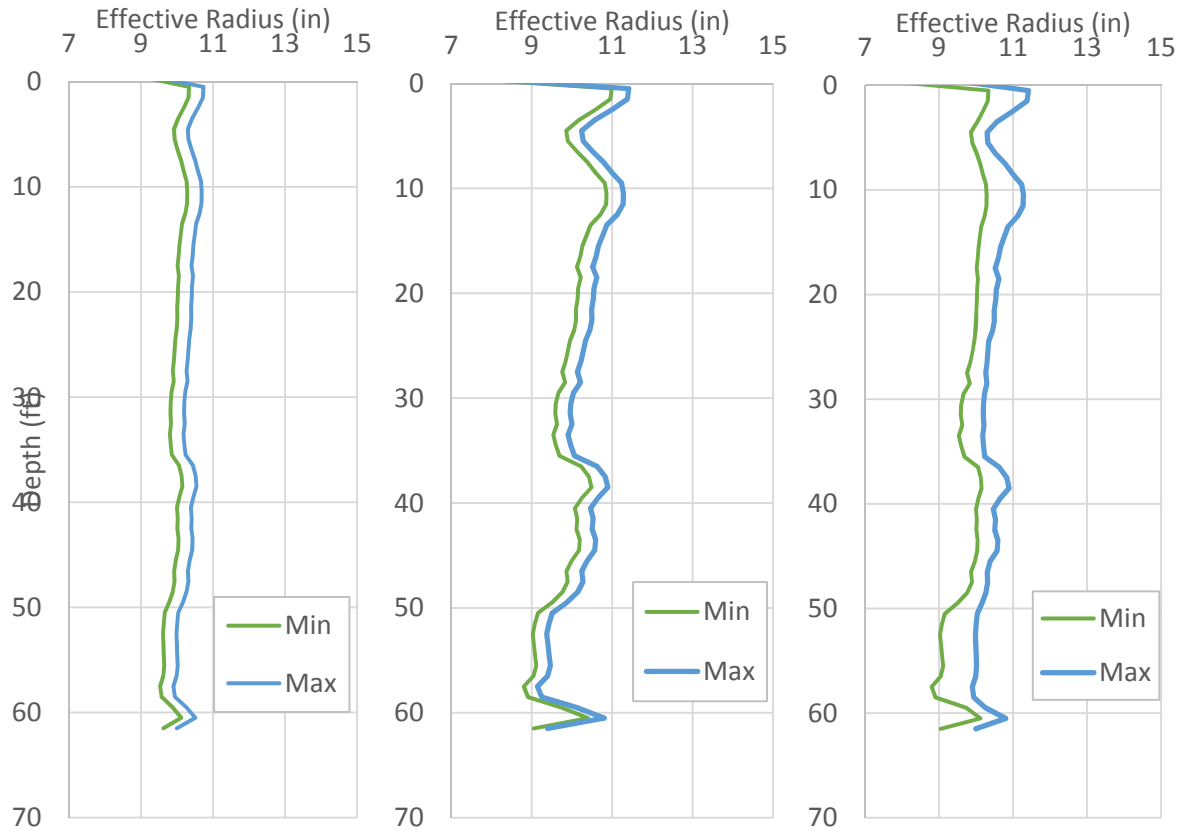
Figure B.2 Pile C1 effective radius from center bar wire data using actual reported grout volume (max) and reported volume grout less initial pump count (min) – T0 method (left), Tsoil method (center), min/max from all combinations (right).

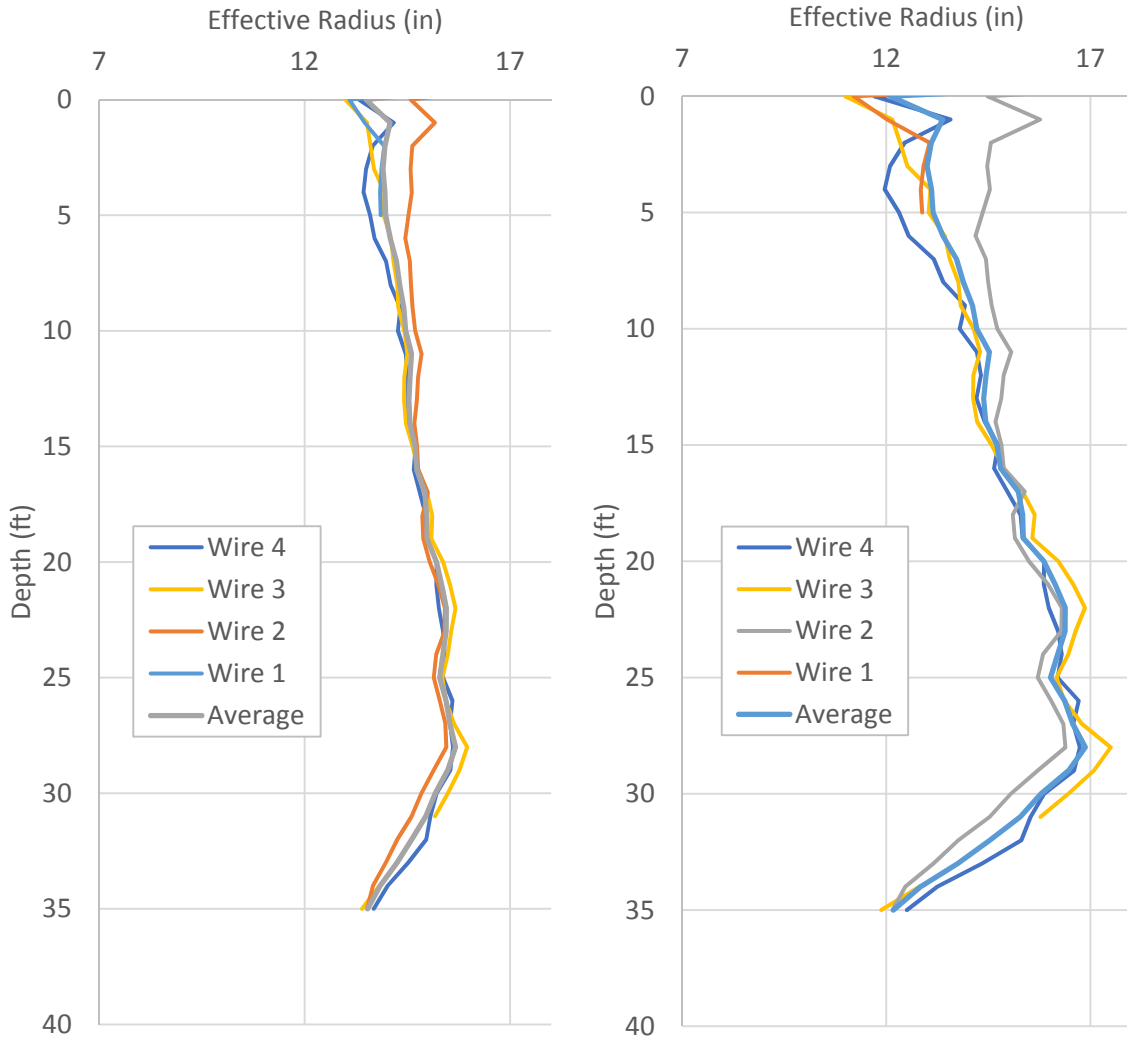
Figure B.3 Pile C2 effective radius from cage wire data using reported grout volume over given partial length, T0 method (left), Tsoil method (right).

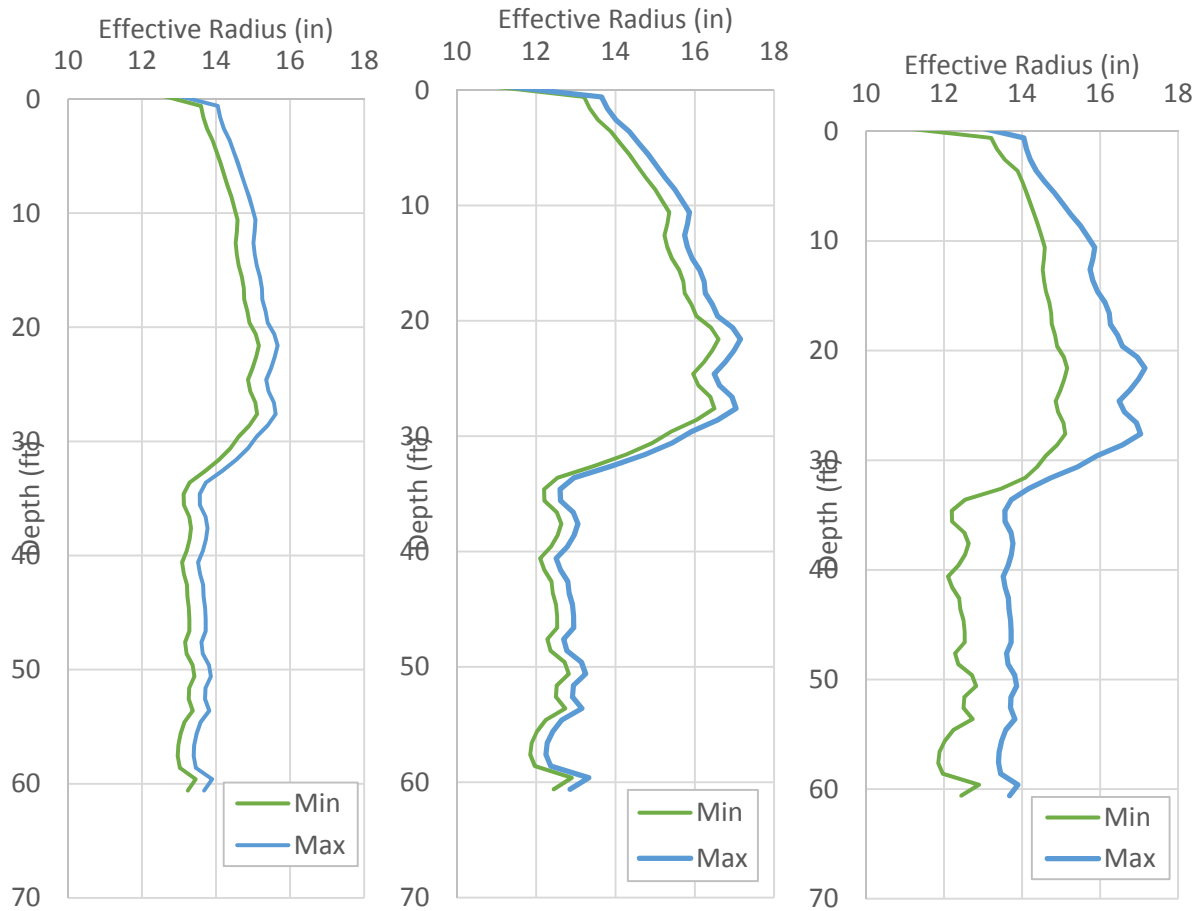
Figure B.4 Pile C2 effective radius from center bar wire data using actual reported grout volume (max) and reported volume grout less initial pump count (min) – T0 method (left), Tsoil method (center), min/max from all combinations (right).

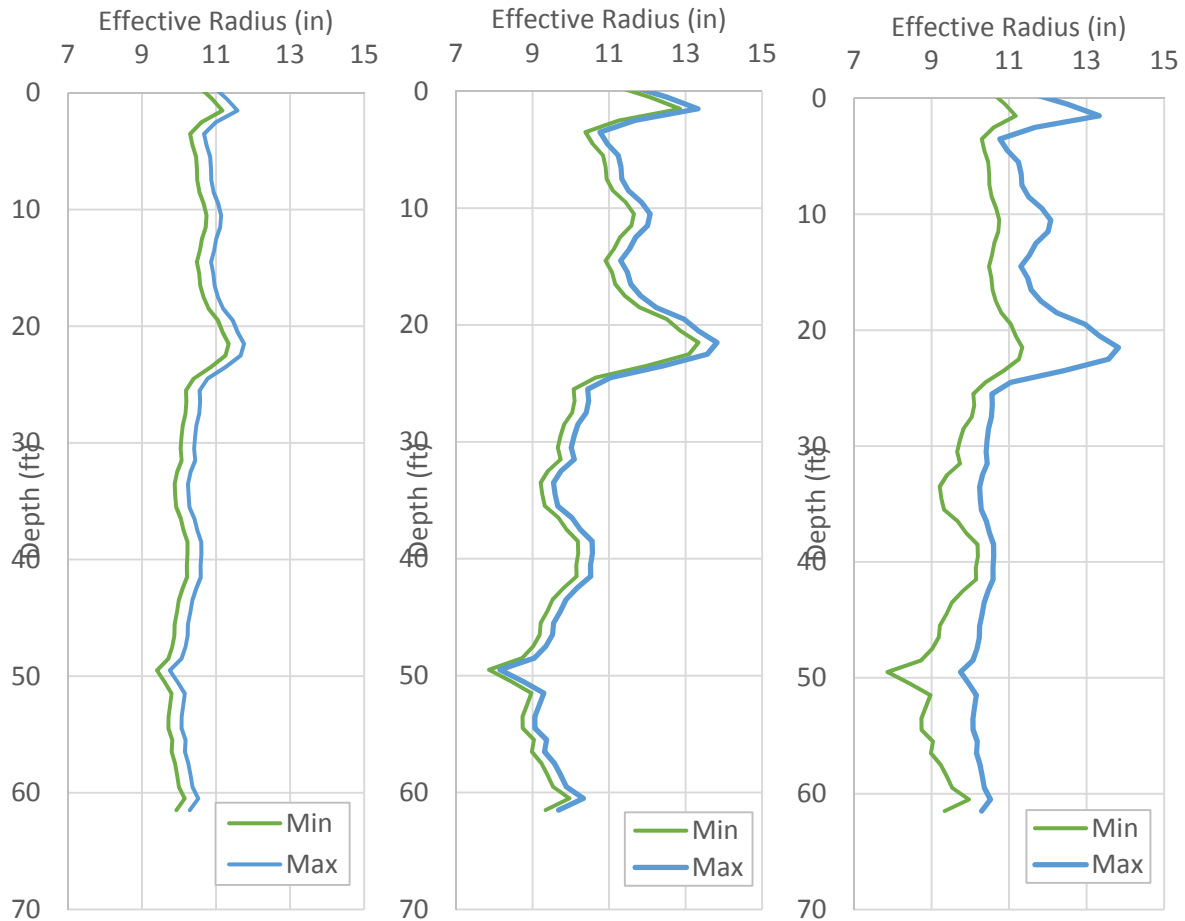
Figure B.5 Pile T1 effective radius from center bar wire data using actual reported grout volume (max) and reported volume grout less initial pump count (min) – T0 method (left), Tsoil method (center), min/max from all combinations (right).

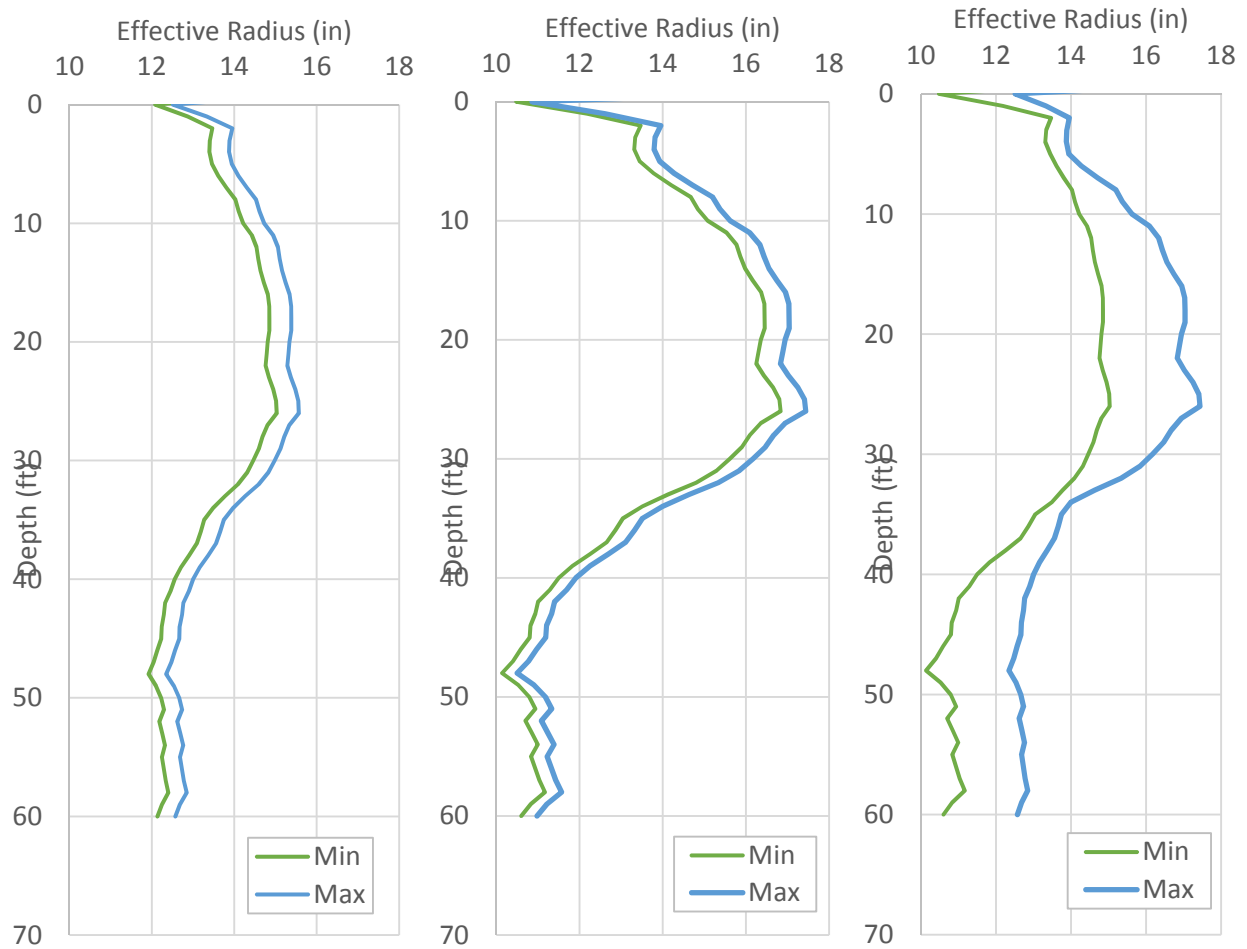
Figure B.6 Pile T2 effective radius from center bar wire data using actual reported grout volume (max) and reported volume grout less initial pump count (min) – T0 method (left), Tsoil method (center), min/max from all combinations (right).

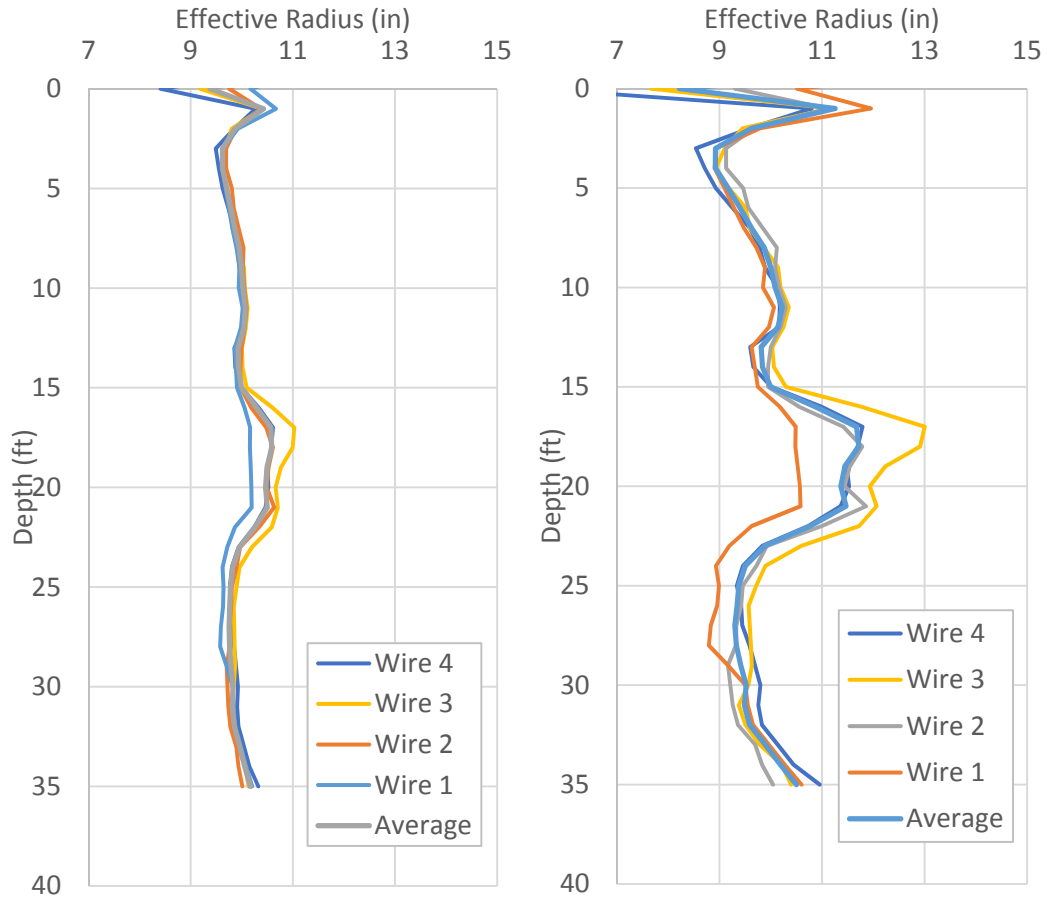
Figure B.7 Pile L1 effective radius from cage wire data using reported grout volume over given partial length, T0 method (left), Tsoil method (right).

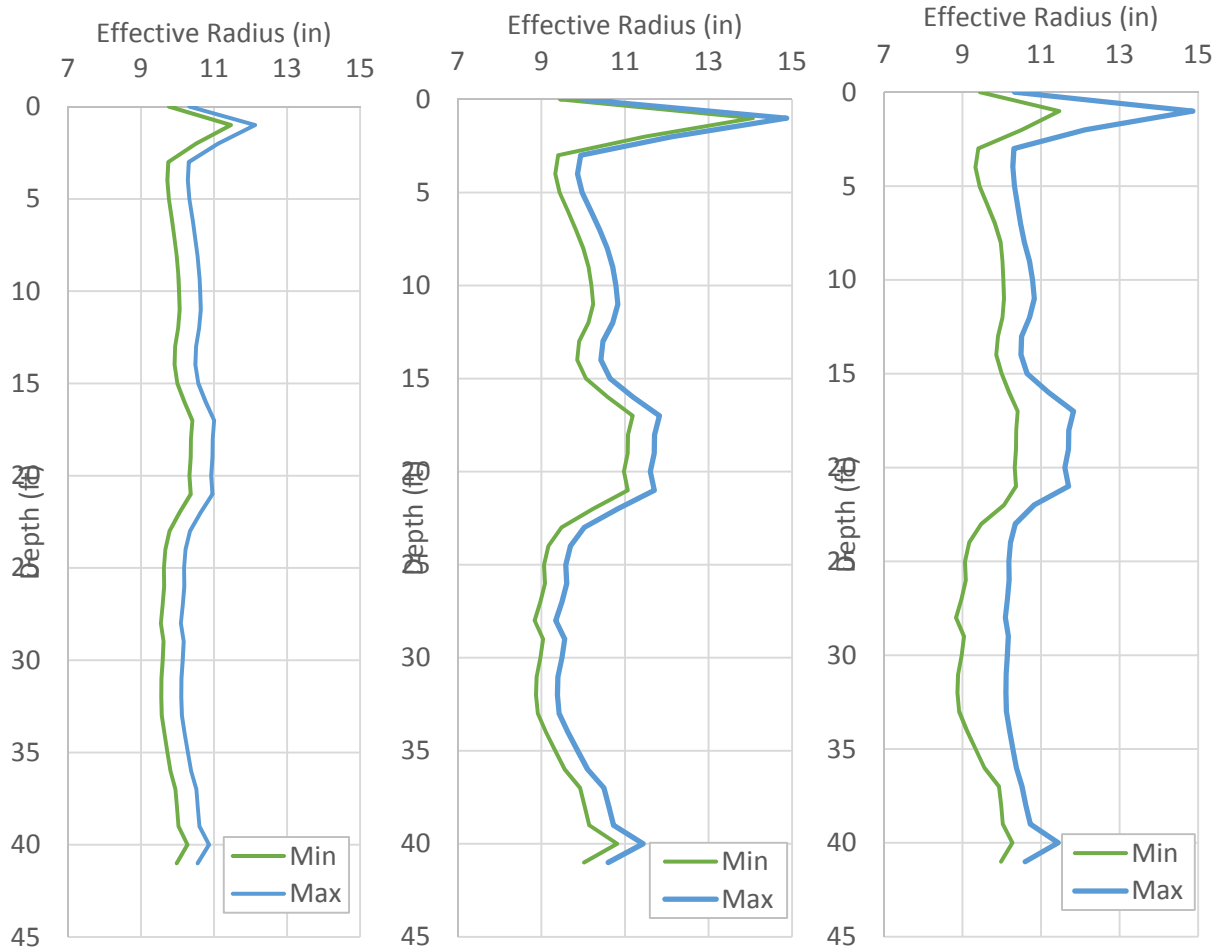
Figure B.8 Pile L1 effective radius from center bar wire data using actual reported grout volume (max) and reported volume grout less initial pump count (min) – T0 method (left), Tsoil method (center), min/max from all combinations (right).

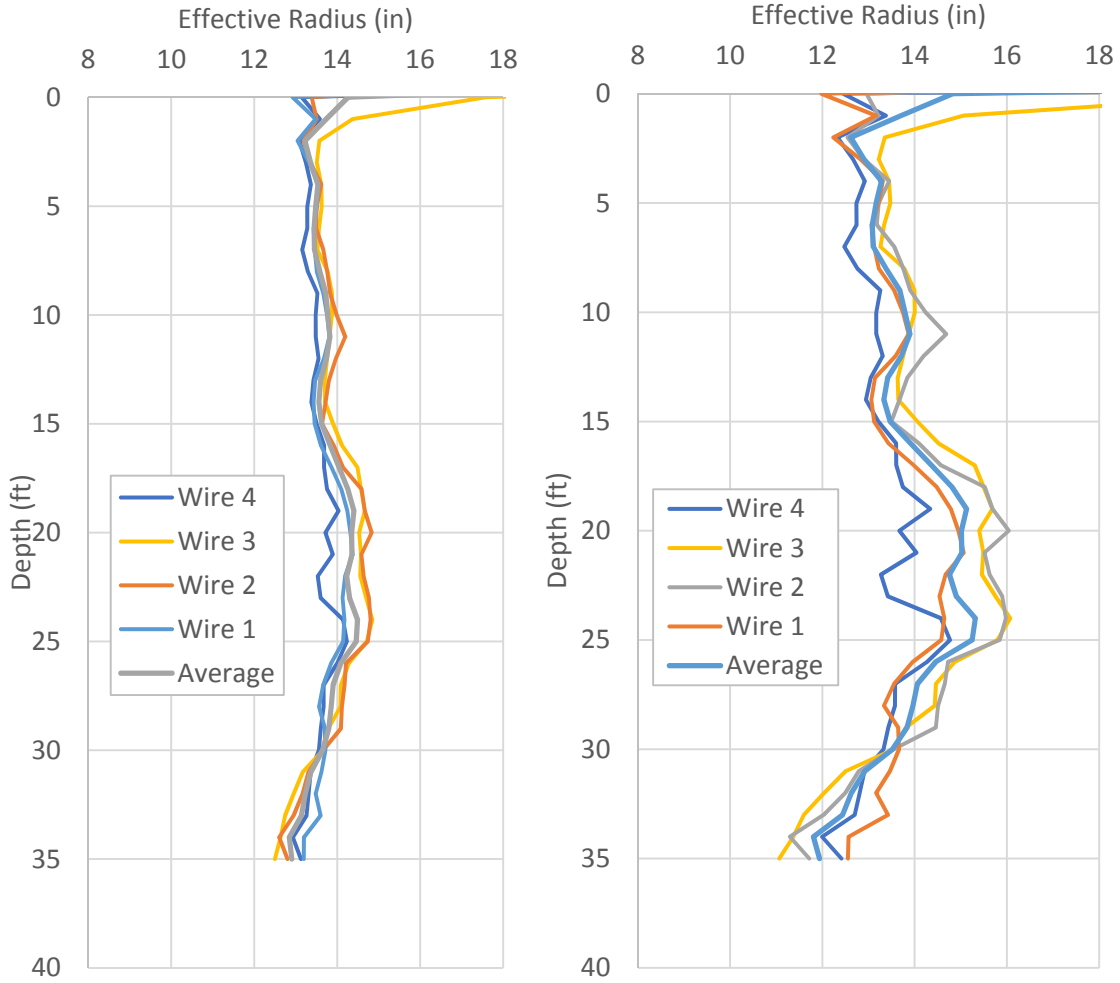
Figure B.9 Pile L2 effective radius from cage wire data using reported grout volume over given partial length, T0 method (left), Tsoil method (right).

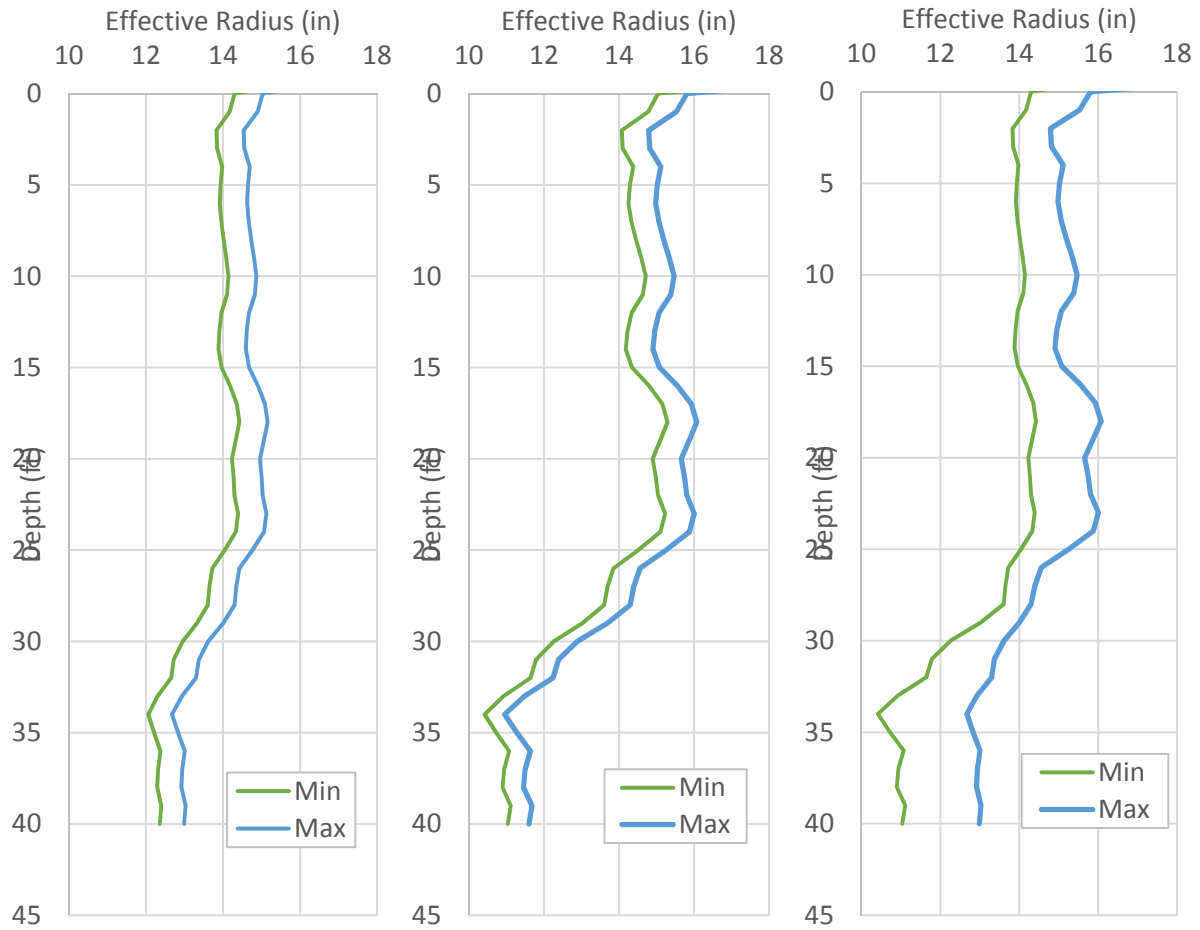
Figure B.10 Pile L2 effective radius from center bar wire data using actual reported grout volume (max) and reported volume grout less initial pump count (min) – T0 method (left), Tsoil method (center), min/max from all combinations (right).

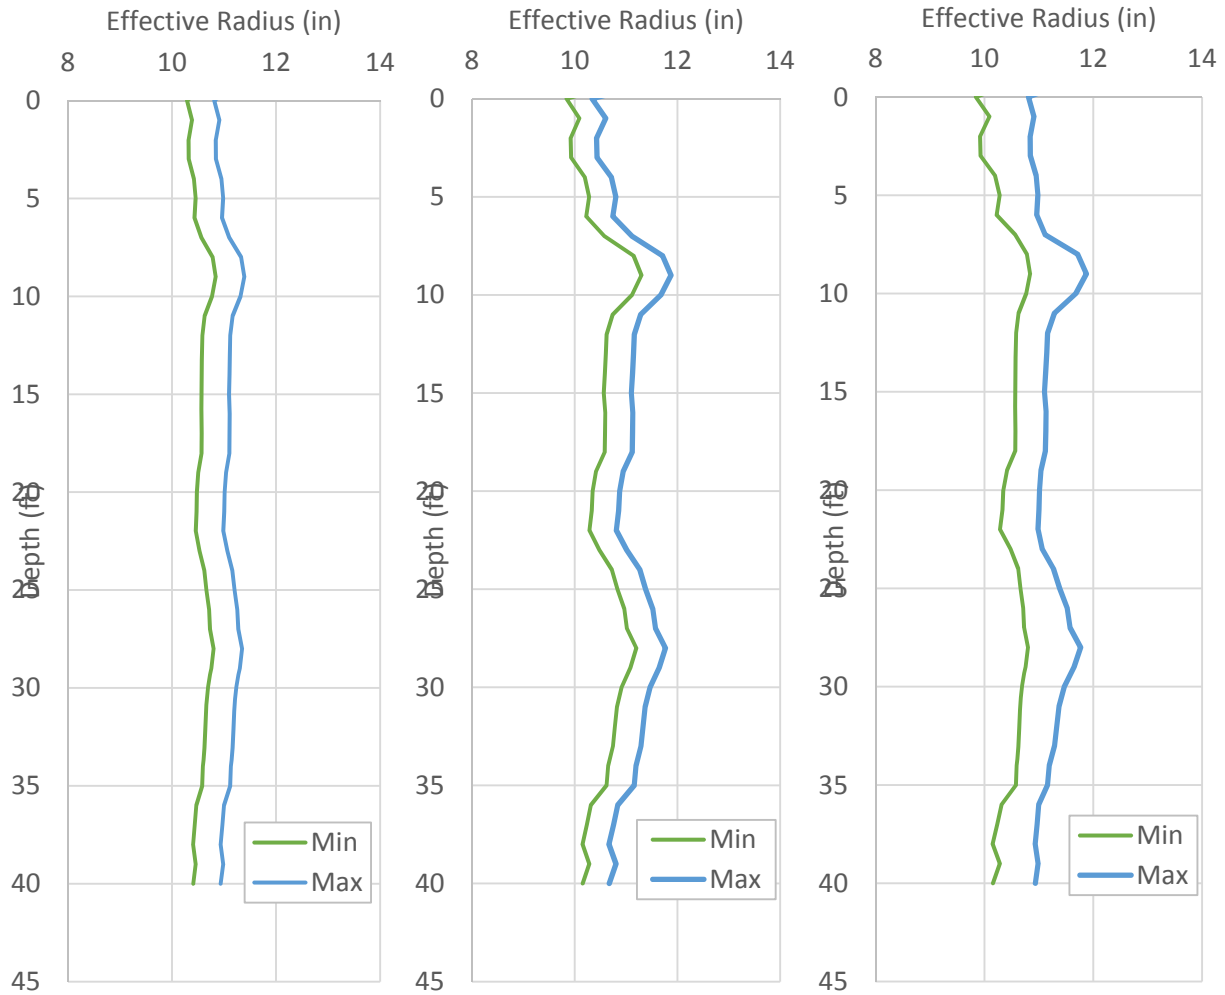
Figure B.11 Pile E1 effective radius from center bar wire data using actual reported grout volume (max) and reported volume grout less initial pump count (min) – T0 method (left), Tsoil method (center), min/max from all combinations (right).

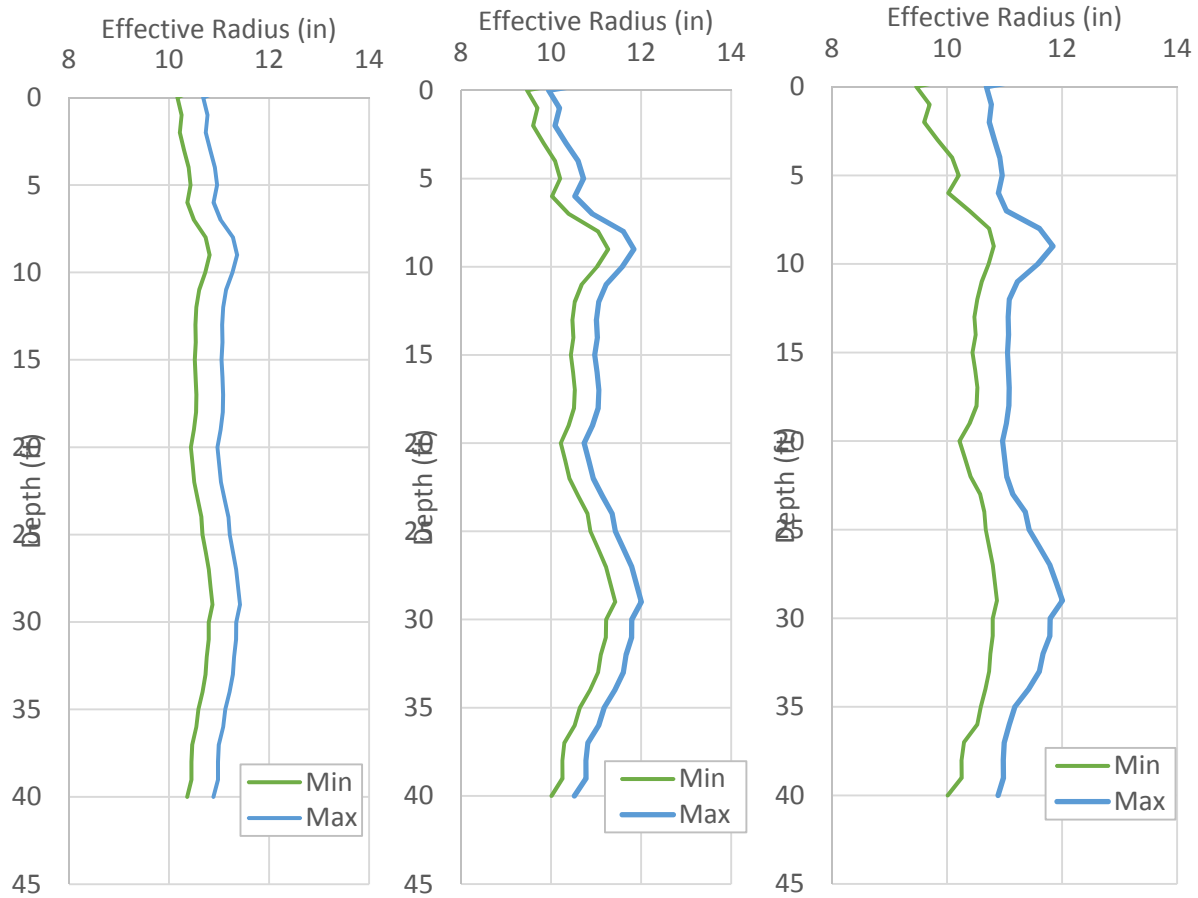
Figure B.12 Pile E1 effective radius from cage wire data using actual reported grout volume (max) and reported volume grout less initial pump count (min) – T0 method (left), Tsoil method (center), min/max from all combinations (right).

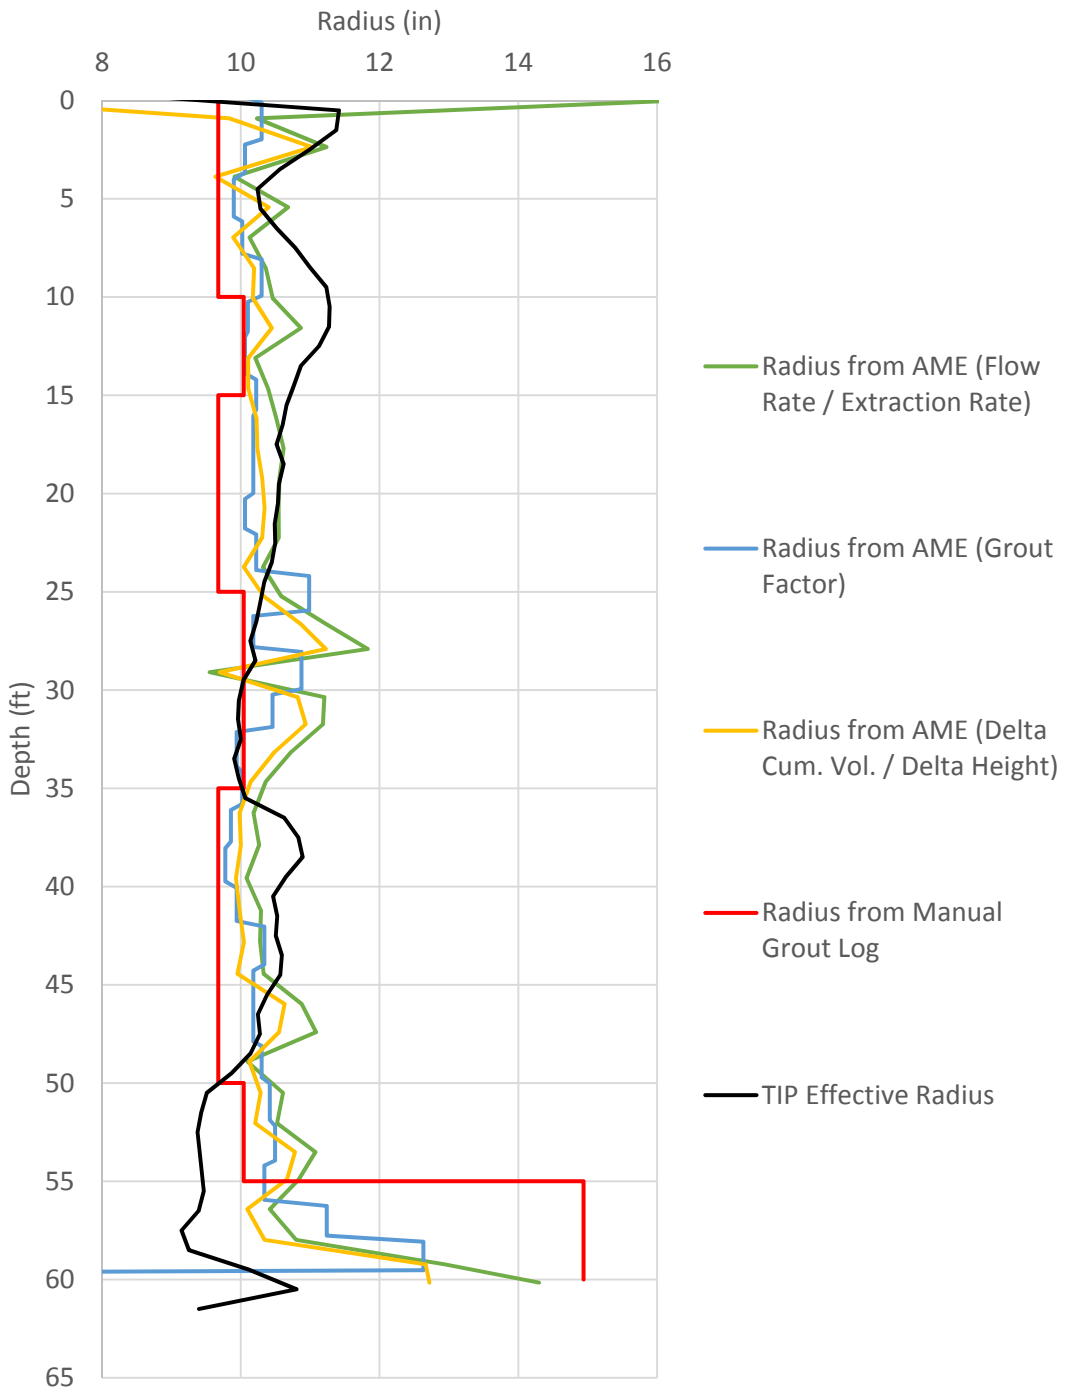
Figure F.1 Pile C1 Computed Radius from AME Data, Manual Grout Log, and TIP Data.

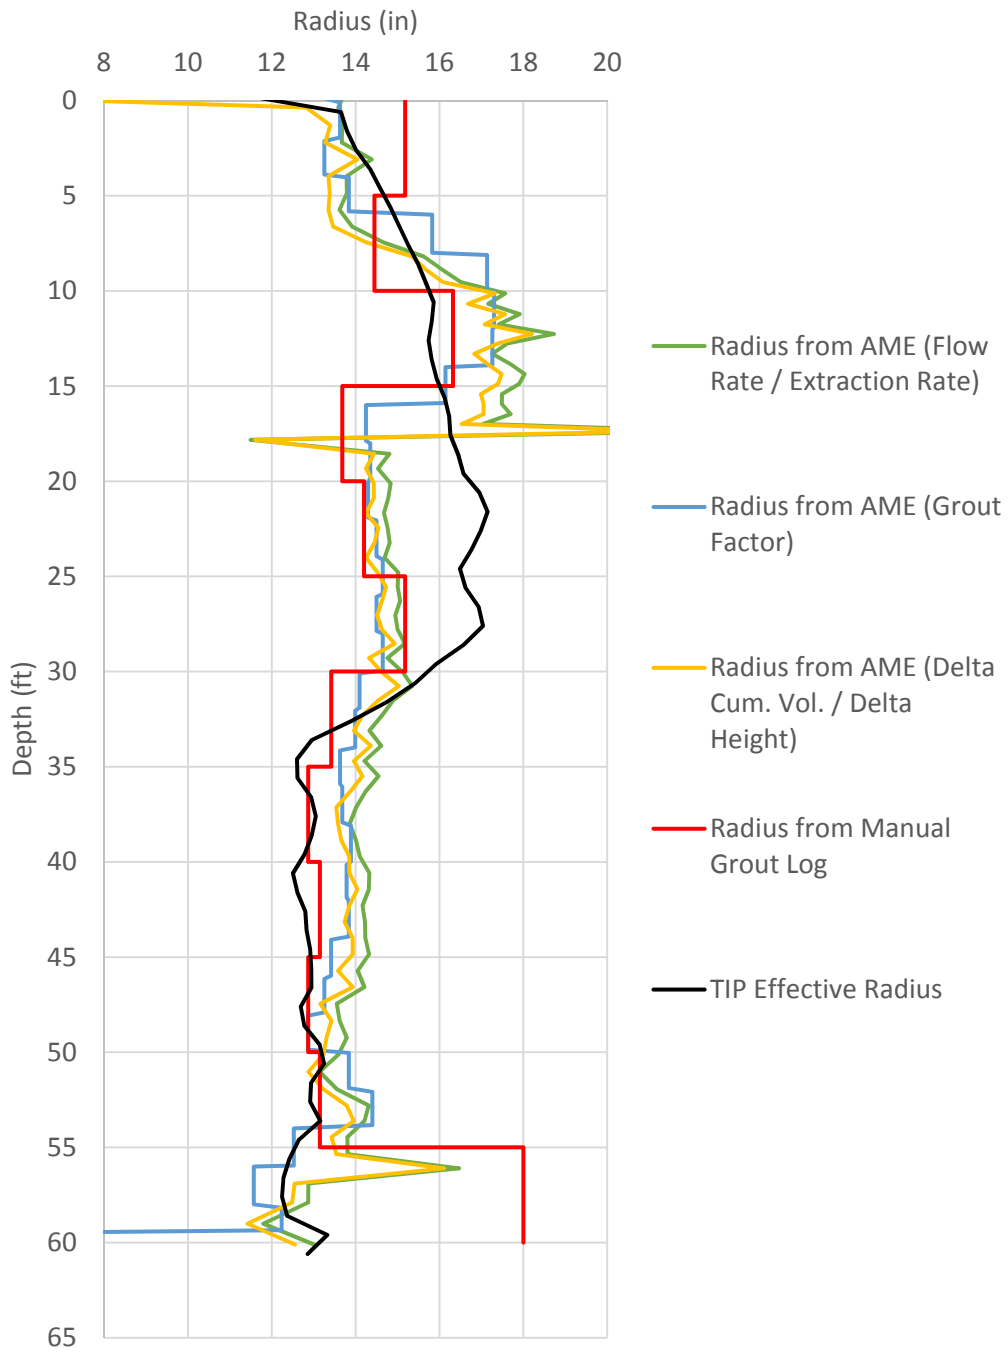
Figure F.2 Pile C2 Computed Radius from AME Data, Manual Grout Log, and TIP Data.

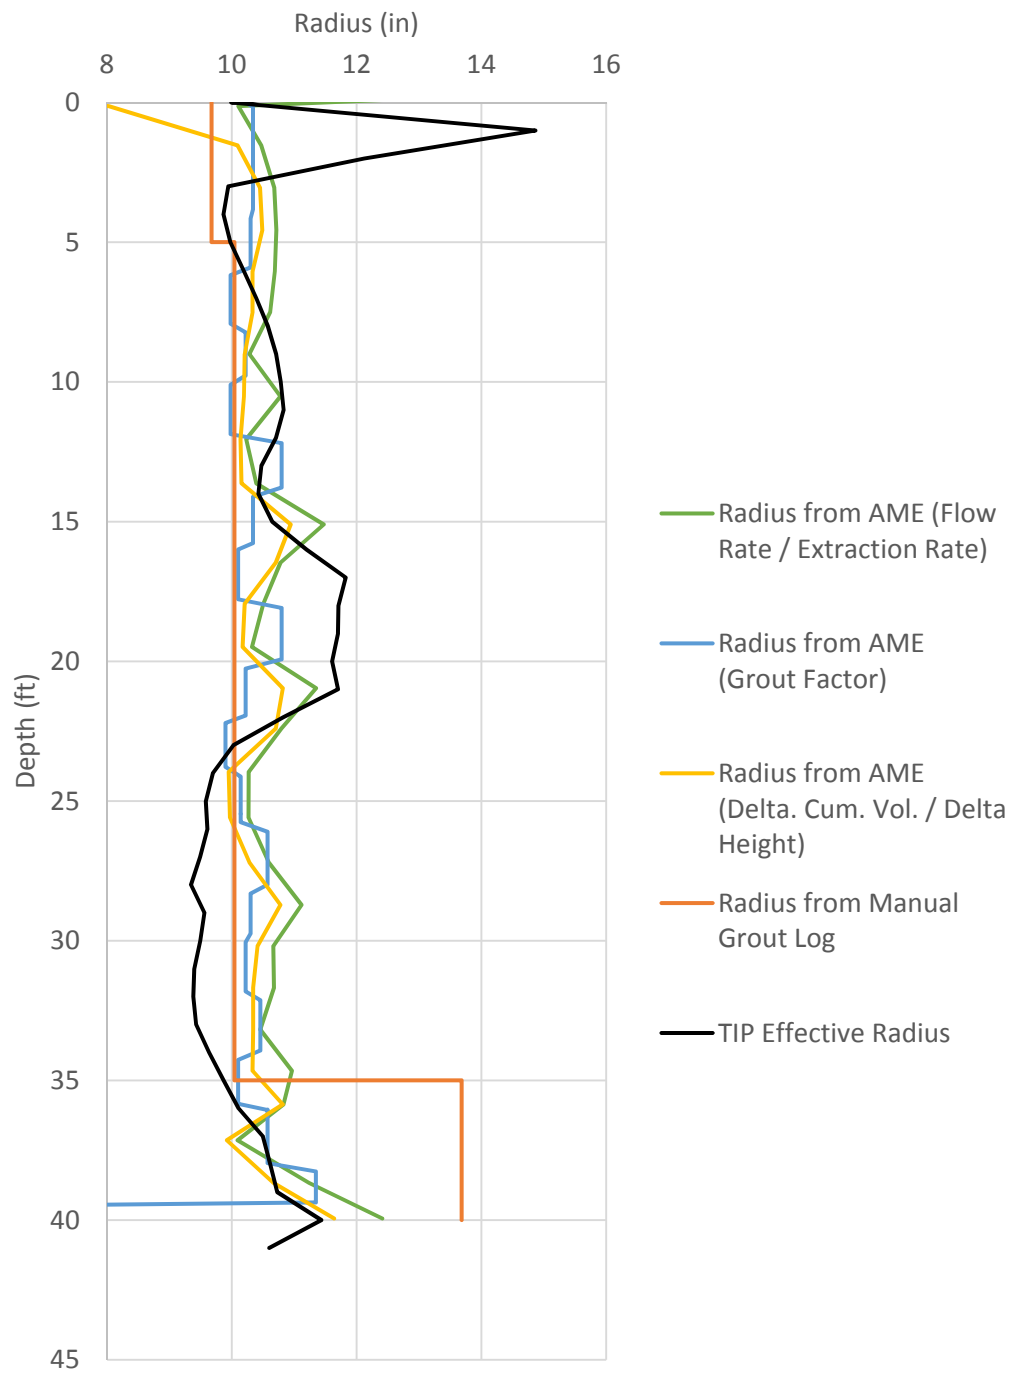
Figure F.3 Pile L1 Computed Radius from AME Data, Manual Grout Log, and TIP Data.

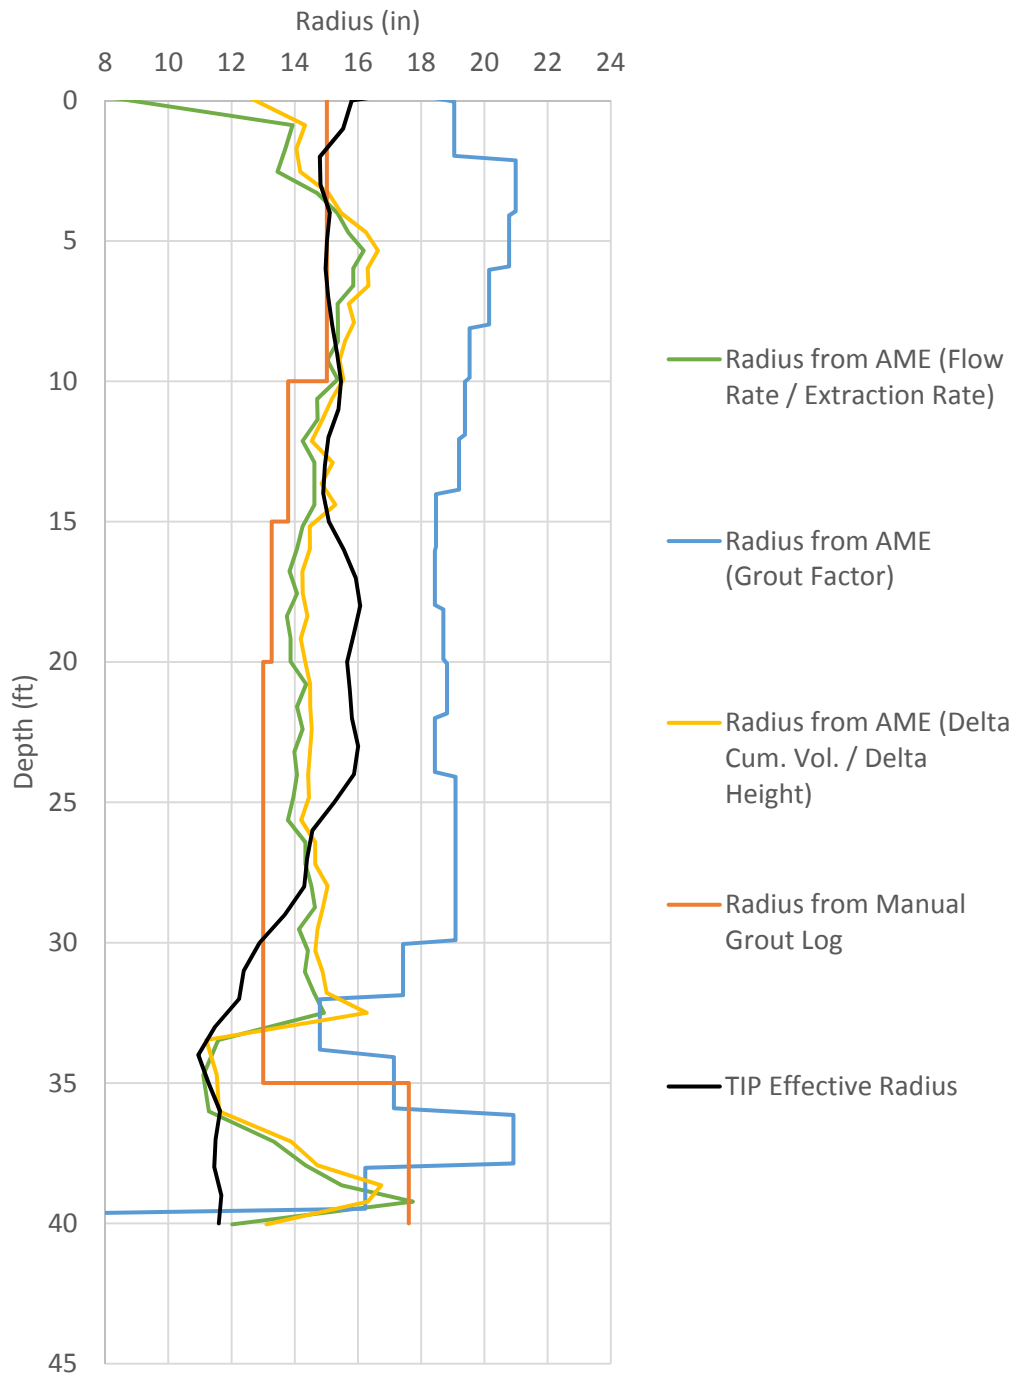
Figure F.4 Pile L2 Computed Radius from AME Data, Manual Grout Log, and TIP Data.

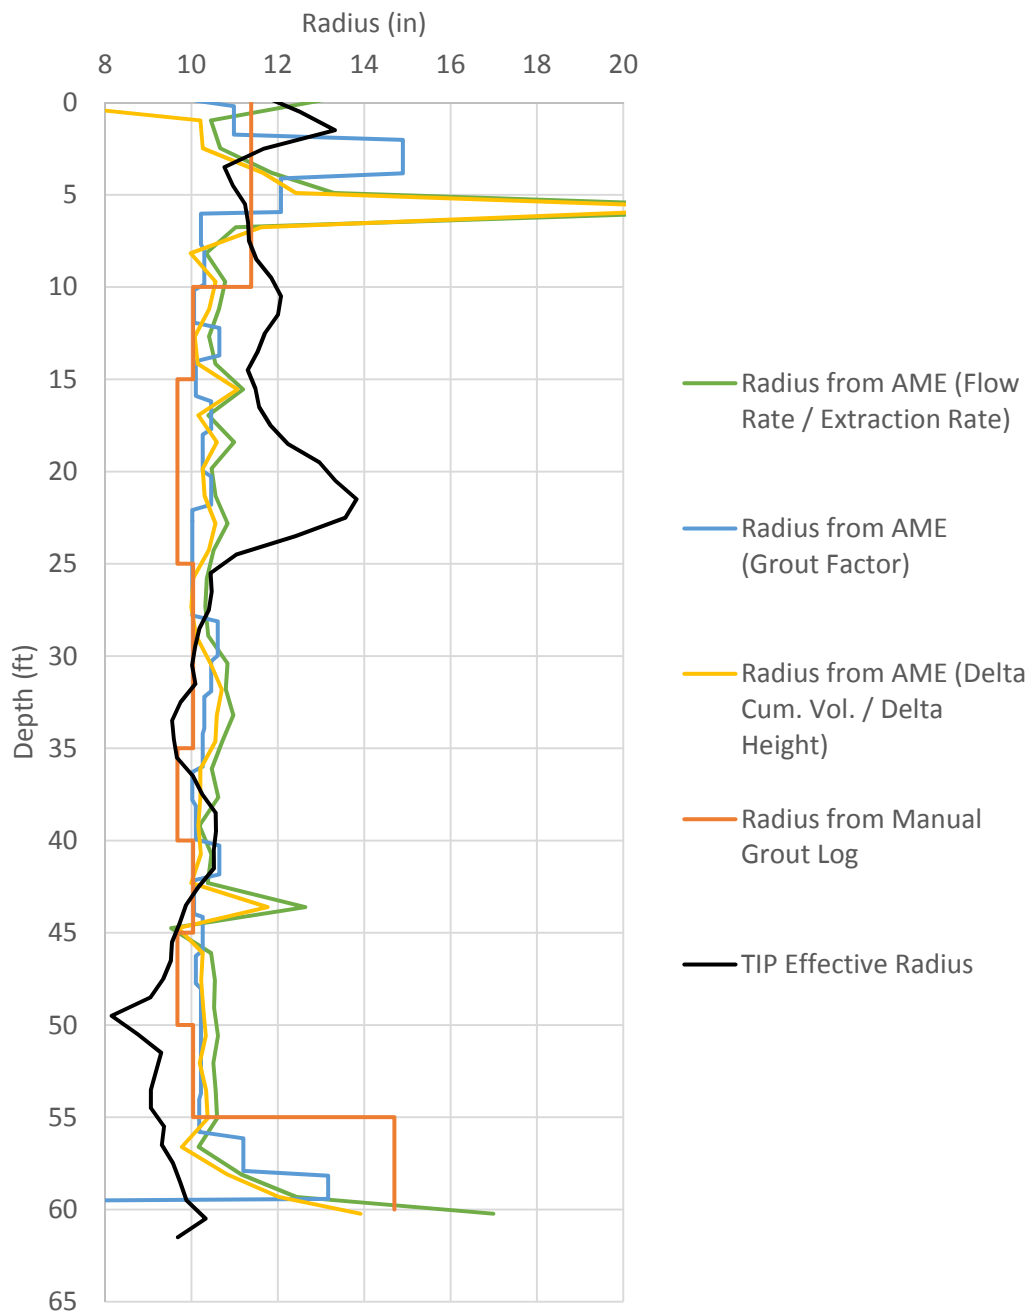
Figure F.5 Pile T1 Computed Radius from AME Data, Manual Grout Log, and TIP Data.

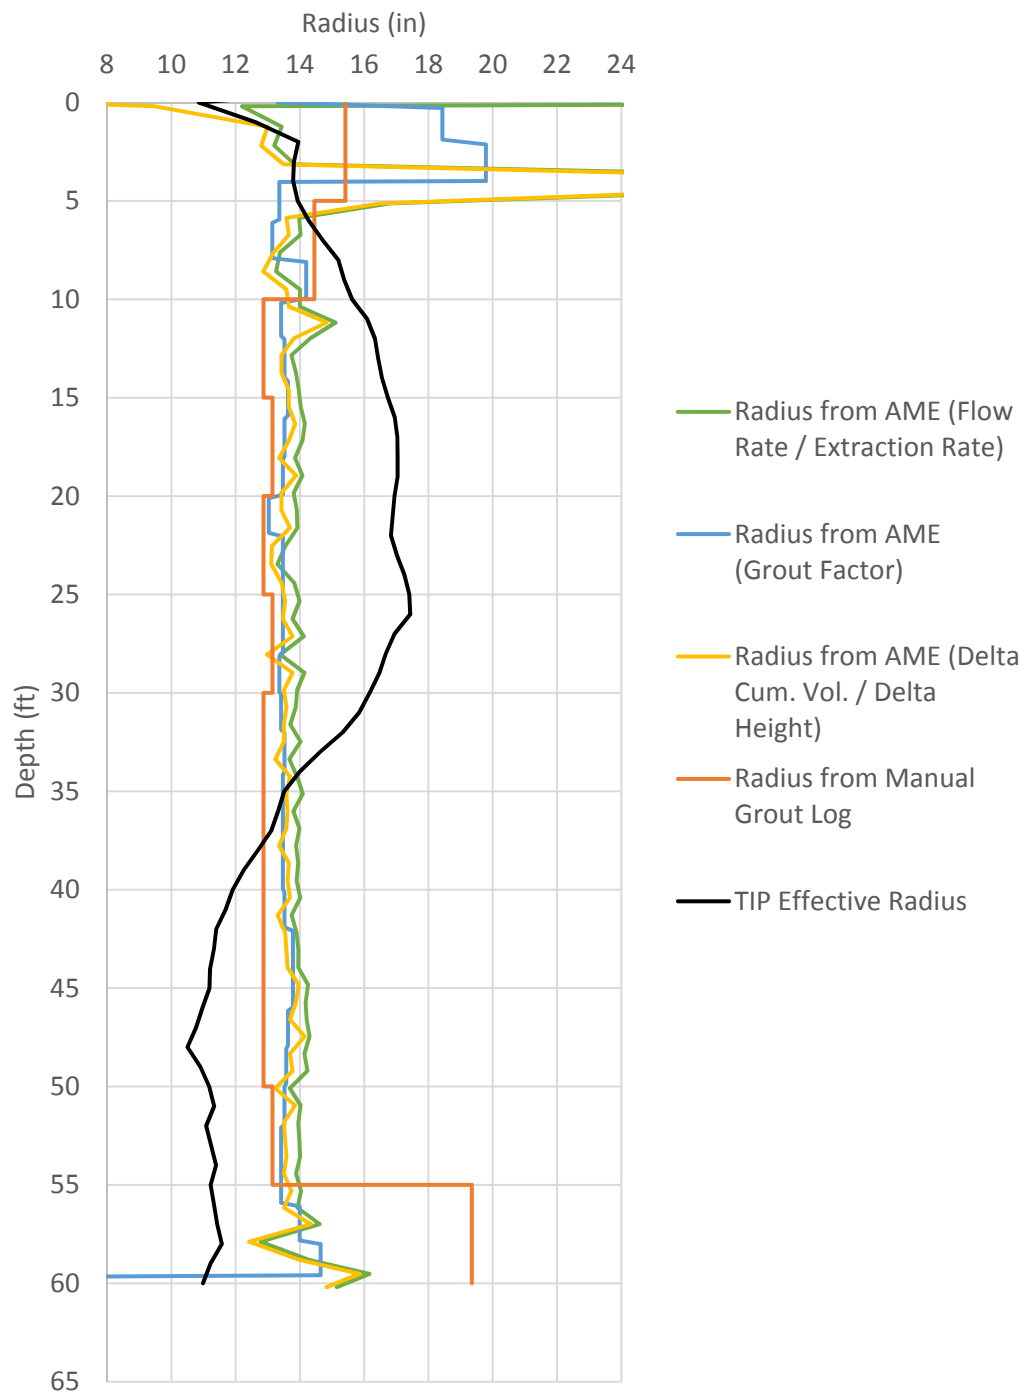
Figure F.6 Pile T2 Computed Radius from AME Data, Manual Grout Log, and TIP Data.
