**THERMAL INTEGRITY SYSTEM FOR
AUGERED CAST-IN-PLACE PILES
(PART II, IMPLEMENTATION PLAN)**

BDV25-977-34

DRAFT FINAL REPORT

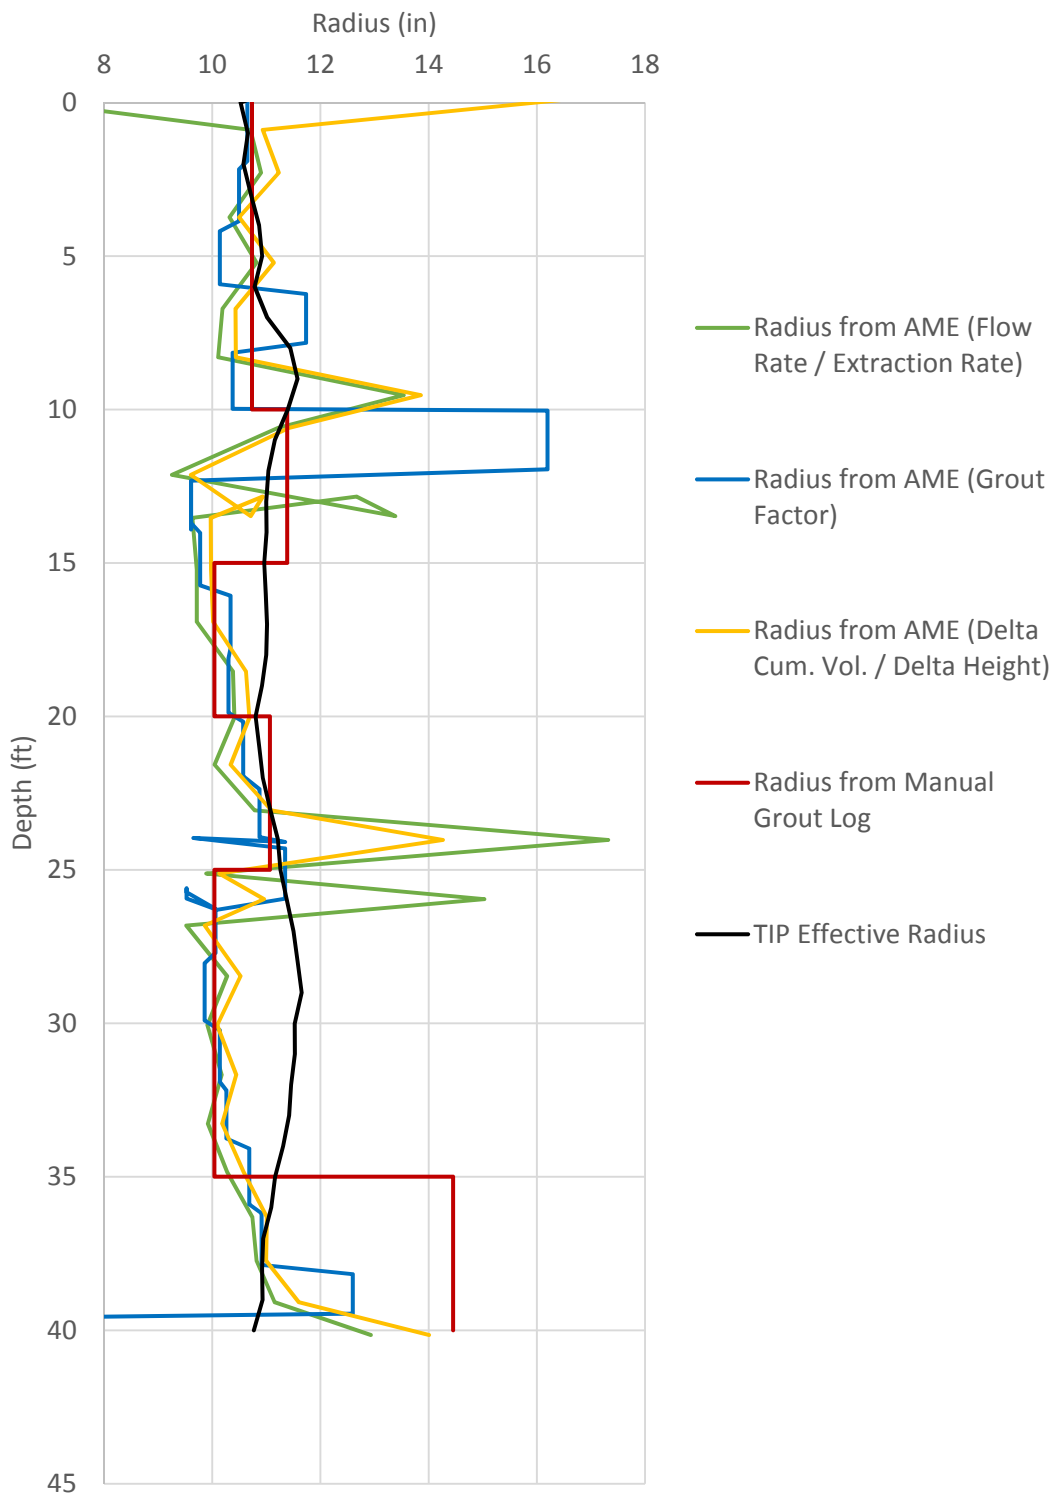
Figure F.7 Pile E1 Computed Radius from AME Data, Manual Grout Log, and TIP Data.
