**EVALUATION OF SELF CONSOLIDATING CONCRETE AND CLASS IV CONCRETE FLOW
IN DRILLED SHAFTS – PART 1**

BDV25 TWO977-25

Task 2b Deliverable – Field Exploratory Evaluation of Existing Bridges with Drilled Shaft Foundations

***Chapter Four: Field Exploratory Evaluation of Existing Bridges with Drilled Shaft Foundations
(Task 2b Deliverable)***

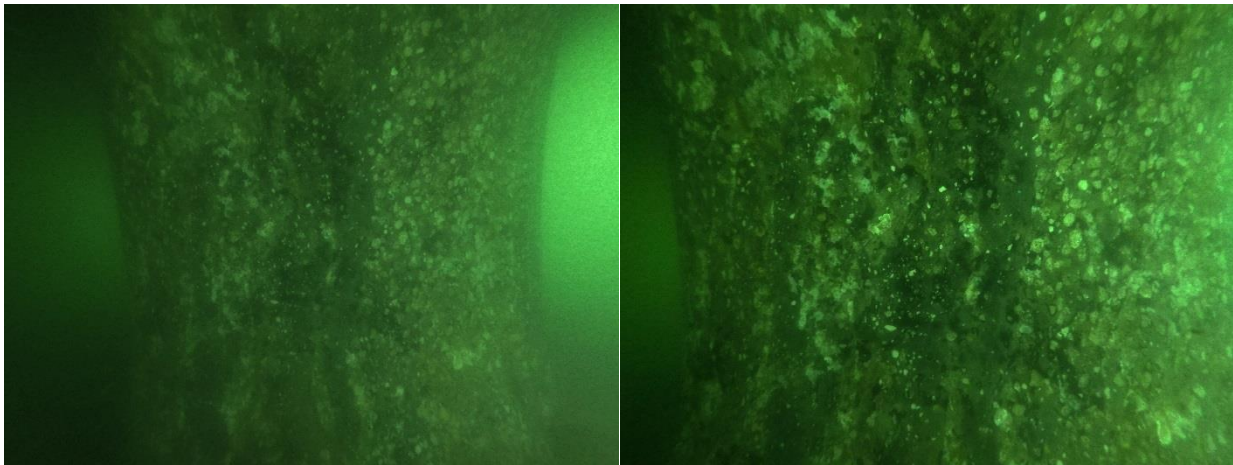
95-1 did have a void as noted, and it was noticeable even prior to cleaning (Figure 4.20). This void was substantial; Figure 4.21 shows the void before cleaning, which involved scraping barnacles, grinding and/or wire-brushing. A screwdriver was used for reference of void depth, which was about 2-3 in. (Figure 4.22). However, on the south (interior) side of the same shaft, the concrete was smooth (Figure 4.24). Figure 4.24 does demonstrate a crease, however this was noted to be from casing removal as it was a singular occurrence. The north and south sides of the shaft can be seen in Figure 4.23 and 4.24 respectively. It should be noted that the sides of shafts appear to be concave; however, this is only from lens distortion.

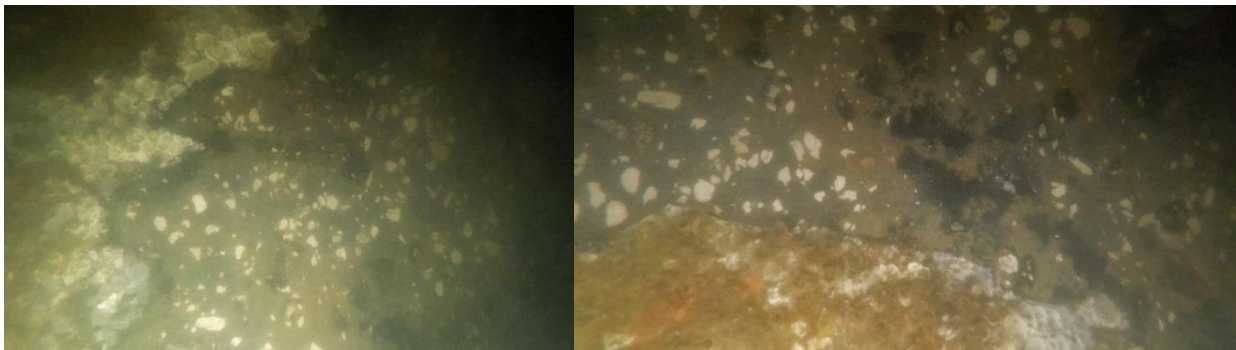
Figure 4.26 Shaft 95-3 sections post-cleaning

95-3 was cleaned for comparison as a shaft with no observed problems. Figure 4.25 shows 95-3 prior to cleaning. Due to the lack of water clarity on the day of inspection it was difficult to take a picture of the entire shaft, so sections are presented instead of an overall image. Figure 4.26 demonstrates a cleaned portion of the shaft. This shaft did not have any noticeable voids like 95-1. As seen from the cleaned portions the concrete surface was smooth.

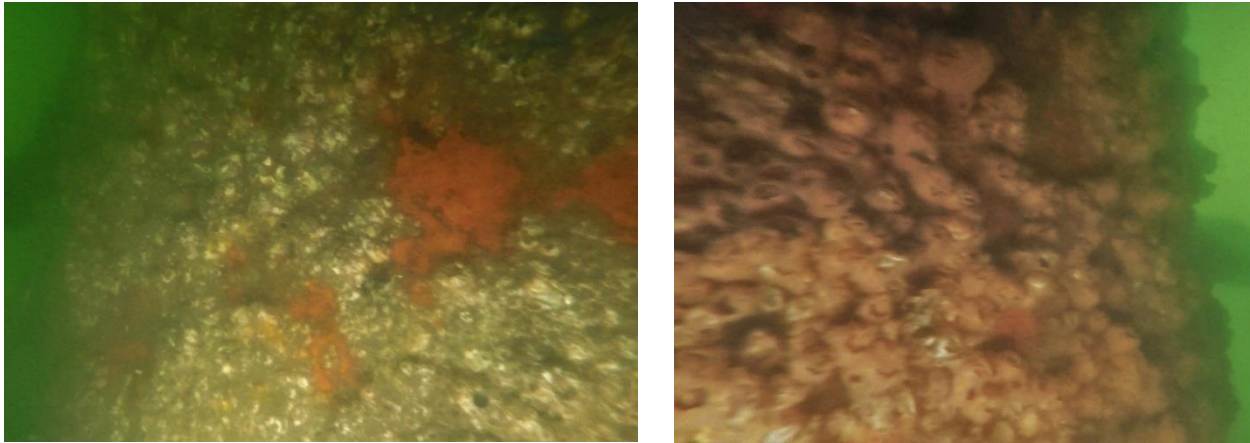
Figure 4.27 Shaft 94-4 pre-cleaning

Shaft 4 from Pier 94 was chosen for cleaning to demonstrate what a steel casing looks like versus the concrete. It can be difficult to tell if the shaft has a casing or not because of the thick layer of barnacles surrounding the shaft. Pier 94 was not mentioned in the diver report, and thus it was thought to be a good candidate to have a casing. Figure 4.27 shows 94-4 prior to cleaning and Figure 4.28 shows 94-4 during cleaning. In Figure 4.29 the steel from the casing is visible. As seen from Figure 4.29, there is a black layer underneath the encrustation and on top of the steel casing.

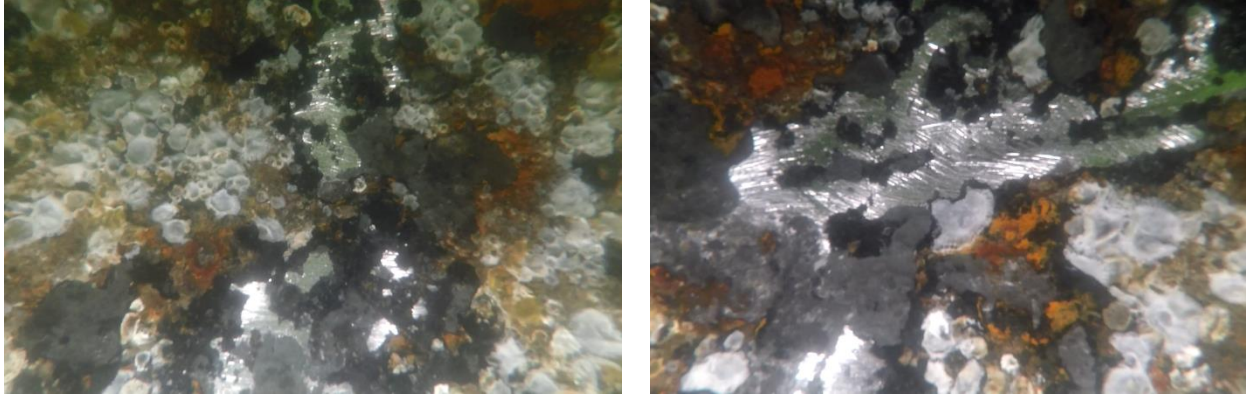
Figure 4.29 Shaft 94-4 after cleaning showing steel casing

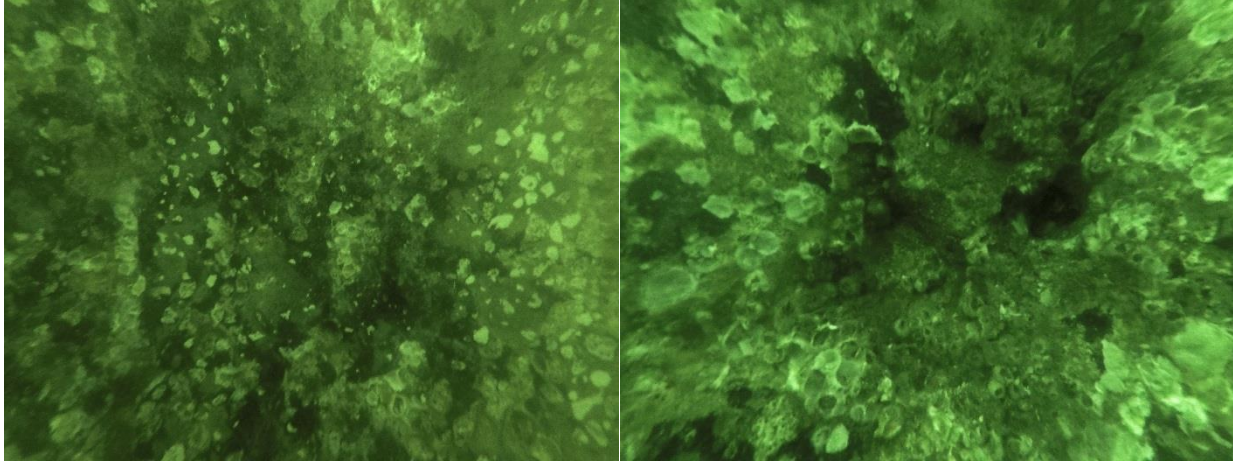
Figure 4.40 Cleaned concrete on 71-4, close pictures

Pier 71 contains 7-ft diameter Type 1 shafts (Figure 4.19(d)). Two shafts 71-1 and 71-4 were listed as having voids in the dive report, and shaft 71-4 was chosen for inspection. Unfortunately, no images of the shaft were taken before cleaning; however, it looked similar to the shafts shown above, covered in a layer of barnacles. Figure 4.38 shows each side of the cleaned portion of the shaft. As noted for Piers 84 and 85, the 7-ft shafts also had small voids in the cleaned concrete surface (Figure 4.39). Sections of cleaned concrete can be seen up-close in Figure 4.40; note that this concrete was the roughest seen on this bridge. Figure 4.41 shows a long crevice in 71-4.

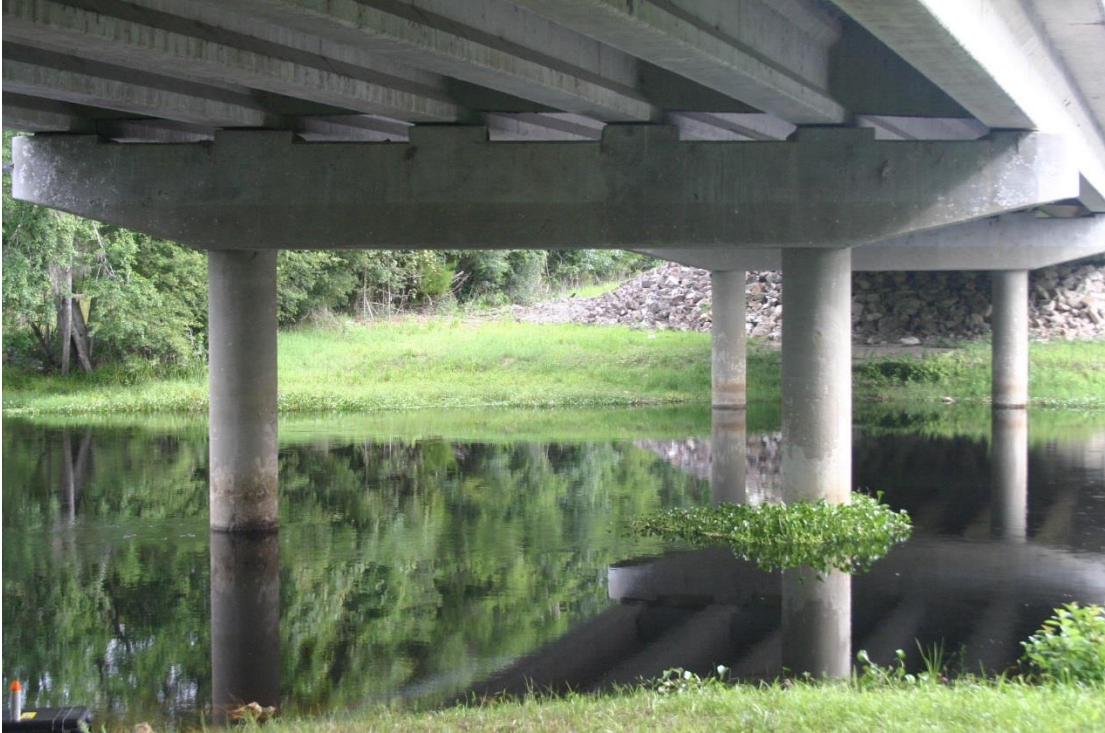
The Santa Fe River Bridge has three intermediate piers (Figure 4.43), each on two 5-ft shafts (Figure 4.42). Two piers were in the river at the time of the on-site review (Figure 4.44). The shafts for this bridge were cast using bentonite slurry, making this bridge a good candidate for the study. According to the plans, shafts for this bridge terminate very close to the mudline and are mono-shaft column structures. However, considering river bottom depth changes after looking at the inspection report, it was decided that this bridge yielded potential for investigation. The piers were investigated first by ROV (Figure 4.45), then by divers (Figure 4.46). While it was expected that only the very top of the shaft would

potentially be available, on-site inspection revealed depth changes due to scouring were not enough to expose the shafts. All four shaft/columns were investigated and only the smaller diameter 3-ft columns could be seen (Figure 4.47).

Figure 4.44 Four water column-to-shaft structures.

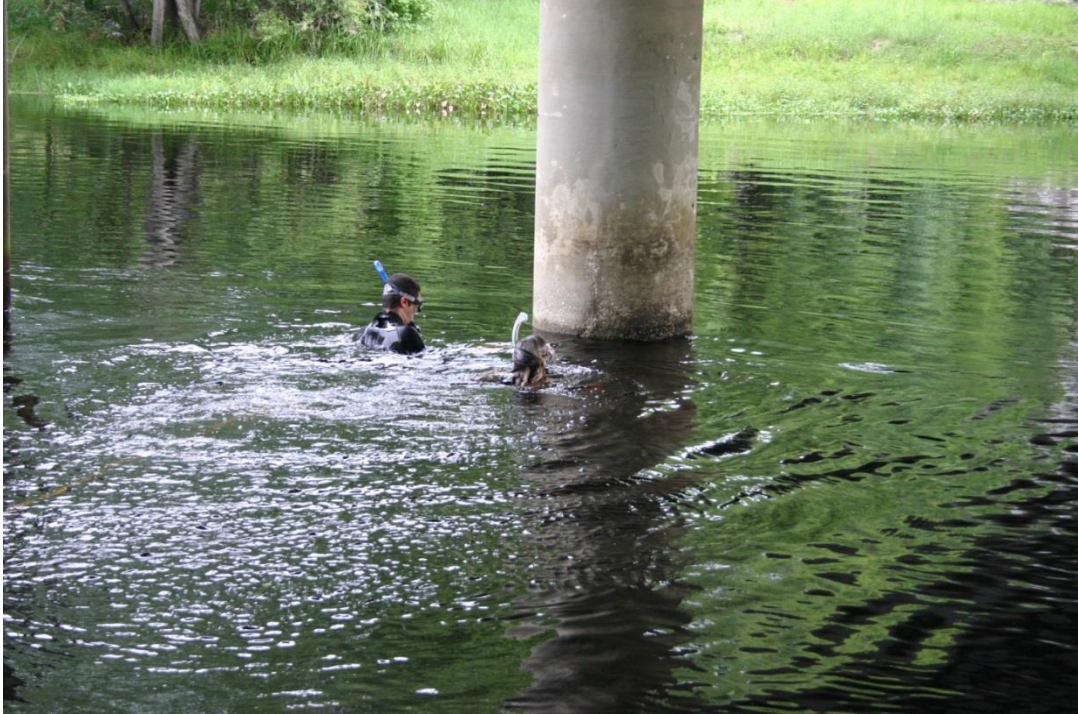
Figure 4.46 Diver follow-up to further review column-to-shaft interface.

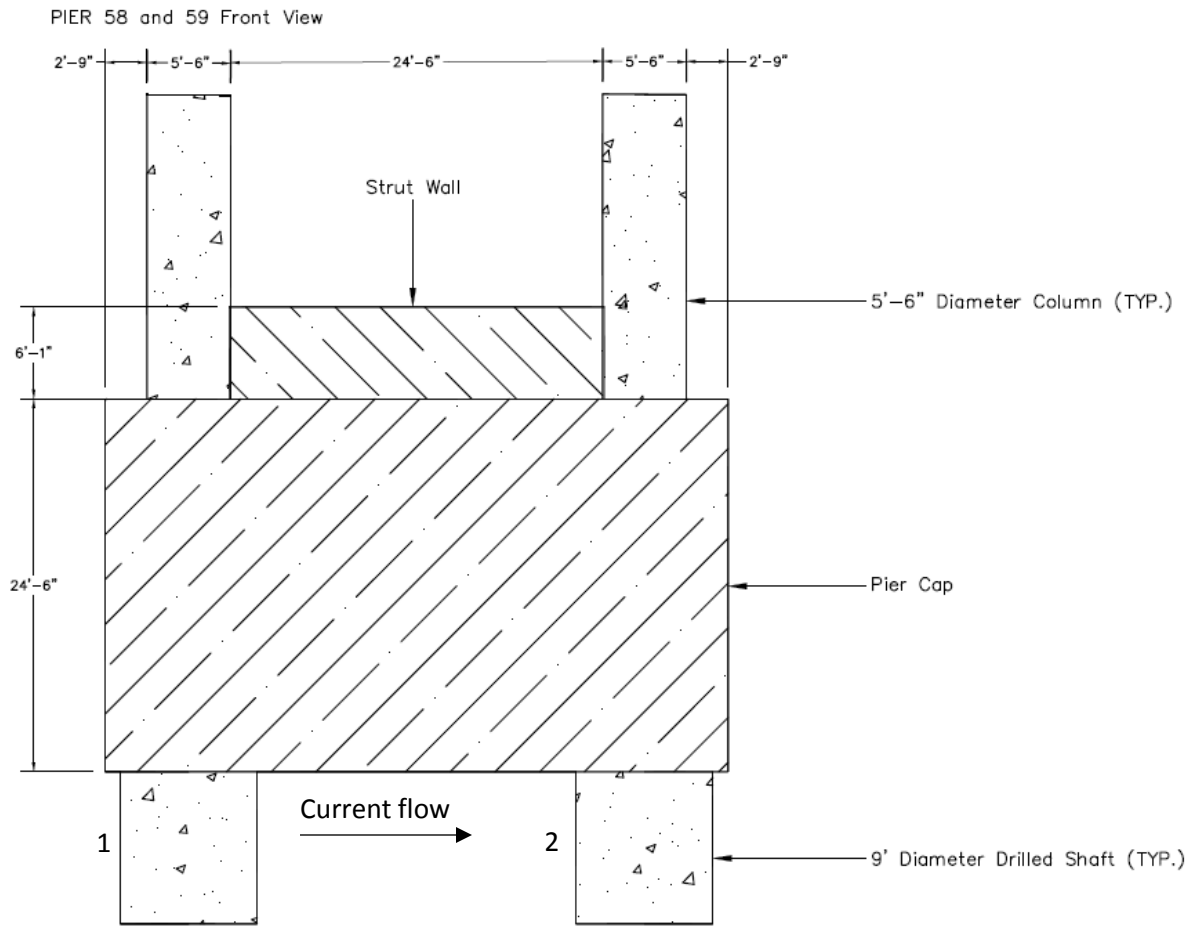
Figure 4.50 Elevation (front) view of Piers 58 and 59 looking east, river flow is to the right.

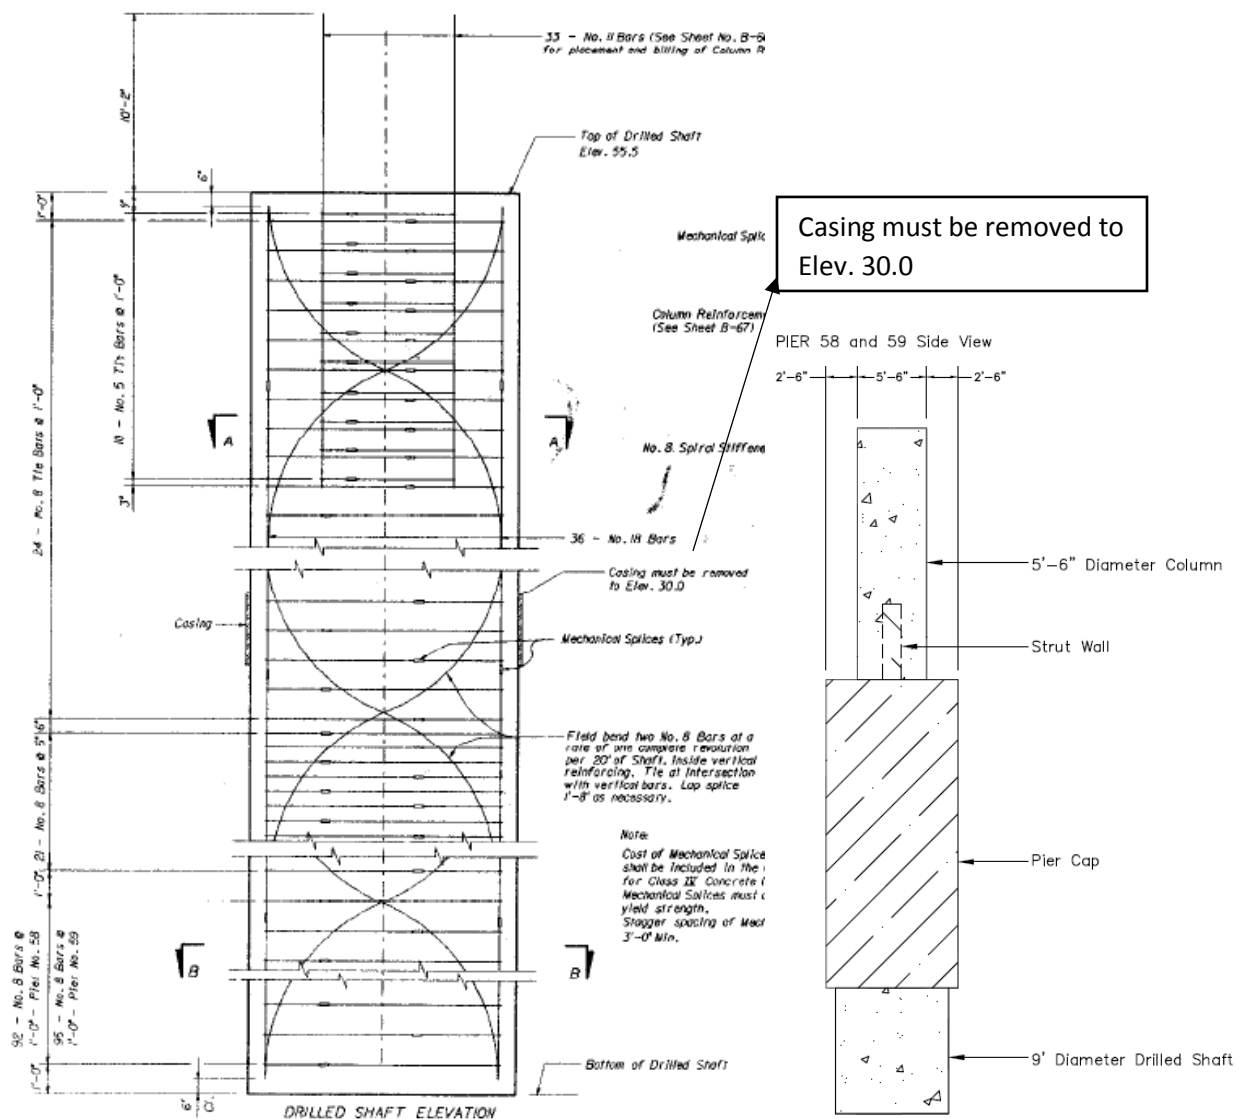
Figure 4.52 Section view of Piers 58 and 59.

While it was expected that there would be exposed shaft, after inspection it was realized that the only portion exposed was from what looked like a missing seal slab (Figure 4.53). Rubble on the bottom or river was likely to be remnants of the seal slab, and a steel collar was seen around shaft 2. Nevertheless, approximately 16-18 inches of uncased shaft was visible. Figure 4.54 is a picture of what the exposed portion of shaft looked like prior to cleaning shaft 58-1 (note shafts were labeled 1 and 2 based on river flow seen in Figure 4.50). Figure 4.55 shows the 58-1 shaft after cleaning. Figure 4.55 also shows four positions labeled 1-4 corresponding to close-up images taken at those locations. The water clarity was poor and made overview images unhelpful. In all four images of Figure 4.55, vertical or horizontal creases were found; image (2) shows both vertical and horizontal creases (camera slightly tilted) along with a white patching compound in the center of the squares that was not concrete.

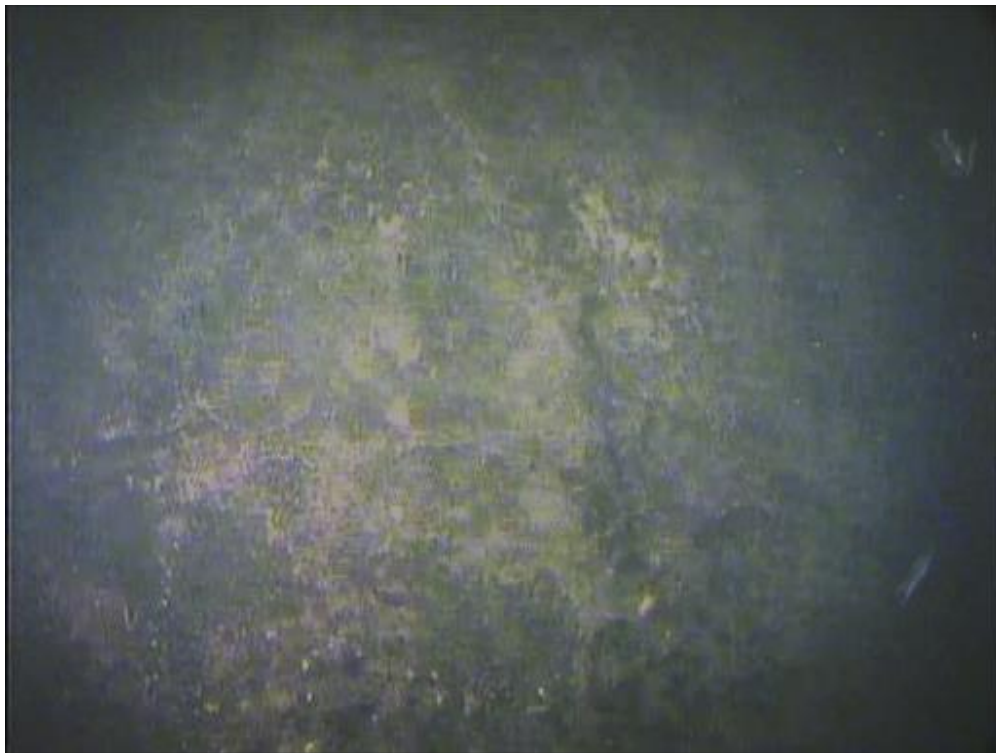
Figure 4.54 Shaft 58-1 prior to cleaning

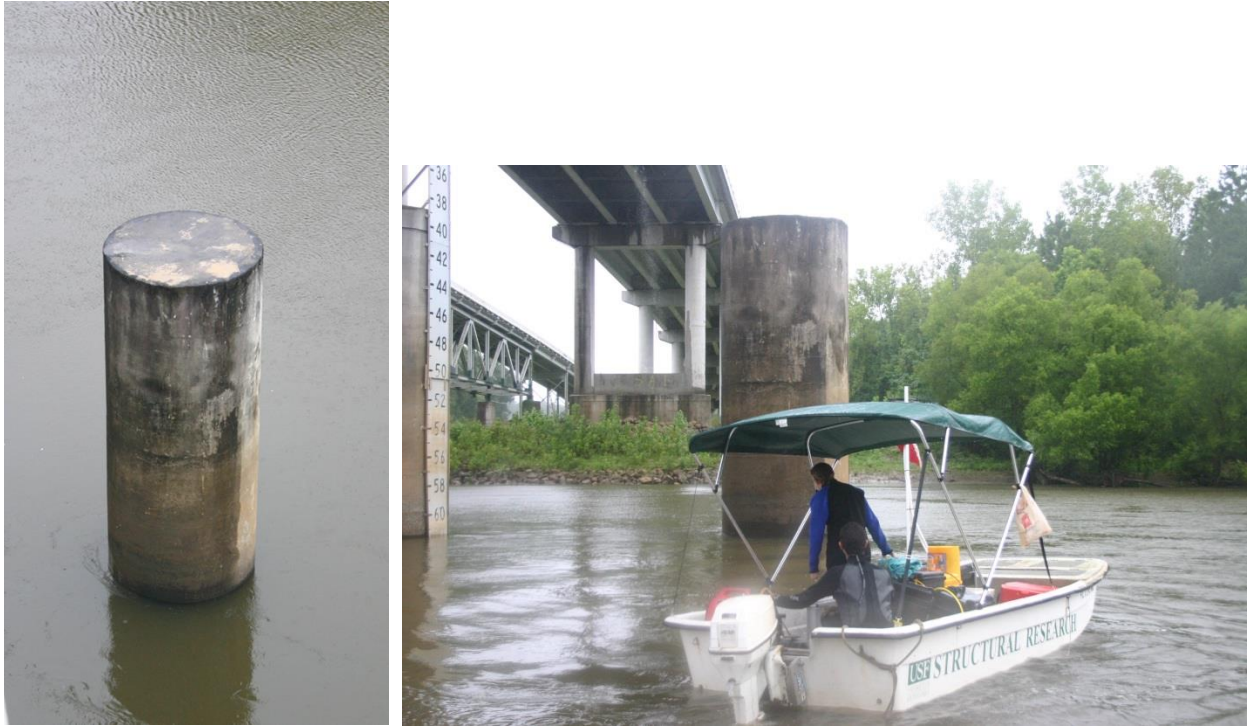
Adjacent Pier 59, test shaft 8 (Figure 4.56) was also inspected. This is a 9-ft diameter out-of-position shaft south of pier 59 near the main channel. By visual inspection there was some light creasing along the vertical reinforcement (Figure 4.57). Figure 4.58 shows test shaft 8 before cleaning; Figure 4.59 shows after cleaning. Again, the creasing is light but it can be seen. Being a test shaft, construction sequencing is often not exactly the same as production shafts. This shaft had additional longitudinal instrumentation, which compounds concrete flow problems.

Figure 4.56 Test Pile adjacent (west) of Pier 59

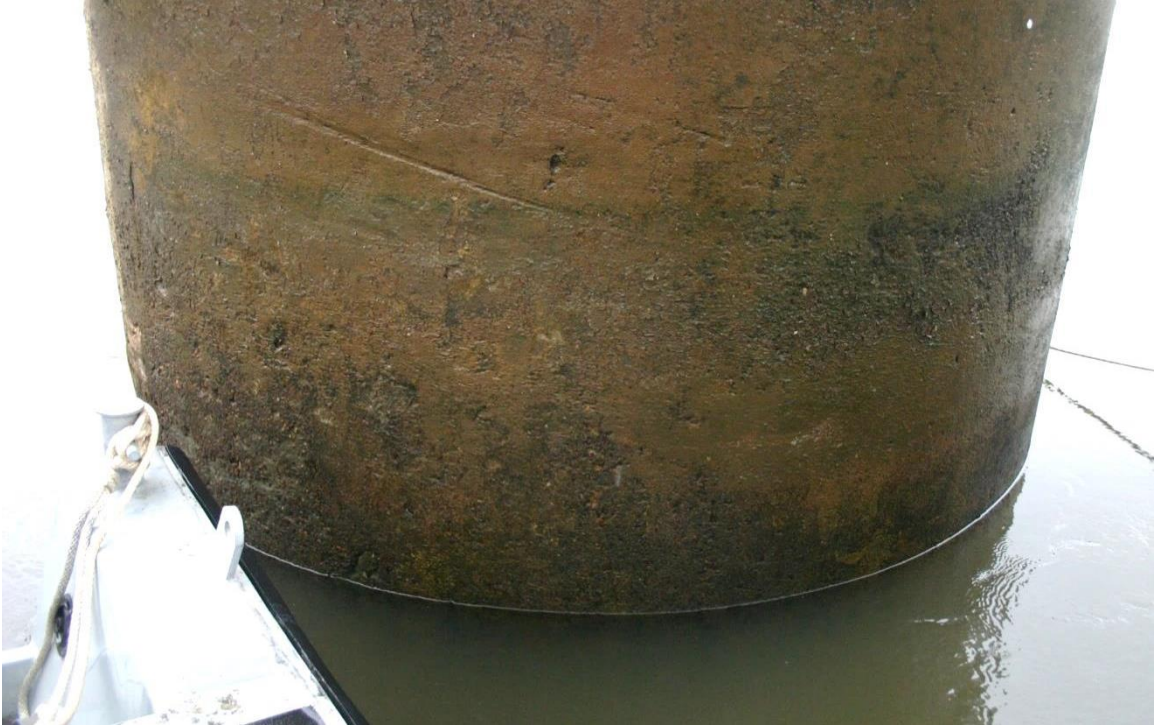
Figure 4.58 East side of test shaft 8 pre-cleaning.

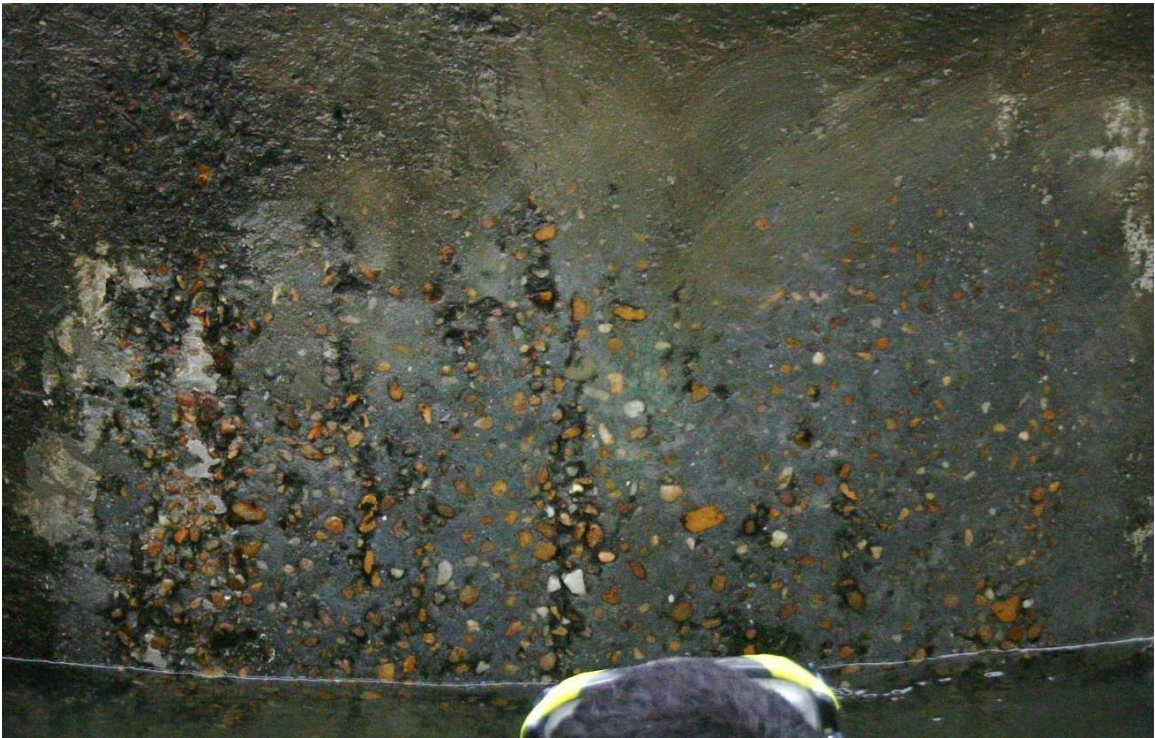
Figure 4.59 East side of test shaft 8 post-cleaning.

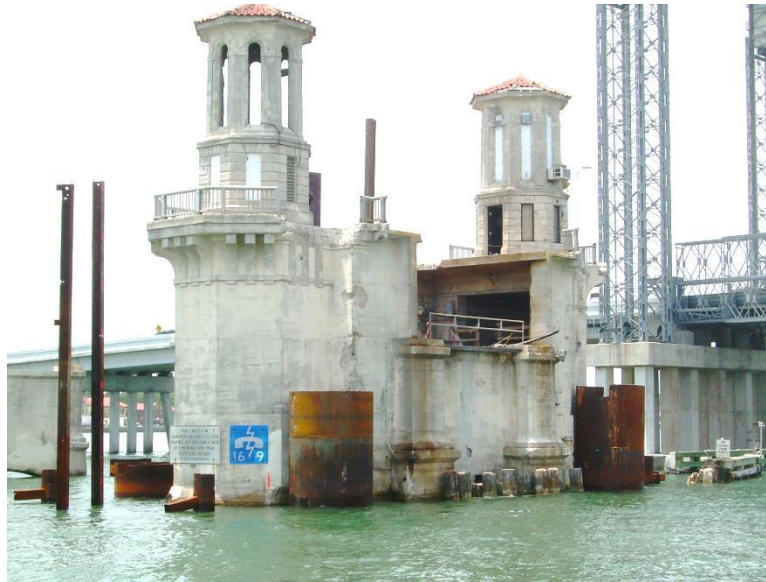
When Bridge of Lions was rehabilitated, shafts were constructed using attapulgate slurry around the existing piers and a below-water footing was cast to tie the existing caissons to the new sister shafts (Figure 4.60 and 4.61). Figure 4.60 shows the 8-ft diameter casing at the corners of the west bascule pier. These shafts were those indicated as possible locations for investigation. Figure 4.61 shows four 8-ft casings around each of the neighboring piers 13 and 14.

Figure 4.60 West Bascule (Pier 15 implied via plans / Pier 11 via inspection report) during rehabilitation; image taken from SE side looking NW.

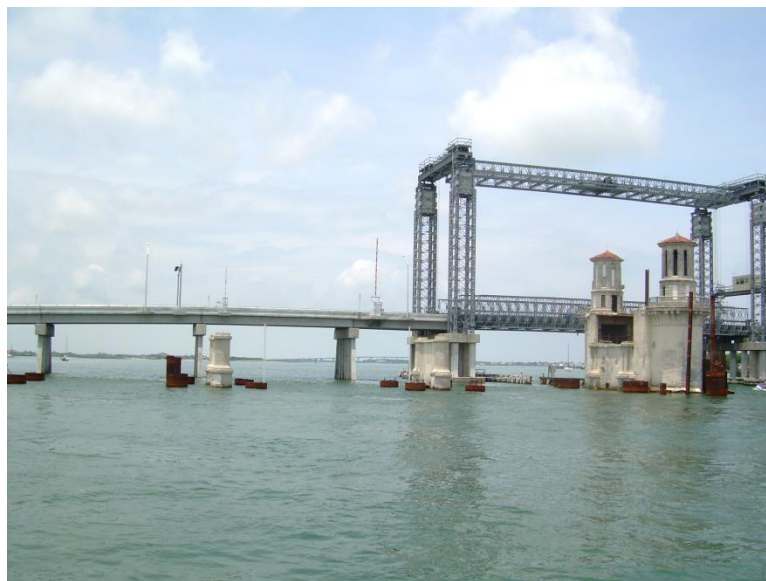
Figure 4.61 West Bascule (Pier 15; right), Piers 14 and 13 moving to the left with four 8-ft shaft casings shown from south looking north during rehabilitation.

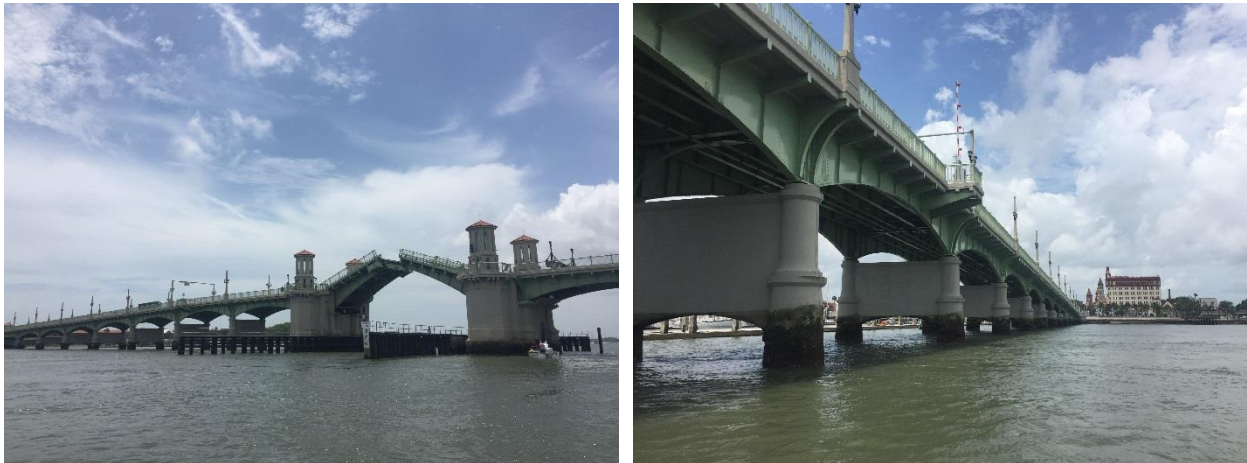
Figure 4.62. Existing main span bascule piers of Bridge of Lions (left); approach spans Pier 14 closest decreasing in number into the distance (per plan numbering).

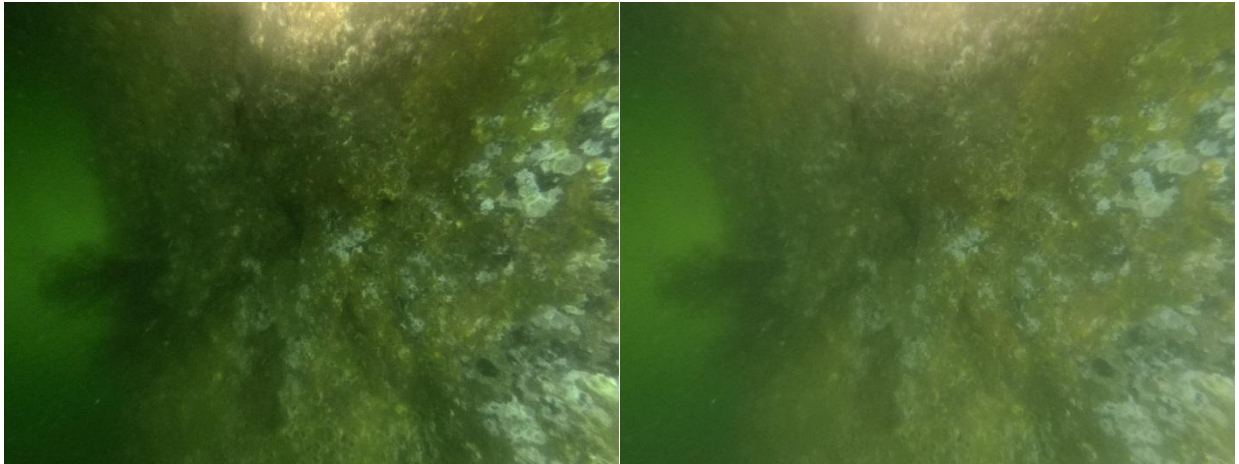
Figure 4.20 95-1 prior to cleaning.

Figure C.1. Figure 4.20 Photoshopped (left), original (right)

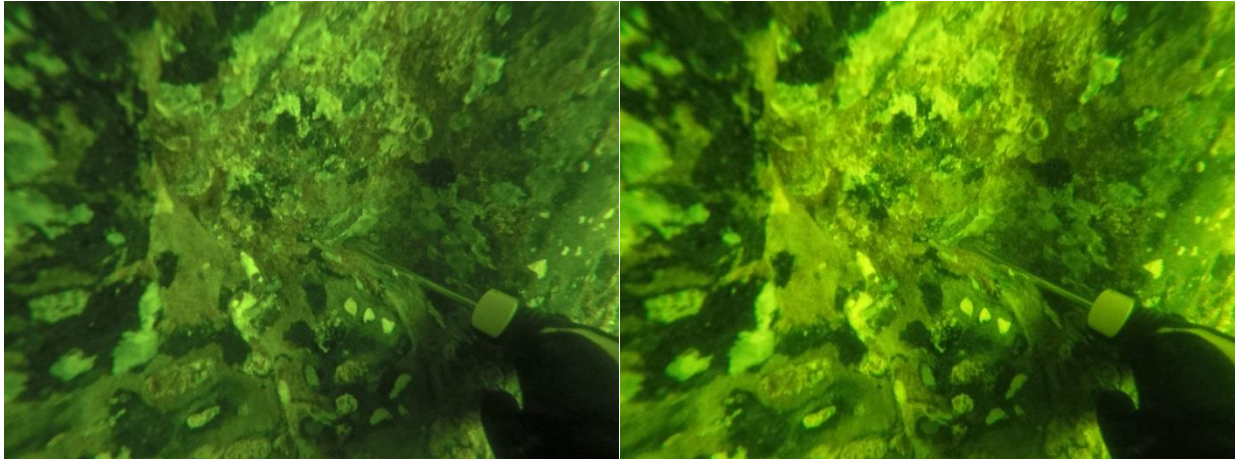
Figure 4.22 2-3in. void in Shaft 95-1 post-barnacle scraping

Figure C.2. Figure 4.22 Photoshopped (left), original (right)

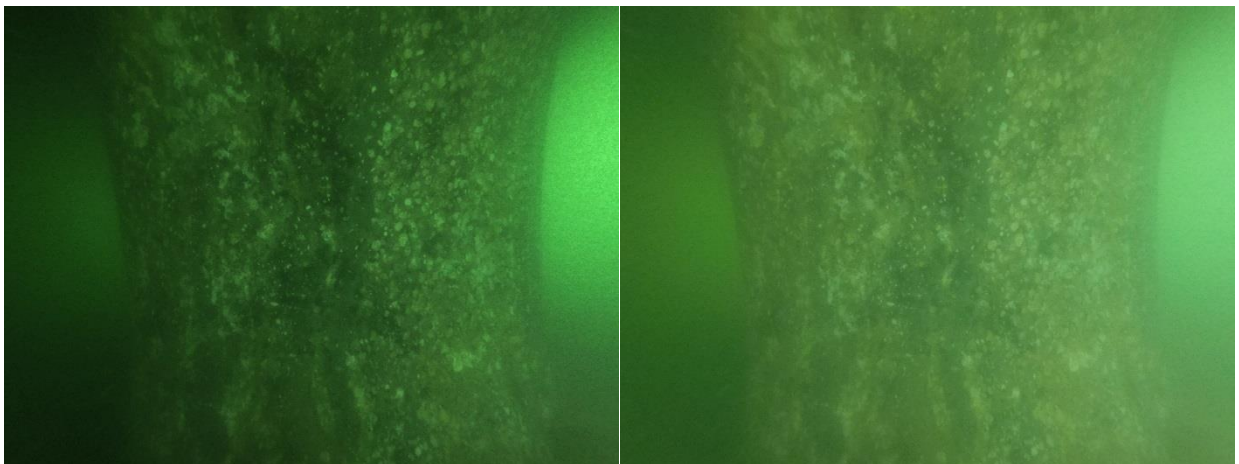
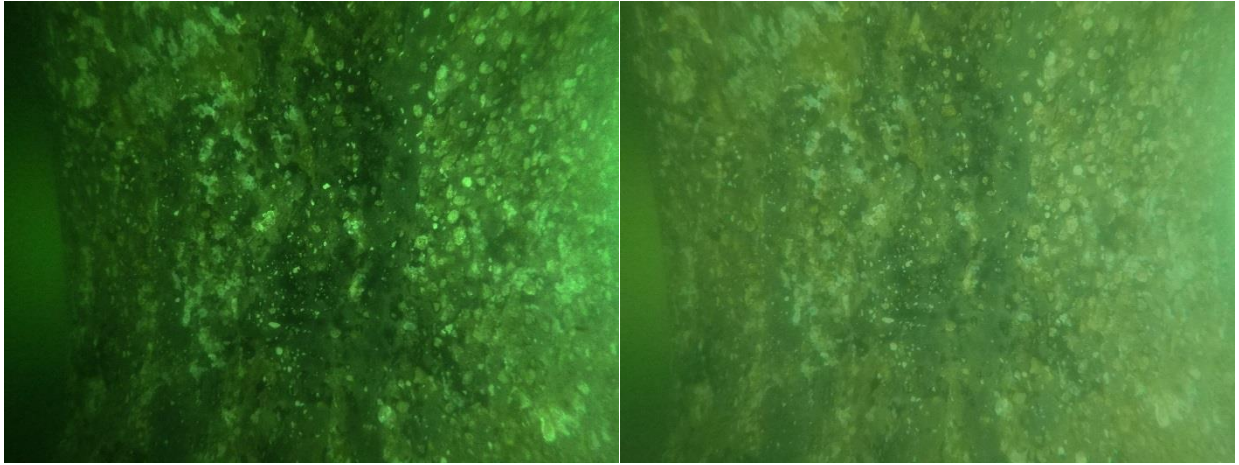
Figure 4.23 (a) View of the north side of 95-1 post-cleaning, (b) zoomed in view of (a)

Figure C.3. Figure 4.23(a) Photoshopped (left), original (right)

Figure C.4. Figure 4.23(b) Photoshopped (left), original (right)

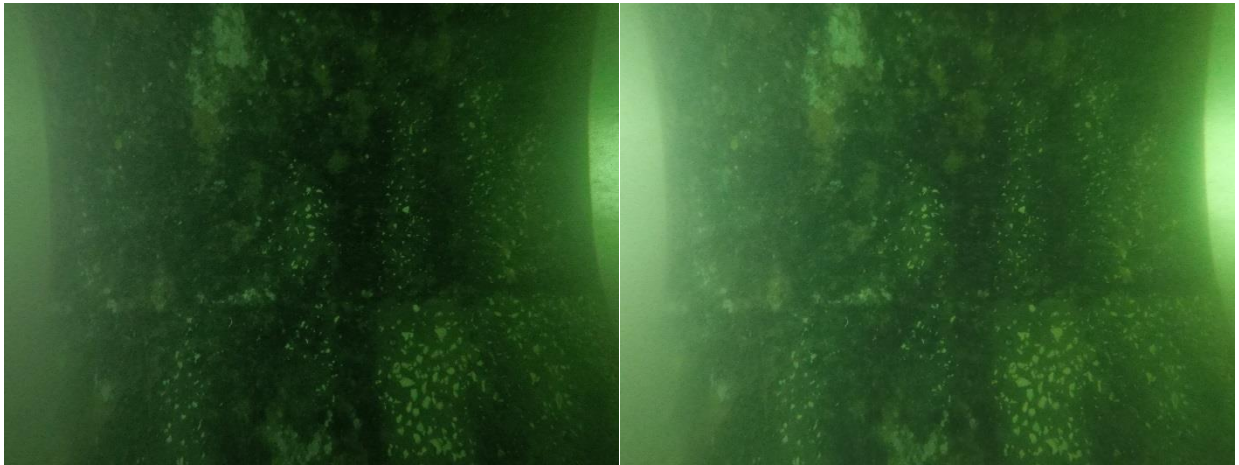
Figure 4.24 (a) South (interior) side of 95-1 post-cleaning, (b) zoomed in view of (a)

Figure C.5. Figure 4.24(a) Photoshopped (left), original (right)

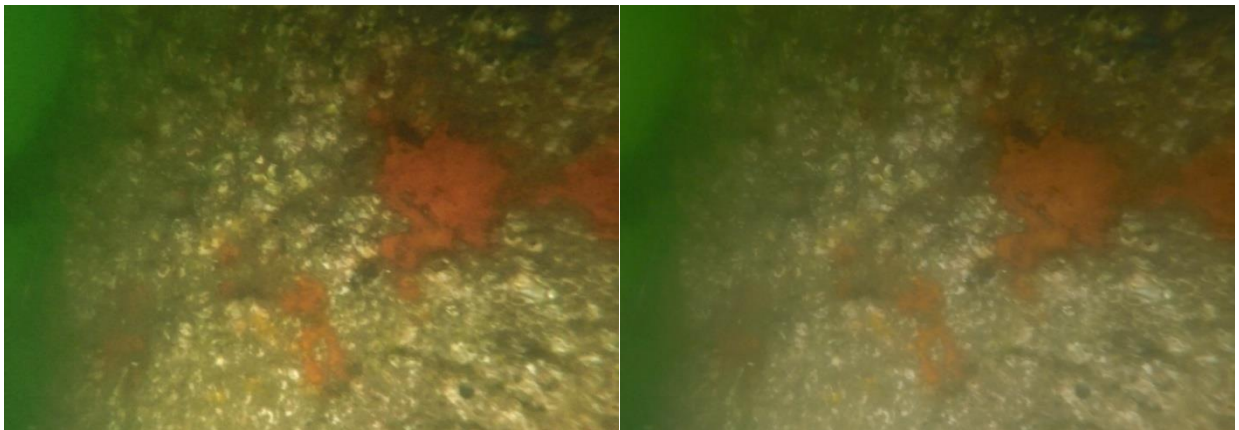
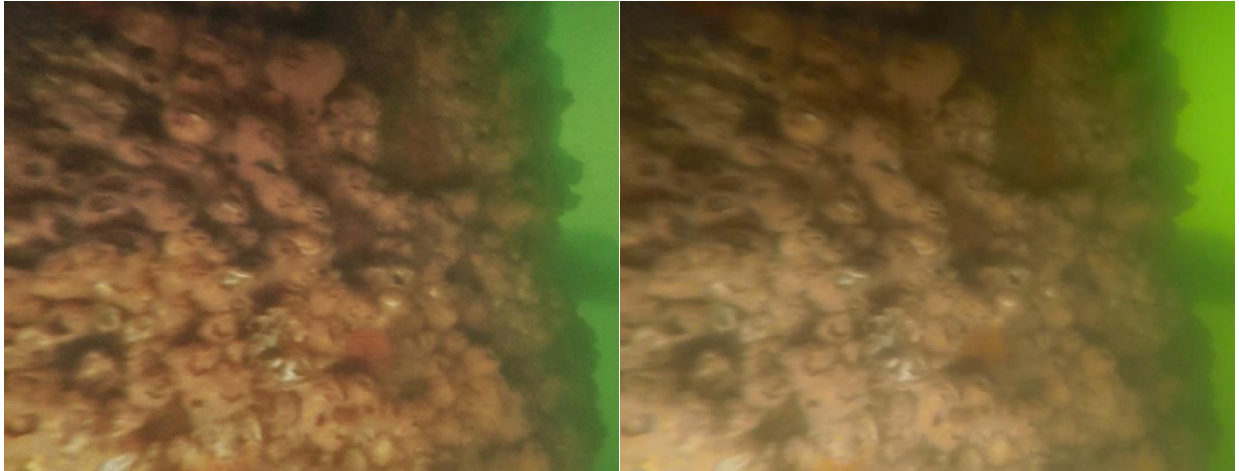
Figure C.6. Figure 4.27 (left image) Photoshopped (left), original (right)

Figure C.7. Figure 4.27 (right image) Photoshopped (left), original (right)

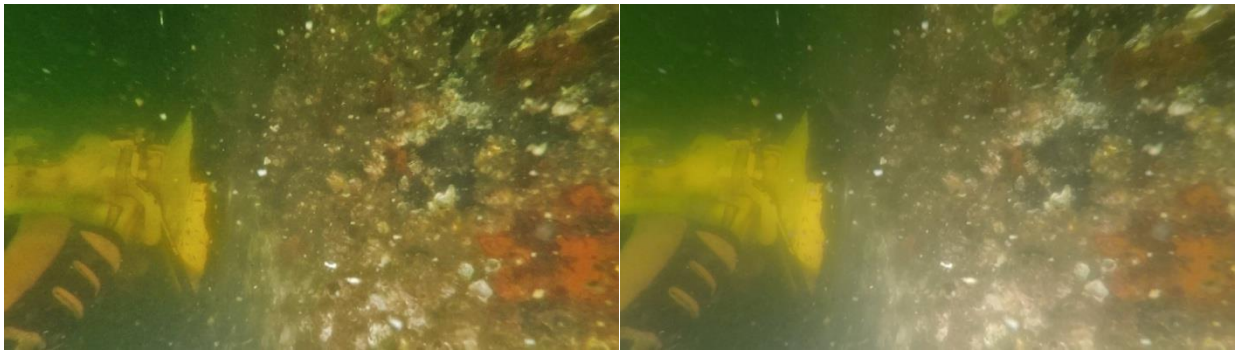
Figure 4.28 Shaft 94-4 during cleaning with the grinder

Figure C.8. Figure 4.28 Photoshopped (left), original (right)

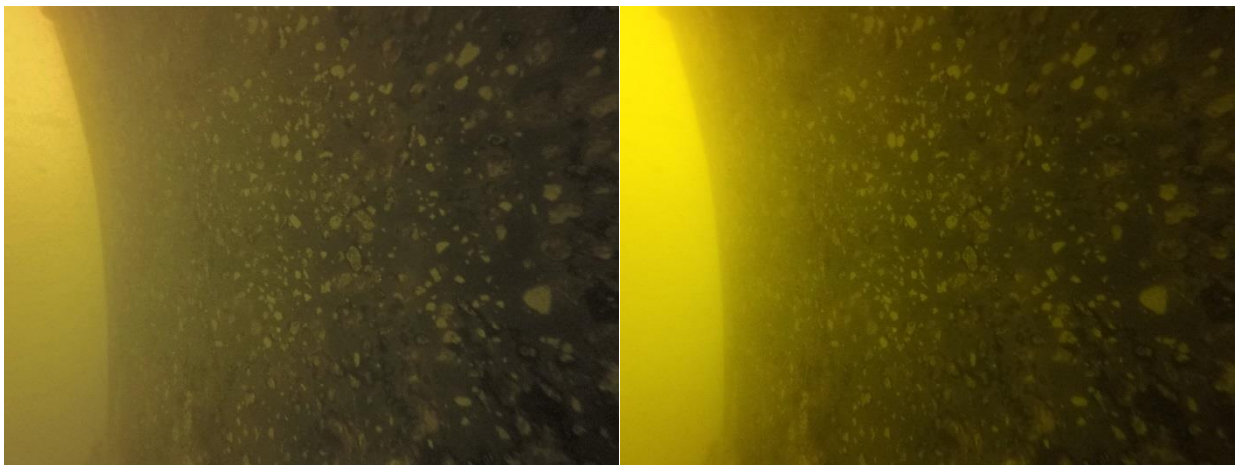
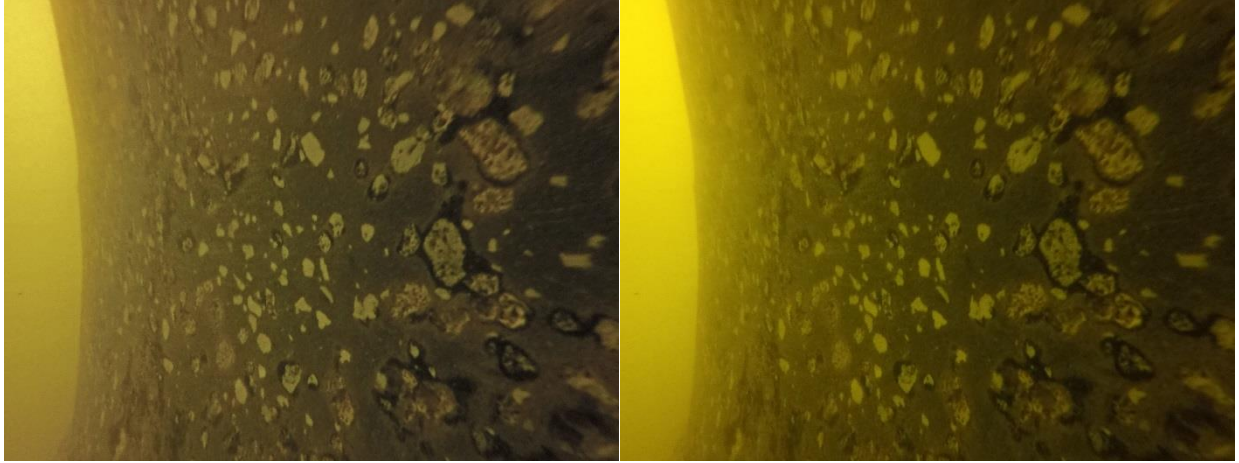
Unfortunately there is no image of 85-2 before cleaning; however, it looked similar to others covered in barnacles. While the cleaned section of the shaft overall shows a smooth surface (Figure 4.30), there are small crevices. As seen in Figures 4.31 and 4.32, barnacles and sea-life fill in these voids. The small voids/crevices are believed to have been caused by the double reinforcement cage, as this was not seen on the 4 ft diameter, single reinforcement cage shafts inspected at Pier 95.

Figure 4.30 Shaft 85-2 after cleaning

Figure C.9. Figure 4.30 (left image) Photoshopped (left), original (right)

Figure C.10. Figure 4.30 (right image) Photoshopped (left), original (right)

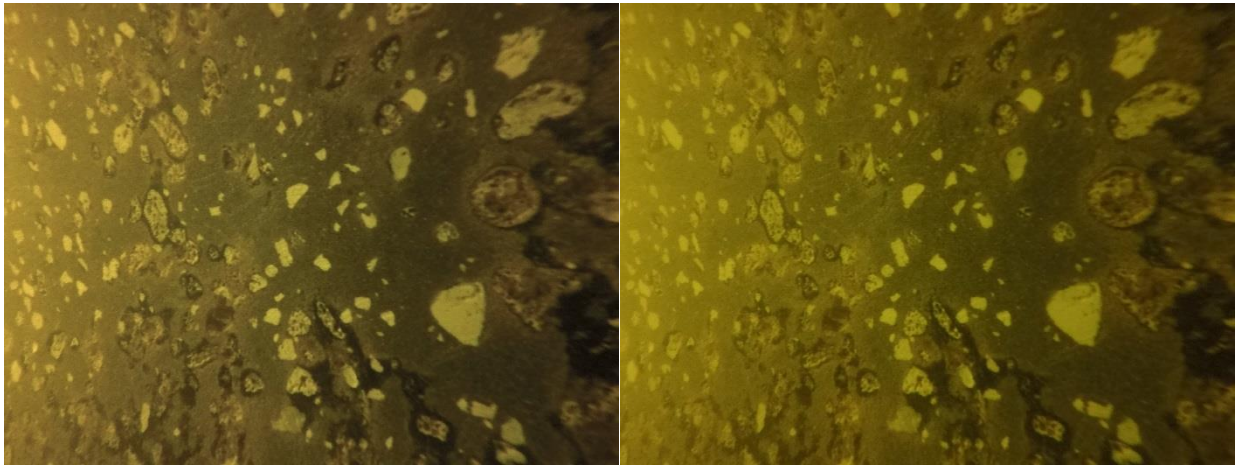
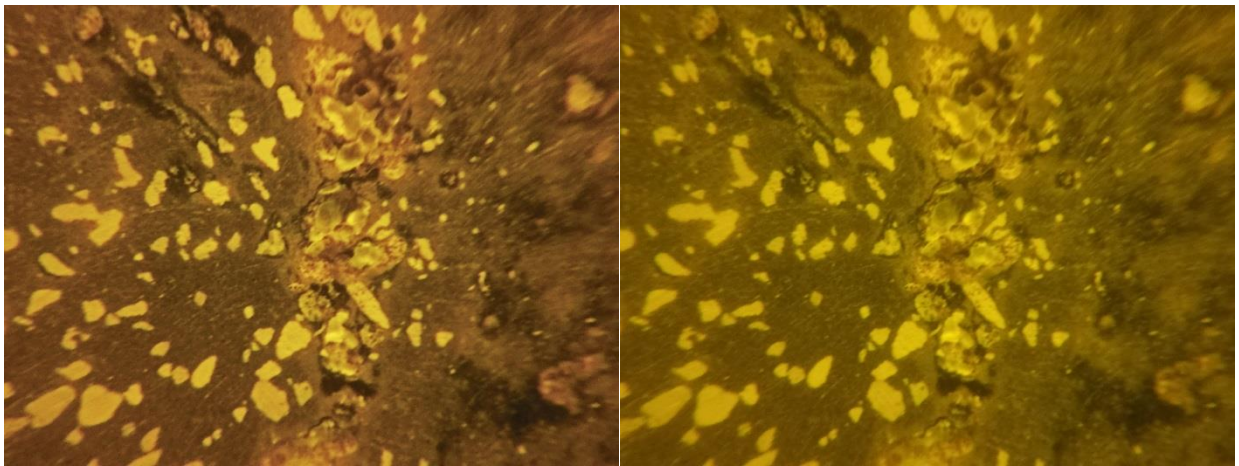
Figure 4.31 Crevices in 85-2 filled with barnacles

Figure C.11. Figure 4.31 (left image) Photoshopped (left), original (right)

Figure C.12. Figure 4.31 (right image) Photoshopped (left), original (right)

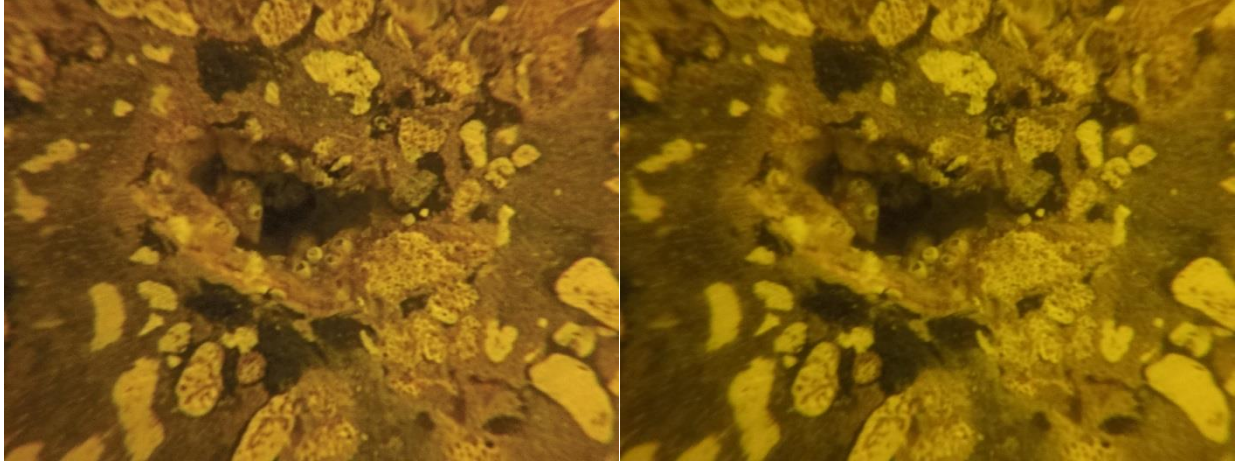
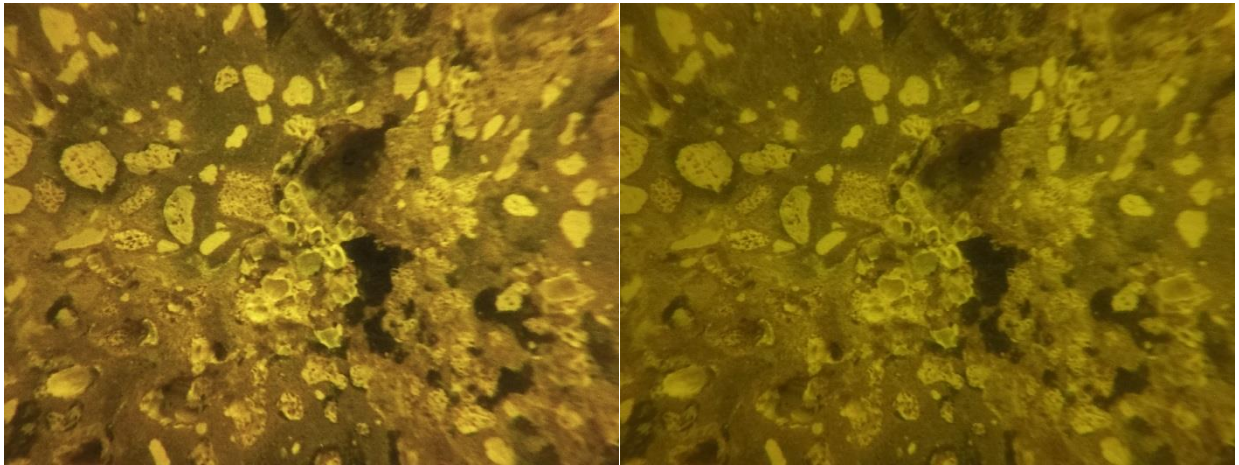
Figure 4.32 Small voids in 85-2 filled with sea-life and barnacles

Figure C.13. Figure 4.32 (left image) Photoshopped (left), original (right)

Figure C.14. Figure 4.32 (right image) Photoshopped (left), original (right)

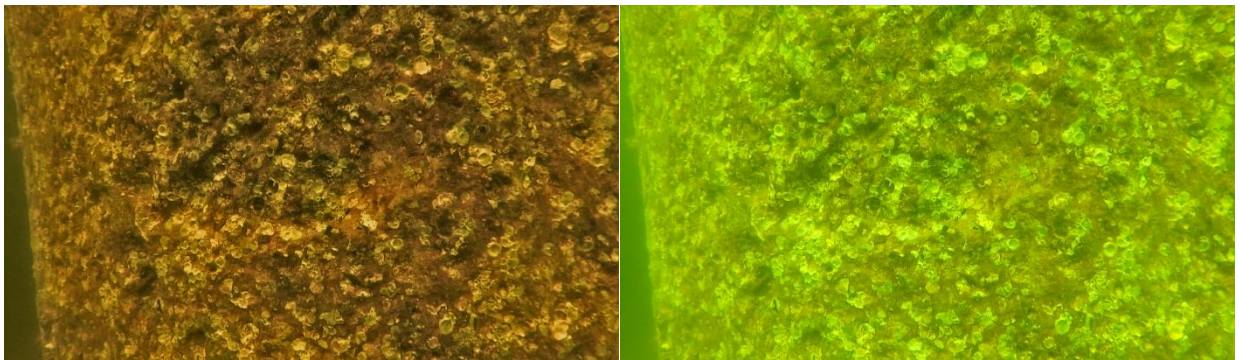
In contrast to Pier 85, Pier 84 had voids on all four shafts. Pier 84 contains 6-ft diameter Type 1 reinforced shafts (Figure 4.19(c)). Shaft 84-4 was chosen for inspection as it is listed as having two voids. Figure 4.33 shows 84-4 with a thick layer of barnacles prior to cleaning. This layer is better viewed in Figure 4.34 where the cleaned concrete transitions into the barnacle layer. Figures 4.35 and 4.36 show the cleaned portions of the shaft from east and southeast sides. It can be seen in these figures that the concrete is not completely smooth like the 4-ft shaft. The circled red areas on Figure 4.35 represent areas of the cleaned concrete that are filled with barnacles. Therefore the 6-ft Type 1 shafts seem to experience at least small voids in the concrete. As mentioned for Pier 85, this is suspected to have been caused by the double reinforcement cage. Figure 4.37 shows the layers found when cleaning the concrete. Consistently throughout the examination of the Gandy shafts, encrustations were found consisting of barnacles and miscellaneous plant life/organisms. Upon initial cleaning, barnacles were knocked/scraped off and the remnants of the barnacle attachment were then removed. Below this layer, a thin black layer was encountered which was difficult to remove. In cases of smooth surfaces with no significant voiding, pristine concrete could clearly be seen. Rougher surfaces with voids retained the plant life, barnacles and black layer. Except for isolated instances, there was no attempt to dig into voids and determine the full depth.

Figure 4.33 Shaft 84-4 prior to cleaning

Figure C.15. Figure 4.33 Photoshopped (left), original (right)
