**EVALUATION OF SELF CONSOLIDATING CONCRETE AND CLASS IV CONCRETE FLOW
IN DRILLED SHAFTS – PART 1**

BDV25 TWO977-25

Task 2b Deliverable – Field Exploratory Evaluation of Existing Bridges with Drilled Shaft Foundations

***Chapter Four: Field Exploratory Evaluation of Existing Bridges with Drilled Shaft Foundations
(Task 2b Deliverable)***

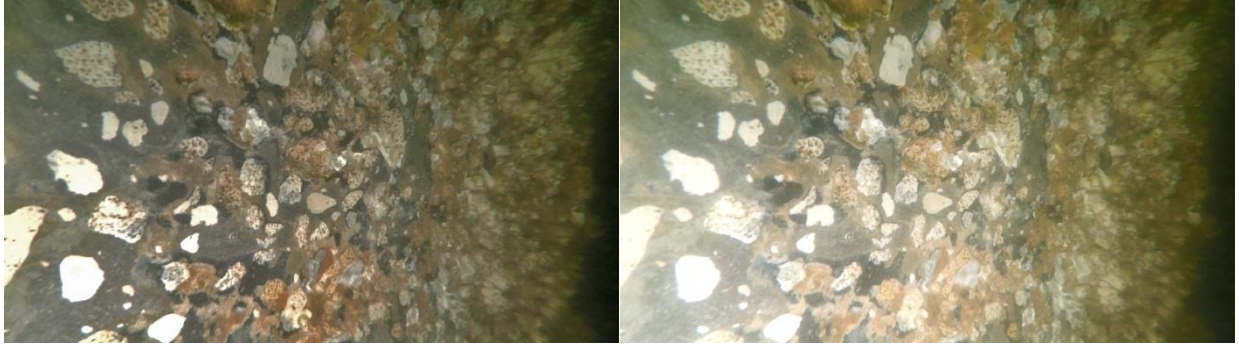
Figure 4.34 Shaft 84-4 partially cleaned, note clean concrete going into layer of barnacles

Figure C.16. Figure 4.34 Photoshopped (left), original (right)

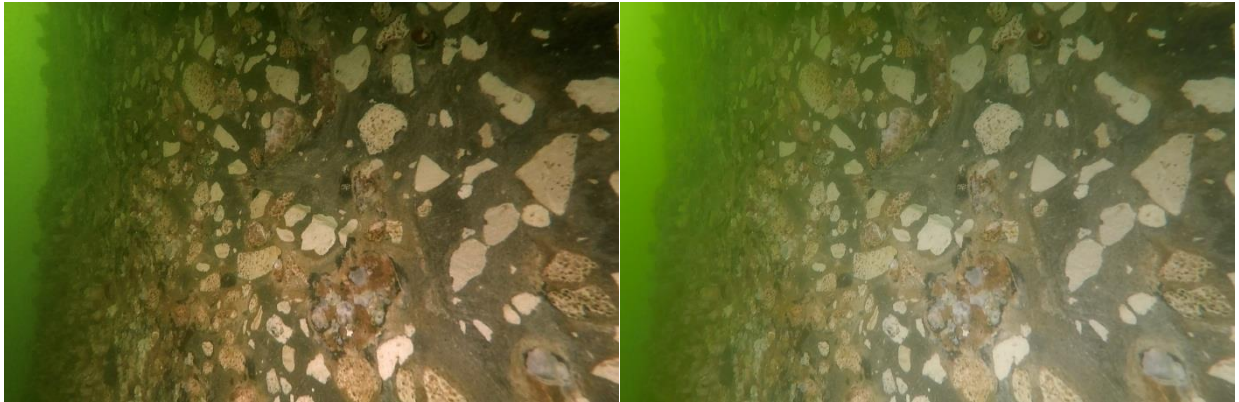
Figure 4.35 Cleaned portion of 84-4 on the southeast side of the shaft, circled sections indicate small voids in concrete filled by barnacles

Figure C.17. Figure 4.35 Photoshopped (left), original (right)

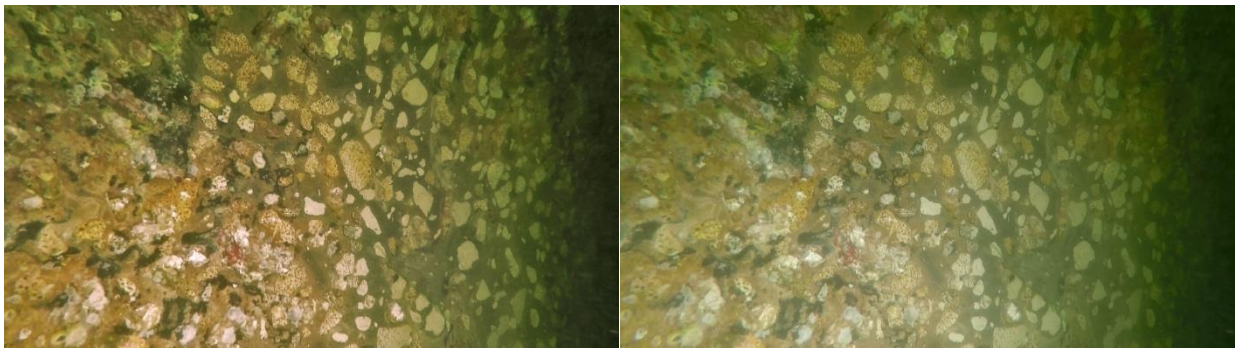
Figure 4.36. Cleaned portion of 84-4, east side of shaft

Figure C.18. Figure 4.36 Photoshopped (left), original (right)

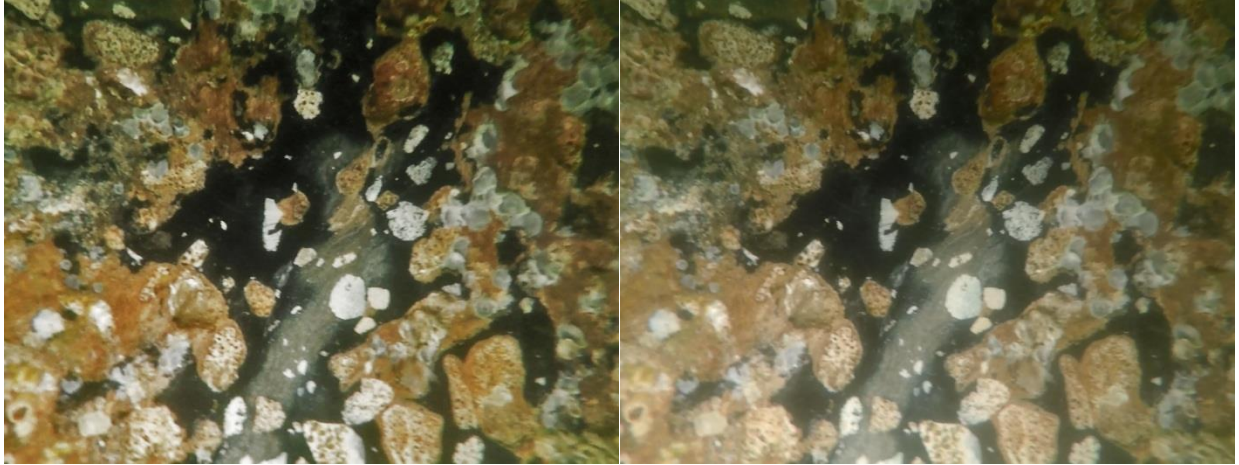
Figure 4.37 Layers from barnacles to black unknown layer to concrete

Figure C.19. Figure 4.37 Photostopped (left), original (right)

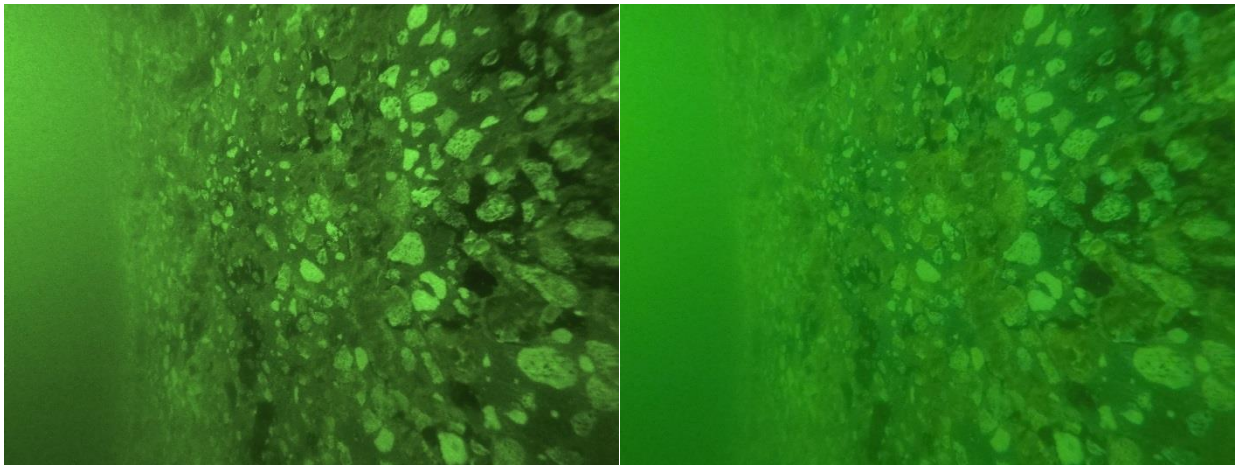
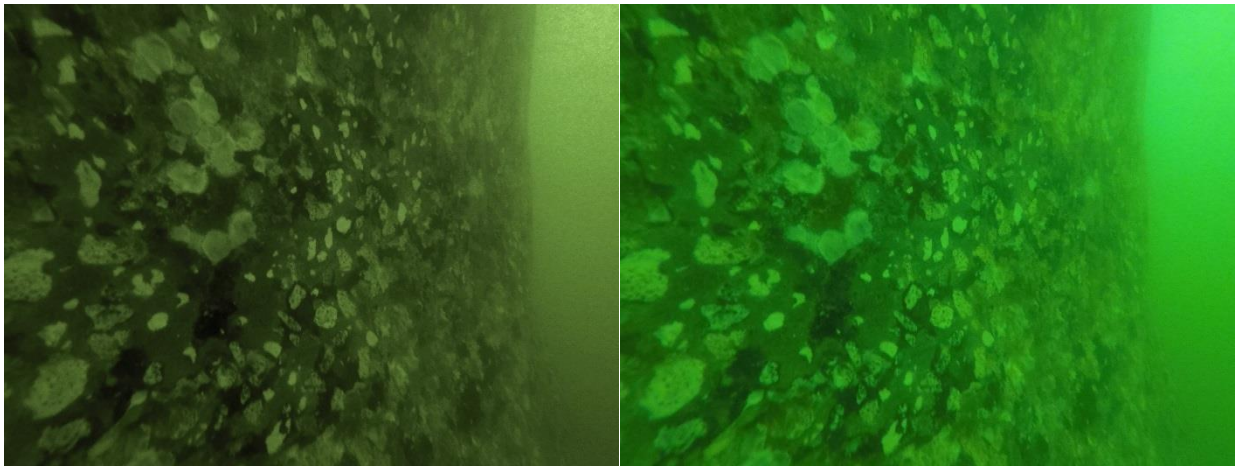
Pier 71 contains 7-ft diameter Type 1 shafts (Figure 4.19(d)). Two shafts 71-1 and 71-4 were listed as having voids in the dive report, and shaft 71-4 was chosen for inspection. Unfortunately, no images of the shaft were taken before cleaning; however, it looked similar to the shafts shown above, covered in a layer of barnacles. Figure 4.38 shows each side of the cleaned portion of the shaft. As noted for Piers 84 and 85, the 7-ft shafts also had small voids in the cleaned concrete surface (Figure 4.39). Sections of cleaned concrete can be seen up-close in Figure 4.40; note that this concrete was the roughest seen on this bridge. Figure 4.41 shows a long crevice in 71-4.

Figure 4.38 Shaft 71-4 post-cleaning

Figure C.20. Figure 4.38 (left image) Photostopped (left), original (right)

Figure C.21. Figure 4.38 (right image) Photostopped (left), original (right)

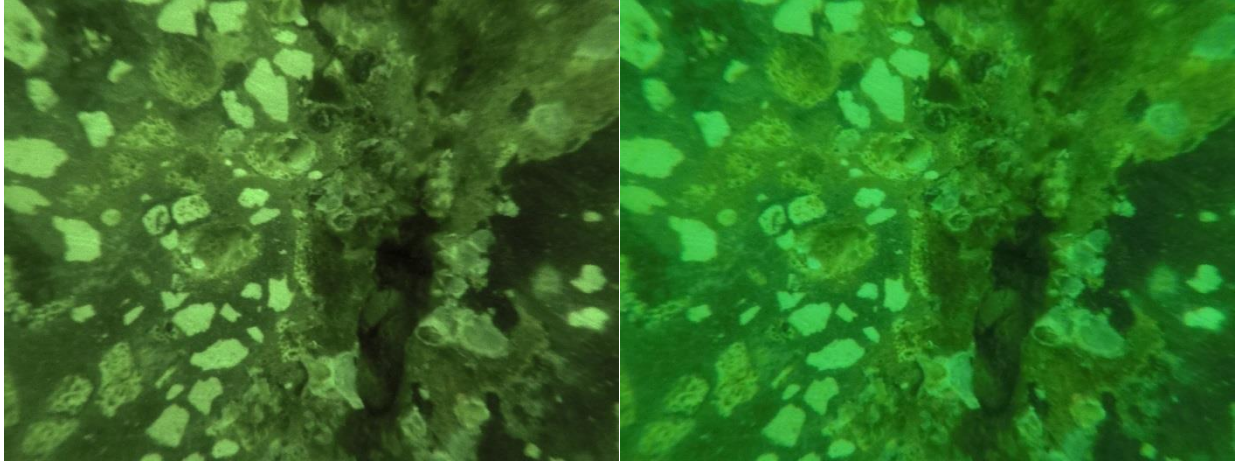
Figure 4.39 Close up of a small void on 71-4

Figure C.22. Figure 4.39 Photoshopped (left), original (right)

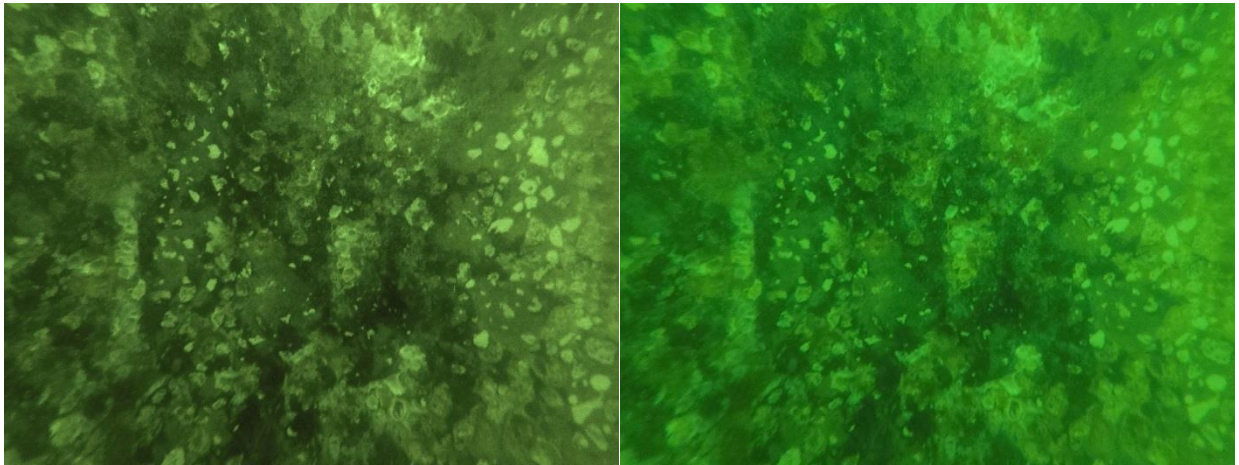
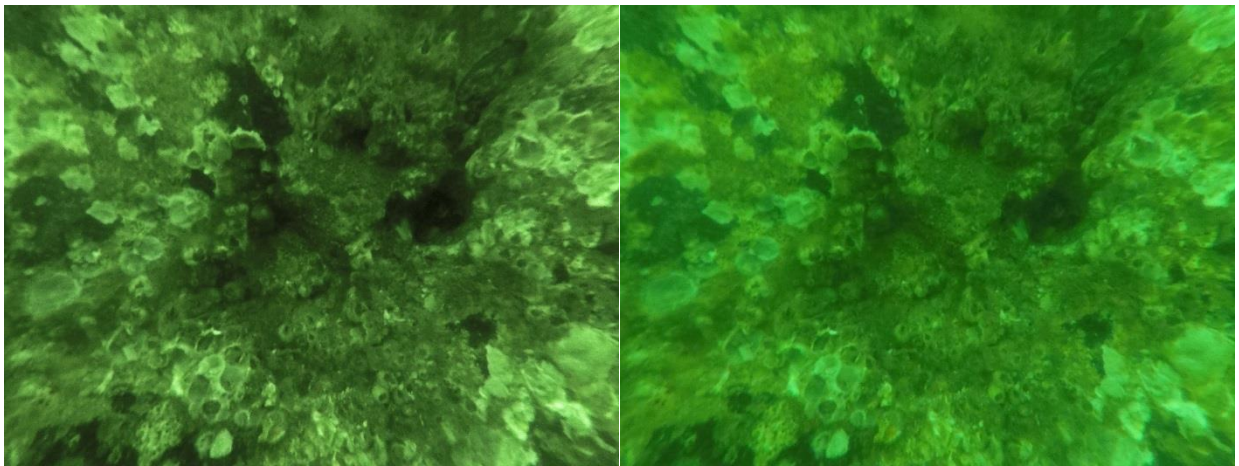
Figure 4.40 Cleaned concrete on 71-4, close pictures

Figure C.23. Figure 4.40 (left image) Photoshopped (left), original (right)

Figure C.24. Figure 4.40 (right image) Photoshopped (left), original (right)

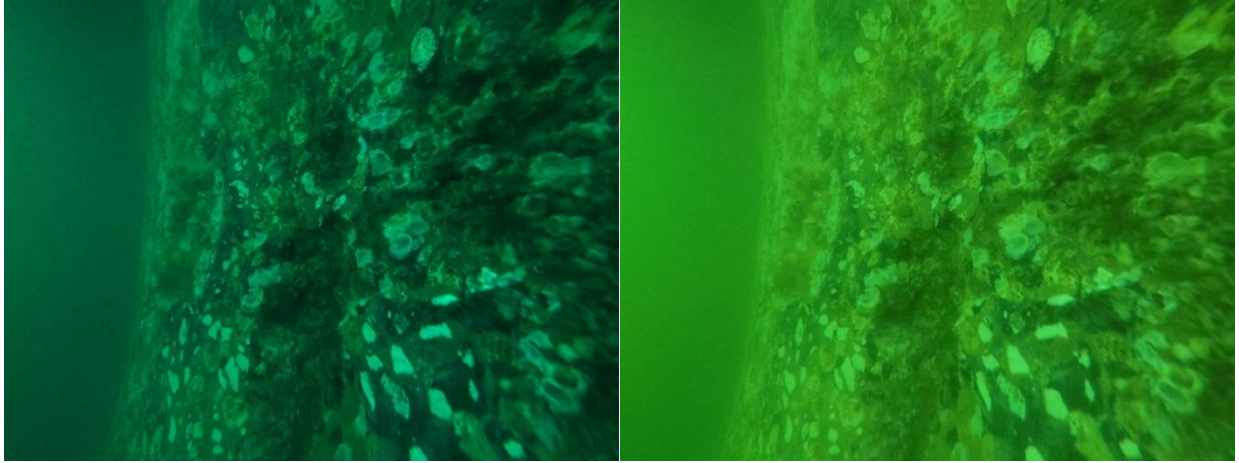
Figure 4.41 Large void found on the south side of 71-4

Figure C.25. Figure 4.41 Photoshopped (left), original (right)
